ALIGNMENT ERROR ANALYSIS OF KAL KE007 INERTIAL NAVIGATION SYSTEM

Chan Ung Park

Won Kwang University, Electronics Dep't

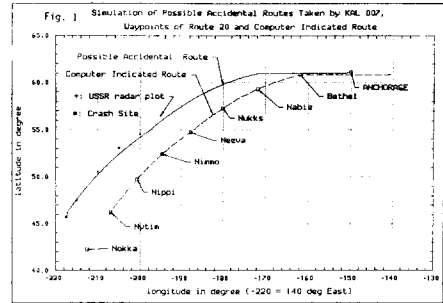
The possible explanations as to why 007 was off course at Bethel are extremely limited. The actual flight path is not known exactly and sketchy to the public except the USSR radar plot for KAL published (ref. 3). The Japan version of radar plot is slightly different from the USSR's. A possible actual route including the shutdown location is simulated and shown in Figure 1.

A computer indicated simulated flight path is shown in Figure 1. Big arc circle path is assumed between each waypoints. The crash site and the USSR radar plot for KAL positions are also shown in Figure 1.
