Alternating Current - Induced Fatigue Damage in Cu Interconnects

박영배, C. A. Volkert*, E. Arzt*
안동대학교 신소재공학부, * 막스플랑크금속연구소

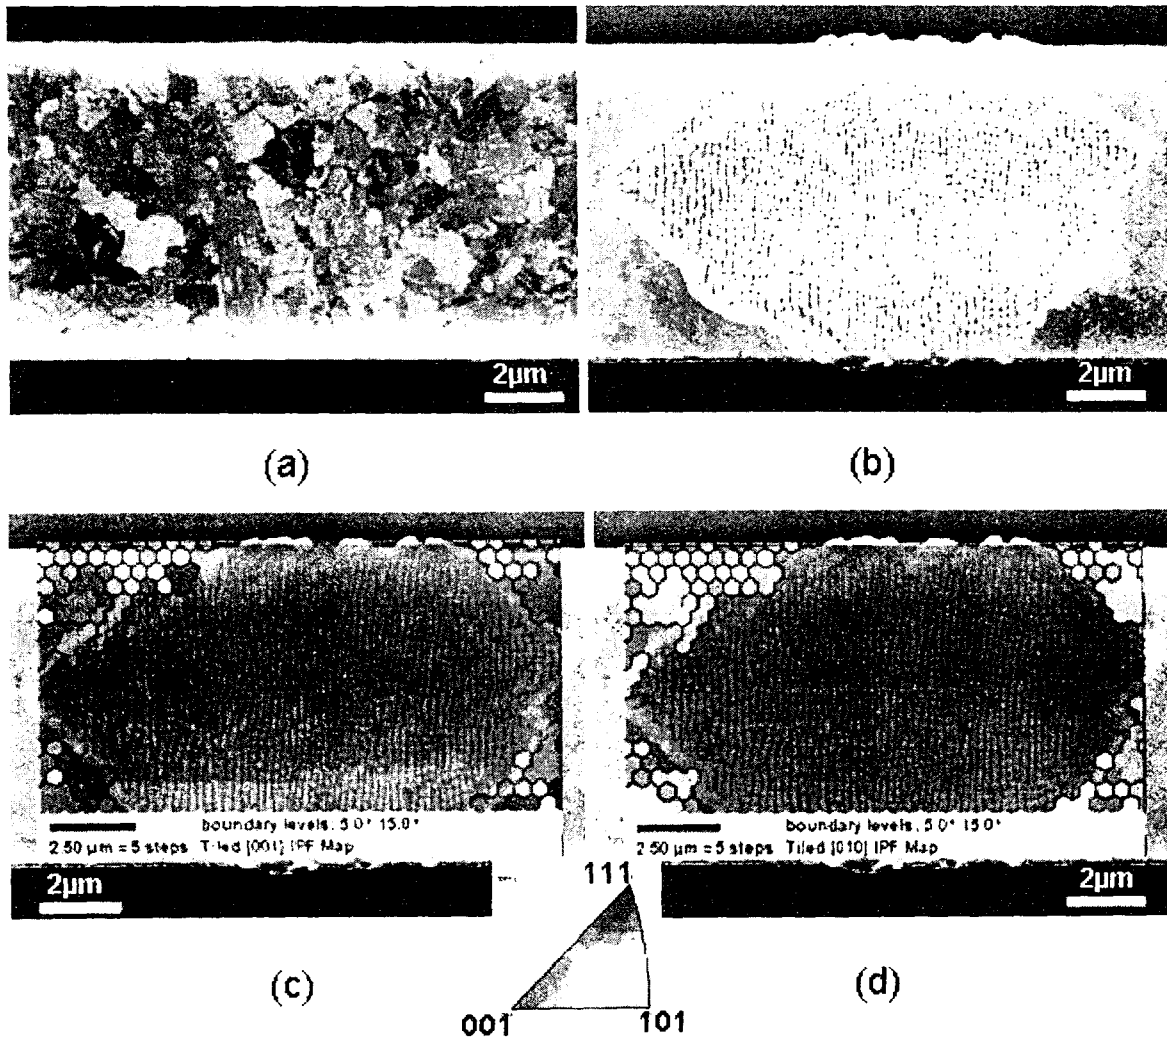
Fig. 3. Damaged (100) grain microstructure of 10nm Ta\200nm Cu line (a) BSE image of the line before AC test, (b) SEM image, (c) EBSD map of out-of-plane orientation, and (d) EBSD map of in-plane transverse (line) orientation for a big damaged (100) grain after AC test at 10kHz frequency, $\Delta T = 190^{\circ}\text{C}$, and 7.5×10^5 cycles. Here, [001] and [010] directions marked in EBSD pictures corresponded to out-of-plane orientation and in-plane line orientation, respectively.

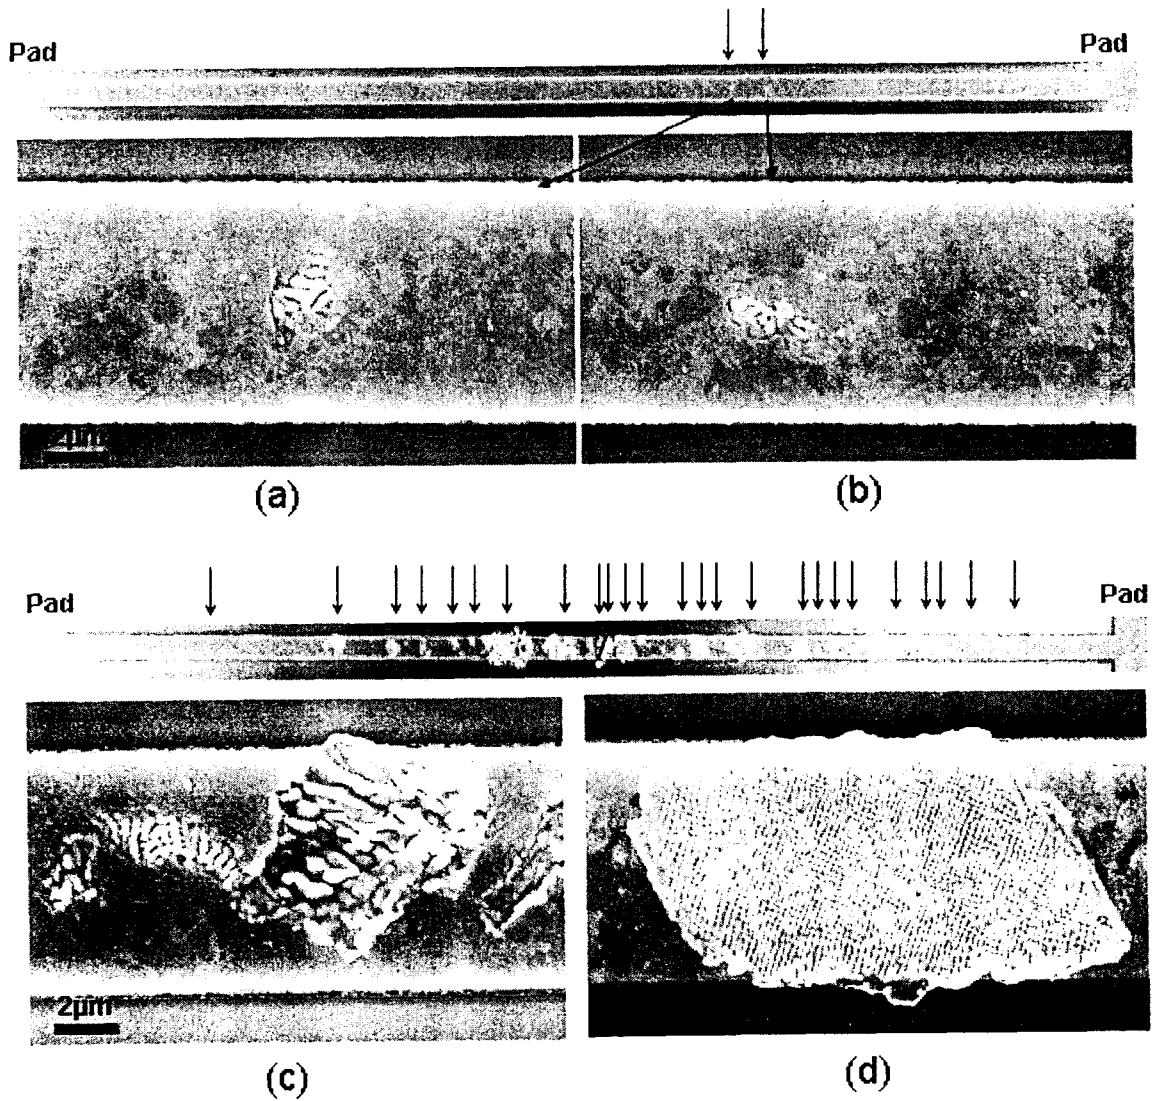
Fig. 4. Loading frequency effect of coarse-grained 10nm Ta/200nm Cu lines SEM pictures of tested whole metal lines (upper long lines) and of representative damage morphologies (lower damage pictures) for $\Delta = 190^\circ\text{C}$ by applying (a), (b) 100Hz and stopped at 8.0×10^7 cycles with 0.2% DAF, and (c), (d) 10kHz and failed at 8.0×10^7 cycles with 20% DAF. Here, damaged area fraction (DAF) was defined as total damaged area observed from SEM pictures of whole metal line divided by the whole metal line area. Each arrow in upper line means each damage location in whole metal line.
