Study of point defects caused by a thin contamination layer in a-Si TFT-LCD

Jae Young Oh*, Jae Kyun Lee, Mounng Su Yang, In Byeong Kang

LG. Philips LCD R&D Center, 533, Hogae-dong, Dongan-gu,
Anyang-shi, Kyongki-do, 431-080, Korea

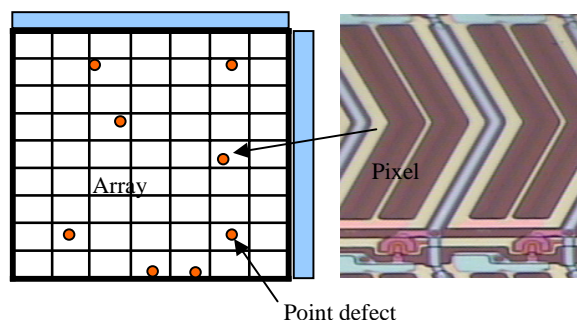
The Invisible Point Defect (IPD) is the fail of a dot which cannot be observed through microscope, but observed at final array test. It was difficult to find out the source of defects because any defect could not be seen even by high magnification microscope. Point defects should be removed for quality improvement and high-end products. Characteristics of IPD were summarized in Figure 1.

Panel test shows that some points are failed. Only one pixel does not work at failed position. No damage or contamination is observed.

Fig. 1. Description of Invisible Point Defect

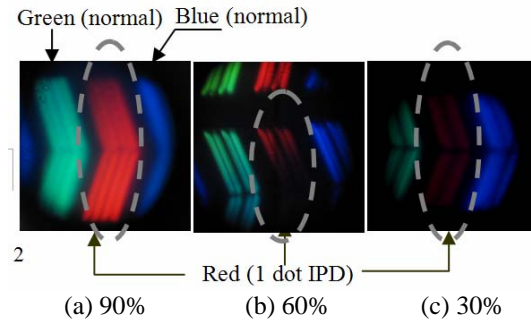
is significantly different to the normal pixel when same AC voltage applied. As shown in Figure 2, the luminance was same at the gray level 90%, but as gray level decreased, the luminance of IPD diminished faster than the luminance of normal thin film transistors (TFTs).

Fig. 2. The voltage driving test results of Invisible Point Defect (IPD) device comparing normal devices at both sides. IPD device shows a decrease in luminance at low gray level.

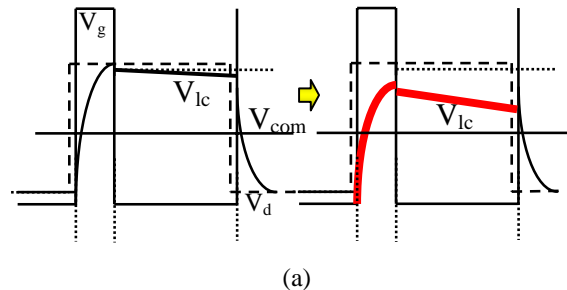
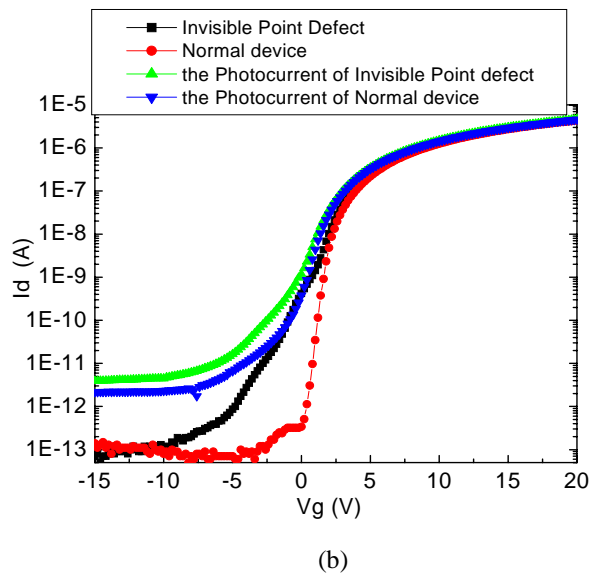
The dependence of s-factor or off-current (I_{off}) in TFT on charging characteristics was shown in figure 3.(a), where V_g , V_{lc} , V_{com} , V_d is gate voltage, liquid crystal drive voltage, common voltage, drain voltage, respectively. The leakage caused by a shift of s-factor, I_{off} in low gray level makes charging characteristics to be degraded. Therefore, it is supposed that luminance have been degraded as shown in Figure 2. The V_{lc} degradation is related to leakage current, resistance and parasitic capacitance in TFT. It was thought that leakage was related to gray level degradation. The transfer characteristics of TFT device were measured in Figure 3.(b). It showed that s-factor, I_{off} and threshold voltage (V_{th}) had degradation curve. That phenomenon was also same at the condition of light irradiation (photocurrent). The luminance decrease of the IPD can be explained by the degradation of holding characteristic identified TFT characteristic degradation. From the TFT characteristic result, it was expected that a-Si:H (active) layer could be damaged during TFT fabrication process. The reason of I_{off} increase was considered through theoretical study. The I_{off} could be increased when localized states distributed in the a-Si energy gap, [4] and when a current passage exist in the active layer. [5]

Fig. 3. (a) Prediction of charge characteristic change by voltage drop model in the case of IPD (b) Current-voltage characteristics of normal and IPD devices

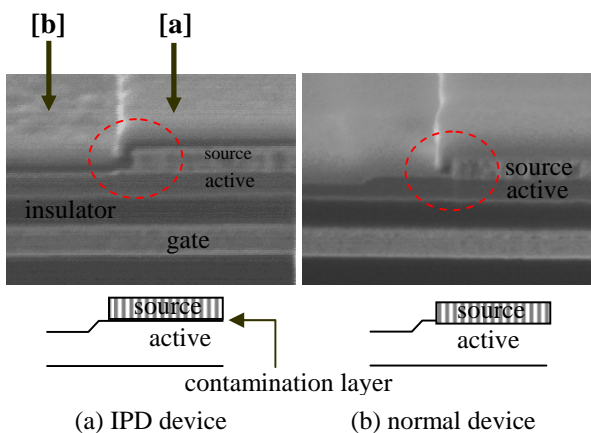
Focused ion beam (FIB) was performed to investigate an internal defect of TFT. The cross section of IPD and normal TFT were shown in Figure 4. A very thin layer was detected between active (a-Si) and source metal (Molybdenum_Mo). In the case of IPD, Mo and a-Si did not show inter-diffused structure compared to normal TFT. The contamination layer at the interface of active and source metal is considered to prevent Mo from diffusing to a-Si layer. It was expected that this phenomenon related device characteristics.

Mo and a-Si can not be silicidation under 320°C that is LCD panel anneal temperature.[6-7]. The slight inter-diffusion between Mo and a-Si was found just physical interface formation during Mo sputtering process. Through some tests, it showed that Argon (Ar) amount is dependent for physical contact between Mo and a-Si during sputtering process. As Ar amount increased, inter-diffusion length slightly increased.

Fig. 4. FIB analysis-the cross section of TFT

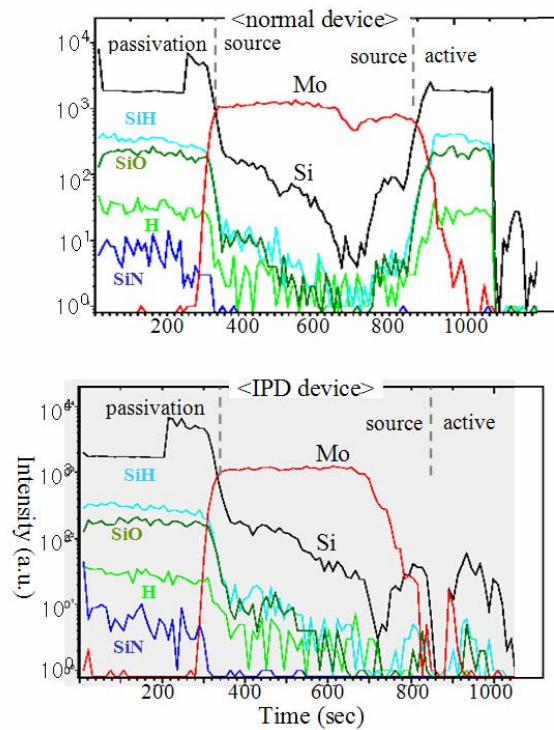
Figure 5 showed secondary ion mass spectrometry (SIMS) profiles of the same sample in Figure 4. SIMS depth profile tests were performed in the source metal and channel region of TFT. In Figure 5.(a), the Mo and a-Si intensities of IPD device were changed compared to normal device at the interface of those layers. Peaks of IPD device were decreased at the interface. This indicated that inter-diffusion, between Mo and a-Si, was blocked by a very thin contamination layer. In Figure 5.(b), the Mo peak increased more than normal device and Fe peak showed more high level intensity than normal device at the active surface region. The TFT degradation, shown in Figure 3, could be expected that the surface of channel was contaminated and the components of contamination layers were remained in the channel region. So, I_{off} current could be increased by contamination component.

**Fig. 5. (a) SIMS analysis-between TFT layers of IPD and normal device ([a] region in Fig. 4.)
(b) SIMS analysis-between TFT layers of IPD and normal device ([b] region in Fig. 4.)**

Further analysis showed the contamination layer components consisted of oxygen and iron and these were from water supply line during the cleaning process. After cleaning nozzle and any modification, the IPS defect decreased as shown in Figure 6.

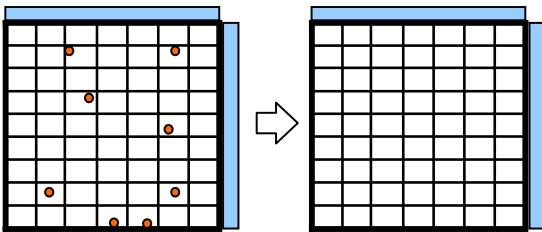
As the number of point defects decrease, high-end quality and yield panel would be attained. Also, less number of point defects, visual performance would be better. The results provided near zero of invisible point defects to the previous some point defects. (Figure 7) Ergonomic requirement could be satisfied with the results and pixel faults tolerance limit [8] could be also satisfied.

Fig. 6. A status of zero invisible point defect for improved visibility

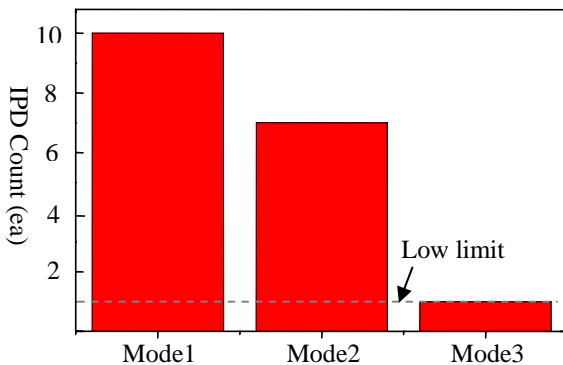
Fig. 7. A status of decrease of invisible point defect by cleaning process modification
