A Case Study on an Investigation of a Defect in a Valve Body for Power Plant

Song-Hee Kim*

1. Scope of Investigation

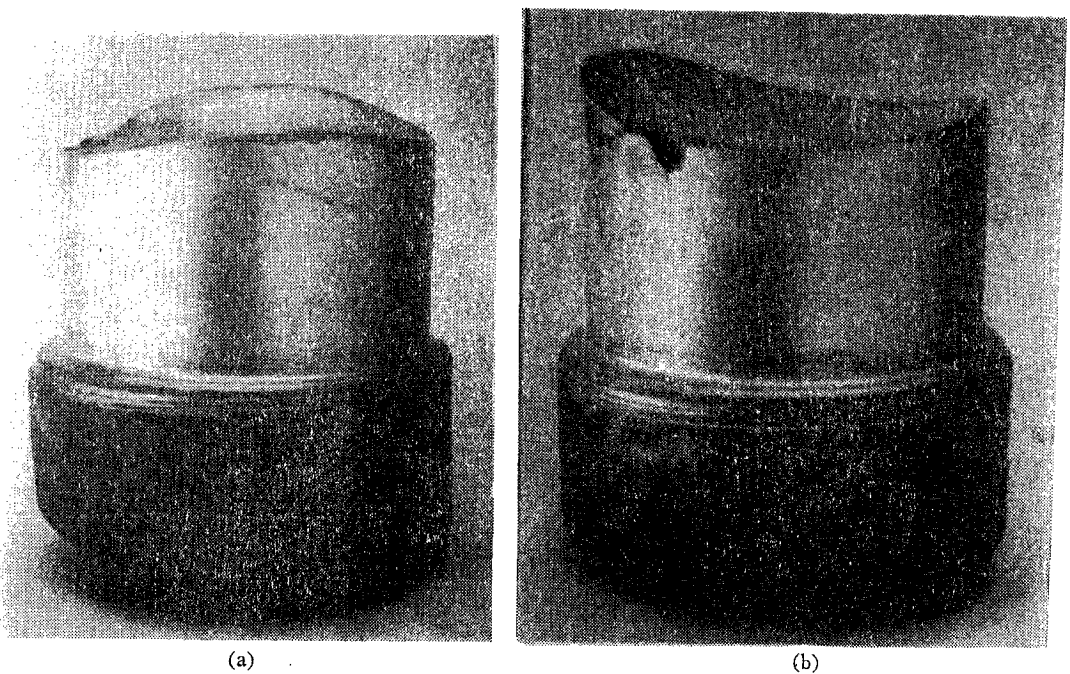
Figure 1. Two views of the sides of the trepanned cylinder.

(i) The weld profile is such that the width of the band of weld metal at the pipe surface is between 65 and 70mm. Further, it may be deduced that the two weld boundaries are, respectively, about 80mm and 145mm from the inside face of the pipe : this deduction is made on the basis that the location and dimensions of the valve seat are as given in the design drawing provided by S.C.O.A., -i.e. the vertical step of the valve seat visible in Figure 1a is 73mm from the inside face of the pipe. (A sketch of the profile is given in Figure 6).

(ii) A weld repair had been made to the casting before the valve seat had been welded in place. This repair is visible in Figure 1a and 1b. An estimate of its extent is sketched in Figure 2b and in Figure 6.

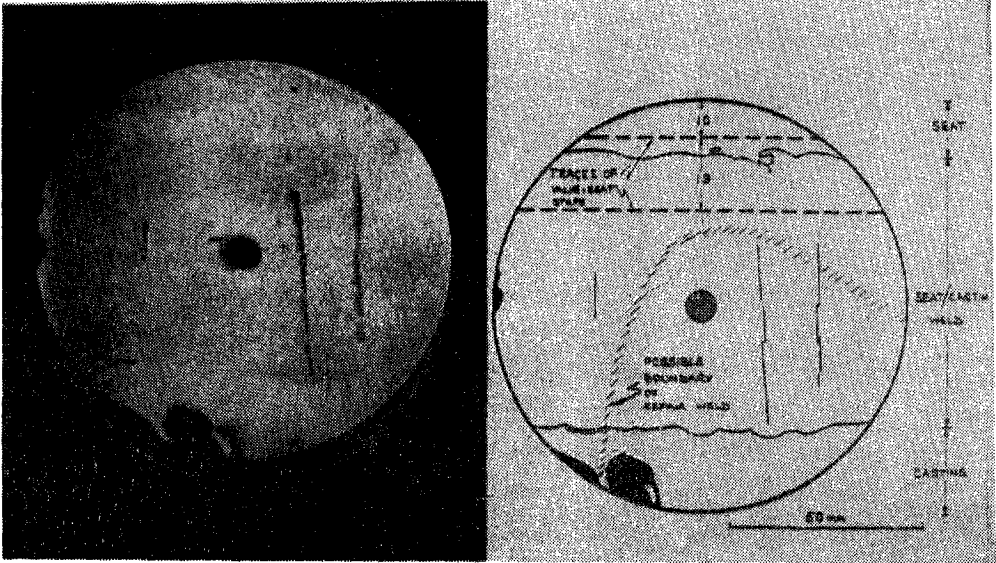
(a) (b)
 Figure 2. The top of the cylinder : i.e. inside face of body.

The remains of the oxygen-cutting scouring can be seen in the photographs. Regarding the top view(Figure 2), the three sets of chisel marks were made at S.C.O.A. to show where sub-surface defects were predicted on the basis of their ultrasonic N.D.I. The N.C.I. operator suggested that the defects under the two longer marks could possibly be linked so that it was in fact one defect and, further, that the defect under the shorter mark was not expected to be large : as will be seen one major defect

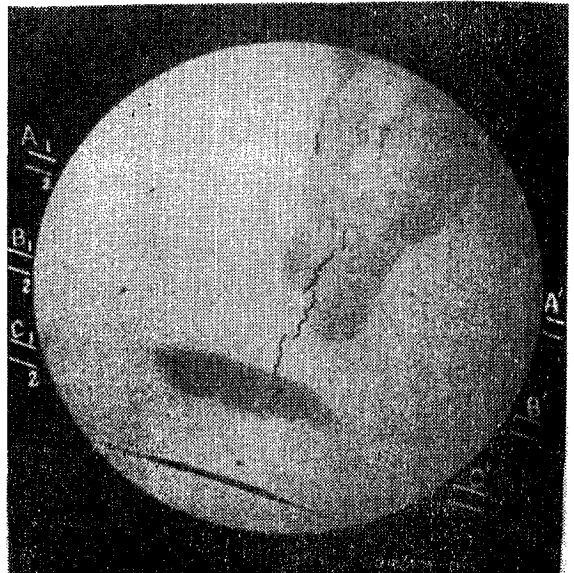
Figure 4. Cross-section of cylinder. Sections AA', BB', CC' are described in 3.2

photograph of the section face nearer the inside pipe face is shown in Figure 4. The major defect in the casting can be seen as can the weld repair and some smaller defects. Also shown in Figure 4 are the locations of the section cuts described in § 3.2.

and CC'). These three sections exposed 6 faces (A₁, A₂, B₁, B₂, C₁, C₂) also labelled in Figure 4. No defect was visible on faces C₁ or C₂ which, essentially, means that the defect was not found in the valve seat. Sketches of the other four faces are shown in Figure 5 together with photographs of three of them,

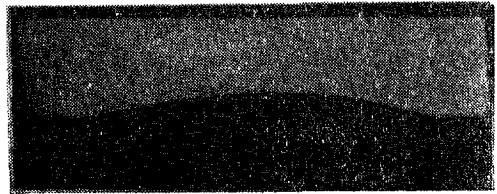
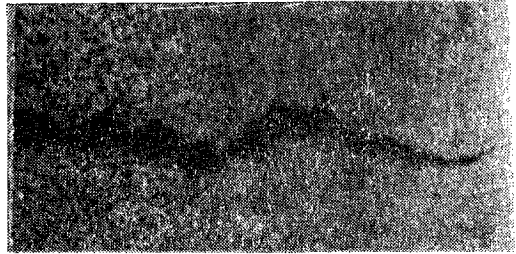
Figure 5. Appearance of four faces revealed by sections AA' BB' as defined from Figure 4.

The evidence of Figure 5 shows that the defect lies almost entirely in the casting. It terminates either near the repair weld boundary, see Faces A₁, A₂, B₁, or near the valve seat weld boundary, see Face B₂: the tip of the defect may lie a small distance inside the weld but the profile suggests that the defect

did not start in the weld (or the weld boundary) and then run into the casting-sec, especially, Face B₁.

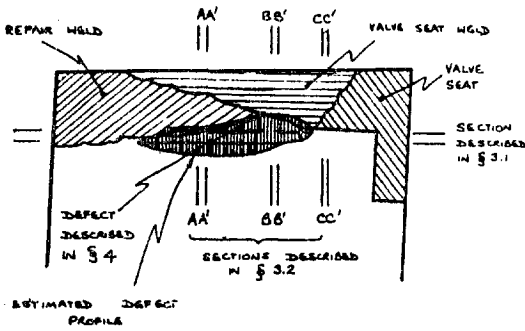
Figure 6. Estimated extent of the defect, of the repair weld and of the valve-seat weld.

An estimate can be made of the extent of the defect from the evidence of Figures 4 and 5. This profile is shown in Figure 6 together with the profile of the valve seat weld (very

approximately) of the repair weld. It should be noted that the defect comes very close to or even intersects the surface machined in the casting to take the valve seat. It must be appreciated that Figure 6 has been sketched without breaking open the entire defect so that the boundaries shown are not at all exact. It is also obvious that any portions of the defect which lay in the weld repair region have been destroyed by that repair.

5. 3 The defect deduced from the S. C. O. A. ultrasonic inspection was observed. It was identified as a casting defect lying beneath the repair weld and beneath the valve seat weld.

5. 4 There is some evidence that the casting defect was very close to, or even intersected, the surface machined in the casting to receive the valve seat and to make the weld preparation. To verify this the rest of the defect will need to be broken open in the way described in § 4.

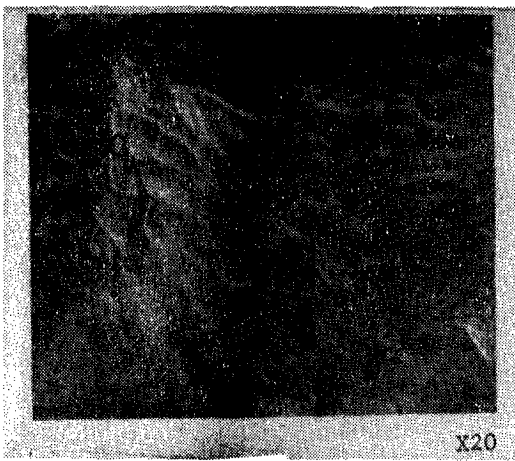
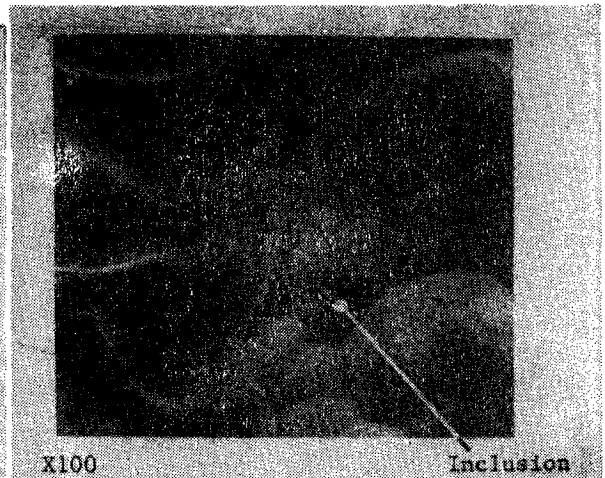
Figure 7. Surface of defect.

Three types of surface are evident in Figure 7; labelled 'p', 'q' and 'r'. Area p consists simply of exposed dendrites and is characteristic of a loss of feeding liquid metal. Area q may be the same as p, but it is more likely a crack which has propagated between dendr-

ites whilst a film of liquid was there (or, perhaps, solid just below the solidus temperature) : what is sure is that the scale of the structure in area q is the same as that of area p so

that the separation process was governed by the dendritic shape. The third area, 'r', has not been interpreted : it is possibly a transgranular crack formed at some lower temperature-

but, nevertheless hot enough to be heavily oxidized. It should be noted that the heavy oxidation implies that the defect was connected to the atmosphere when it formed. The surface contained various inclusions one of which is seen in Figure 7. No detailed survey was made of these but one contained predominantly calcium and sulphur and another contained predominately iron, calcium and silicon.
