# **SAMPOONG COLLAPSE**

## *A Tragic Man-made Disaster*

Sahng Beak Jeon, P.E.

### **1. Outline of the Accident**

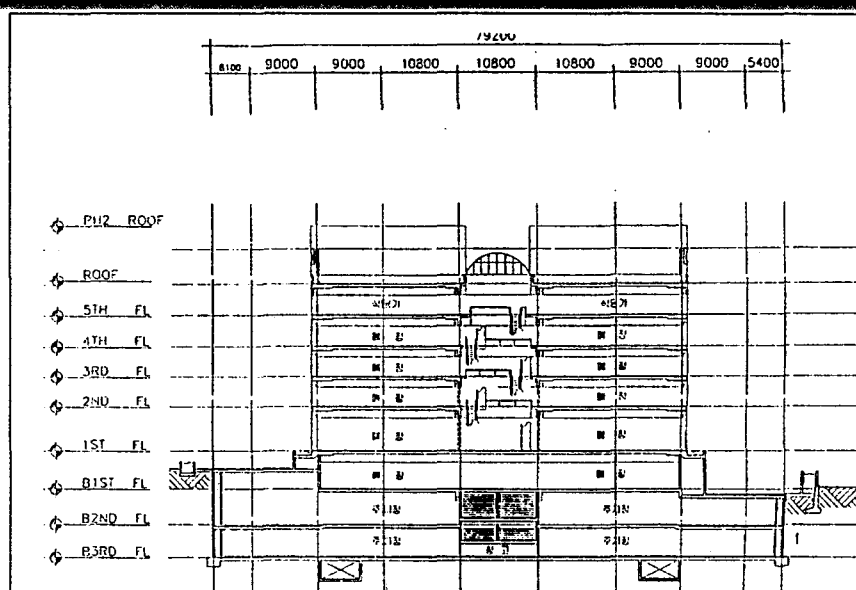
## Cross Section of the Building

<i>Glass roof to concrete slab</i>	<i>R</i>	<i>Roof Garden - cooling towers moved</i>
<i>Expansion of 5th floor</i>	<i>5F</i>	<i>Food Court - modified roller skate link</i>
	<i>4F</i>	<i>Home Appliances</i>
<i>Escalators installed</i>	<i>3F</i>	<i>Men's Clothes</i>
<i>Escalators installed</i>	<i>2F</i>	<i>Lady's Clothes</i>
<i>Escalators installed</i>	<i>1F</i>	<i>Miscellaneous</i>
<i>Expansion work of 660m<sup>2</sup></i>	<i>B1</i>	<i>Fast Food - five pillars eliminated</i>
<i>Expansion of parking lot</i>	<i>B2</i>	<i>Parking</i>
	<i>B3</i>	<i>Parking</i>
	<i>B4</i>	<i>Machine Room</i>

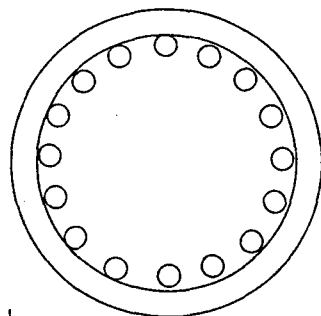
## **Difference Between Drawings & Calculations**

Design:  $\phi$  = 800 m/m w/bars D22-16EA

Actual:  $\phi$  = 600 m/m w/bars D22-8EA

80cm  
HD22 16 EA

*Structural Drawings*  
(original calculations were disregarded)

60cm  
HD22 8 EA
