# Housing Estate Developments and Earthquake Hazards

- Some recent cases in Japan -

Yoshiyuki Murayama\*

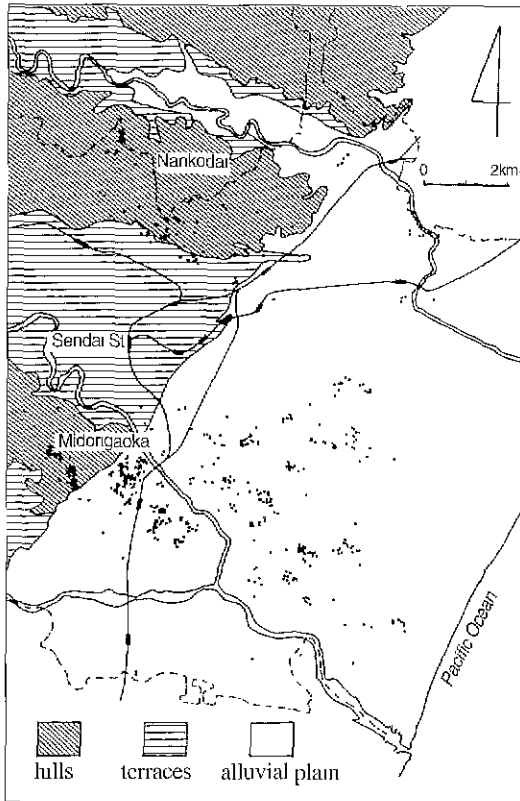
The Miyagi-ken-oki Earthquake 1978( $M_s = 7.4$ ) hit Sendai City, with a million population and much of housing estates built on the surrounding hills. A close relationship was found between the types of damage to houses and land conditions of their sites(Fig. 1). Whilst the CBD and the residential areas on the terraces were only slightly affected, the heavier damages concentrated on the

**Figure 1.** The distribution of houses totally damaged by the Miyagi-ken-oki Earthquake in 1978, and landform classification in Sendai City (Murayama, 1994) Dots in the figure represent totally damaged houses.

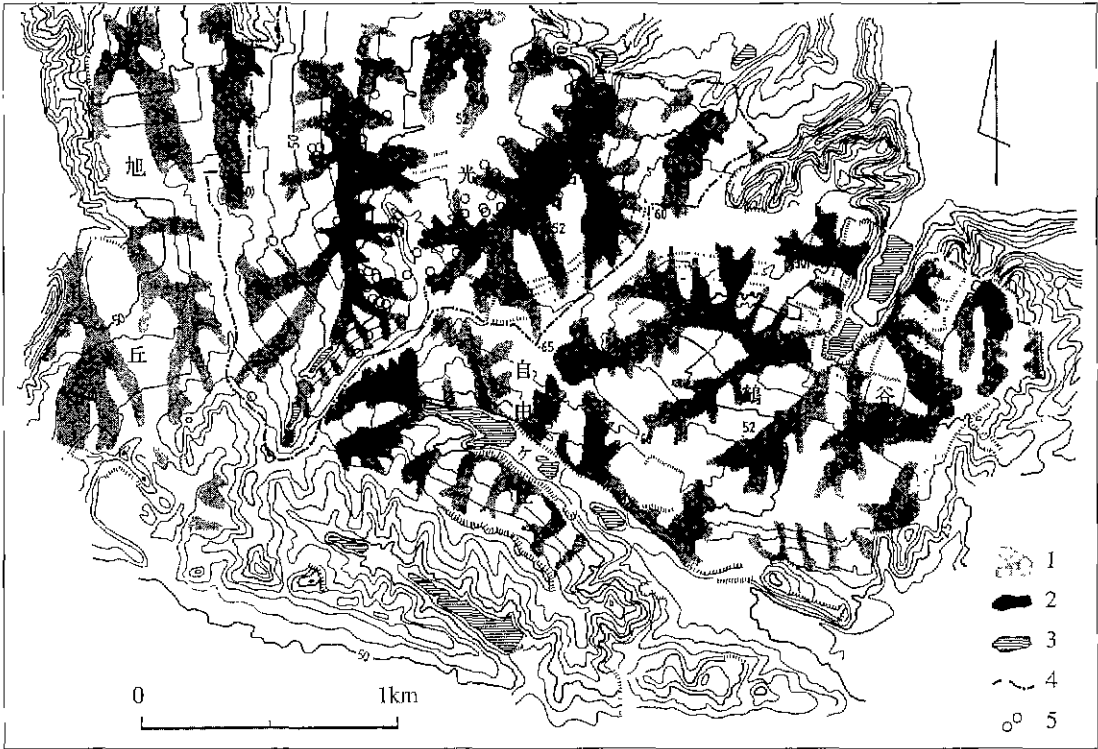
Figure 2 is an example of the affected areas on the transformed hills, showing land transformation and earthquake damages in Nankodai, on the northeast of Sendai. It clearly demonstrates that severely damaged houses concentrate on the cut/fill boundary.

The other is the estate on a massively transformed ground, where several valleys are filled with soils from the cut ridges (Type B in Figure 3). On such places, subsidence may occur on filled areas, in addition to cracks at the boundary between cuts and fills. Houses could be damaged with fissured and/or tilted basement. The damage of the houses showed in Figure 2 is the case of this

Figure 2. Land transformation and earthquake damages in Nankodai(Abe and Murayama, 1982)  
 1 : filled area, 2 : filled pond, 3 : pond, 4 : Nankodai(surveyed area), 5 : severely affected houses  
 Contour lines and numbers show the altitudes in 1970 after transformation, figures in brackets are the elevation before modification.

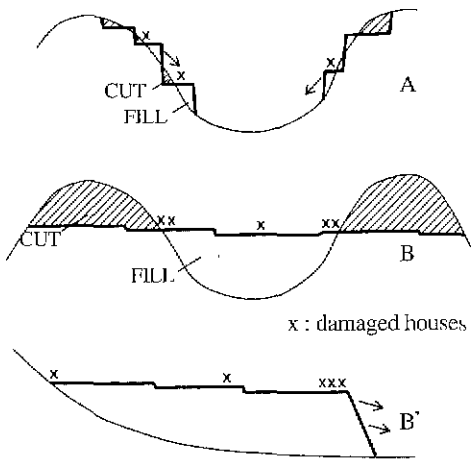
The type of damages to houses on artificially transformed hills differs by the scale and/or the degree of landform transformation(Figure 3). One type is the estate on slight land transformation

where almost every housing lot has small cut and fill with walls retaining the cliff (Type A in Figure 3). The damages mostly occur on retaining walls causing cracks, and at times, retaining walls collapse and houses slide or topple. The damage at Midorigaoka on the transformed hill southwest of the CBD, is the typical case for this type of damage.

type B' in Figure 3 is showing the vertical section of the Type B transformation. Of this dimension, the edge of the fill could be pushed out or would sometimes collapse.

Figure 3. Schematic diagram of land transformation and location of risks(Murayama, 1980)

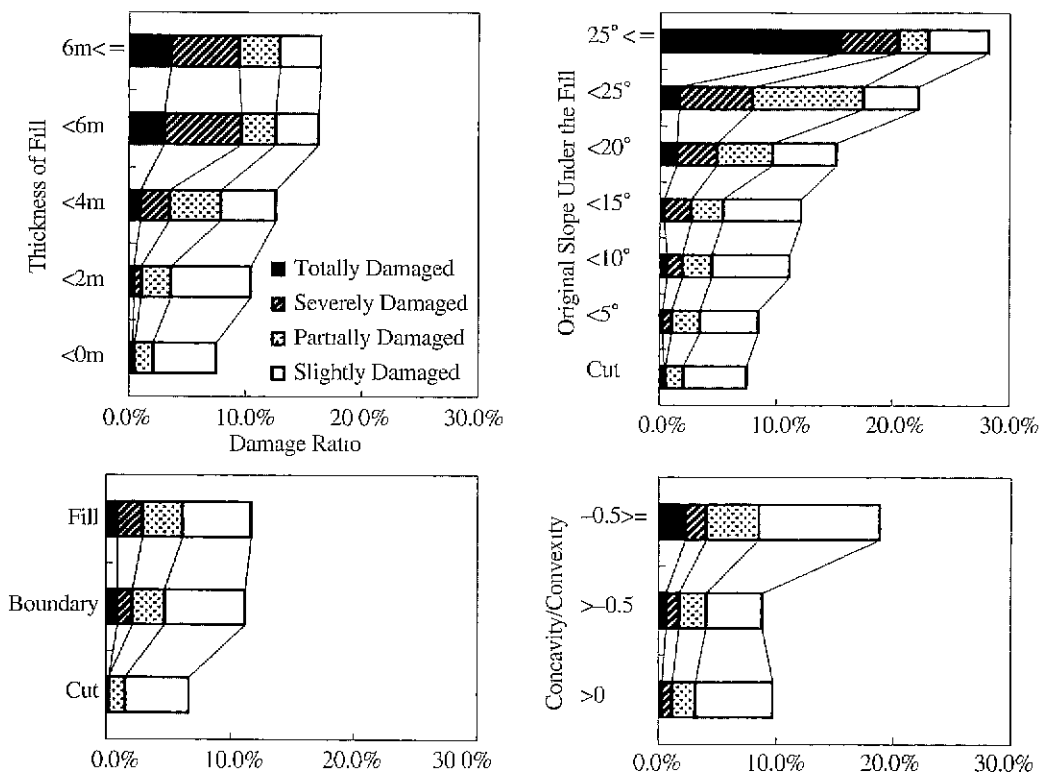
Results from cross tabular analyses in Figure 5 demonstrate that, (1) houses on the filled area and on the cut-fill boundary are more prone to damage

in both quantity and intensity; (2) positive relationship exist between frequency of damage and thickness of fill; (3) heavy damages concentrate on lots where the slope of original surface is steep; and (4) lots with high convexity such as those on the brink of cliffs, are more prone to damage. No apparent effect was found for the slope of the present surface.

Figure 5. Land condition indices and damage intensity

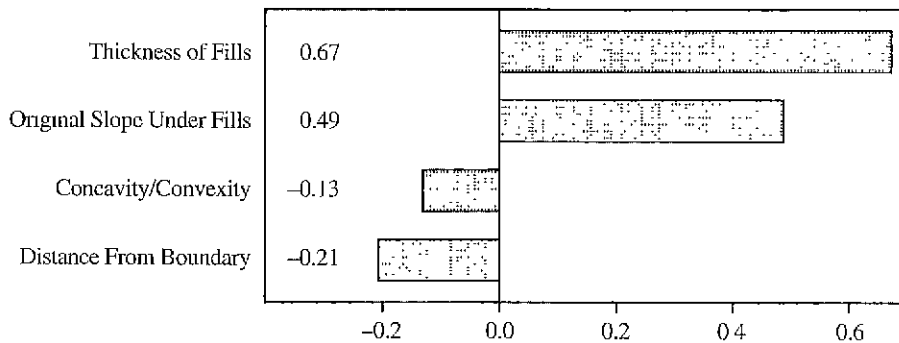
**Figure 6. Standardized discriminant coefficients**

“partially + slightly + no damage” was obtained. The contingency table shows how correct these aggregate categories were predicted using only the land condition indices, with overall prediction ratio of 82%(Table 1). The standardized discriminant function coefficients show that the thickness of fill and the slope of original surface under the fill are the main determinants to the intensity of damage(Figure 6).
