**(Technical Note)**

**A Review of Pressure Tube Failure Accident in the CANDU Reactor and Methods for Improving Reactor Performance**

**Ho-Sik Yoo and Jin-Gon Chung**

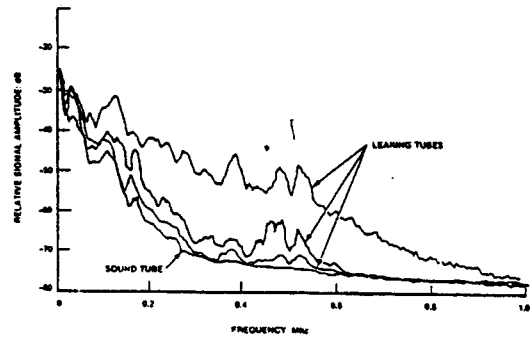
Fig. 2. Characteristic Acoustic Emission Frequency Spectra

both sound and cracked pressure tube removed from Pickering unit 4. Cracked tubes can be easily found since the frequency differences between sound and leaking tubes are significant. Three tubes at Bruce unit 2 in 1982 were replaced due to a similar accident. In the stations mentioned above, pressure tubes made of Zr-2.5Nb alloy were installed. However, in the Pickering unit 1&2, which were constructed earlier than the other stations, Zircaloy-2 tubes were used because the superiority of Zr-2.5Nb alloy was not proven at that time. After the pressure tube failure at Pickering unit 2 in 1983 and after verifying the better mechanical properties and lower hydrogen uptake of Zr-2.5Nb than Zircaloy-2, all the Zircaloy-2 pressure tubes in Pickering unit 1&2 were replaced with Zr-2.5Nb tubes. At Pickering unit 3 in 1985, one tube was found to have cracks and replaced.

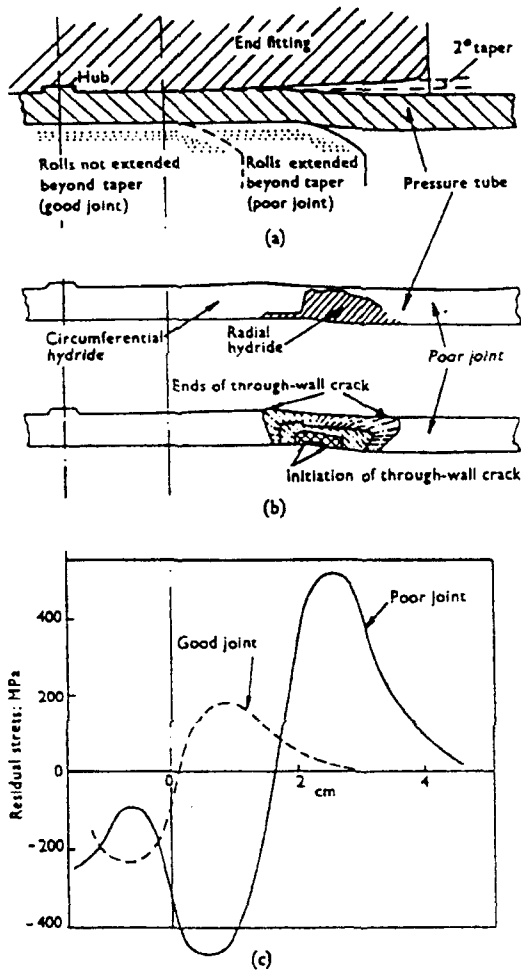
**Fig. 3. Pickering Rolled Joint Stresses.**  
**(Hoop Stress on Inner Wall of the Pressure Tube)**  
**a) Relative Position of Rolling Tool During Installation**  
**b) Position of Radial Hydrides and Cracks in a Poor Joint**  
**c) Residual Hoop Stress Distribution on the Inner Wall of a Good and Poor Joint**

was held on each fuel channel in turn, and the noise due to leakage of the primary coolant was recorded using acoustic emission equipment. It was revealed that DHC was the main cause for the failure through the investigation. It was found that DHC occurred due to a combination of excessive residual stresses at the rolled joint position caused by an improperly rolled joint and hydrides formed by hydrogen that existed within the tube over the Terminal Solid Solubility(TSS) limit. According to the analysis of the cracked pressure tube, the rollers used had extended beyond the parallel part of the end fitting so the pressure tube was strained in that area that should not be strained by the end fitting. As can be seen in Fig. 3., the residual stress at the improperly rolled joint position is much higher than that of a good joint. A small amount of hydrogen had been already picked up during manufacturing of pressure tube. Hydrogen content increases continuously during reactor operation by absorbing hydrogen from the corrosion reaction of the pressure tube with heavy water.

- (a) All cracks were at the coolant inlet end.
- (b) The rolling tool had been inserted about 13 mm too far into the tube.
- (c) The cracks started from the inside tube surface, were 15-20 mm long and occurred just inboard of the rolled joints where the tube had been flared out by the joint rolling.
- (d) The cracks appeared to progress outward as far as the compressive zone under the hub of the rolled joint and inward as far as the zone of

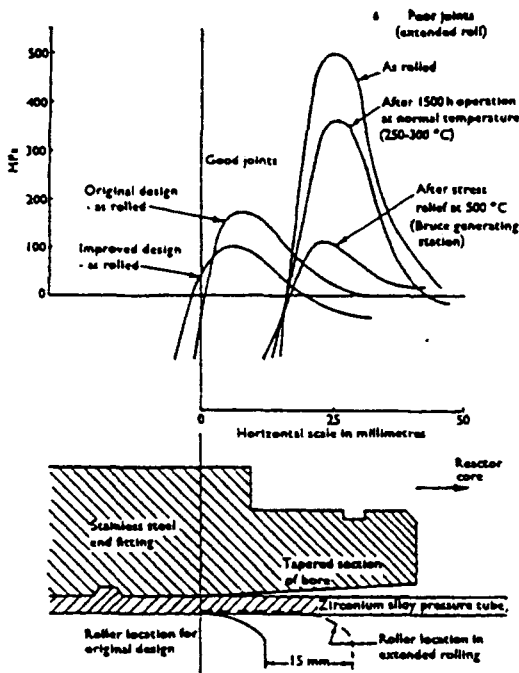
Fig. 4. Variation of Residual Hoop Stress in Pressure Tube Rolled Joints

As shown in Fig.4, the residual stresses of a pressure tube rolled using the improved method is similar to that of the stress relieved tube. Even though the residual stress was relieved by stress relieving annealing, a pressure tube failure accident occurred at Bruce unit 2. Through detailed investigation, it was confirmed that cracks had already existed in the pressure tube and led to the failure of the tube. The results of the studies on the Bruce unit 2 accident performed at Chalk River laboratories of AECL are as follows.[3]

All the pressure tube end fitting joints in Bruce units 1&2 had been rolled at the time of the Pickering problem and they were not very different from those in Pickering. Therefore, stress-relief annealing heat treatments were applied to the Bruce units 1&2 to reduce the residual stress. It was identified that the residual stress up to 772 MPa produced by an improper rolled joint process decreased to 96 MPa after stress relief annealing at a temperature of about 500°C. However, this was a time consuming process. Thus, for Bruce units 3&4, improved rolling processes involving a slight modification in joint design, a tighter rolling tool had been used.

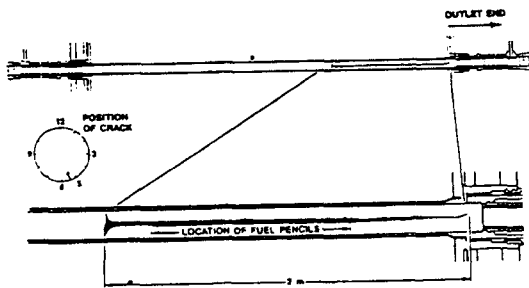
Fig. 5. Location and Orientation on Split in Pressure Tube.

The pressure tube cracking accident that occurred at Pickering unit 2 in 1983 was quite different from that of the other plants mentioned above. The size of crack was very long about 2 m and the crack position was different. (Fig. 5) The cause of the failure was associated with both displacement of a pressure tube support spacer during commissioning (Fig. 6) and the development of much higher than expected hydrogen concentrations in the Zircaloy-2 pressure tubes as a result of corrosion. All the spacer removed from the cracked pressure tube were in distorted and broken states containing large amount of hydrogen.

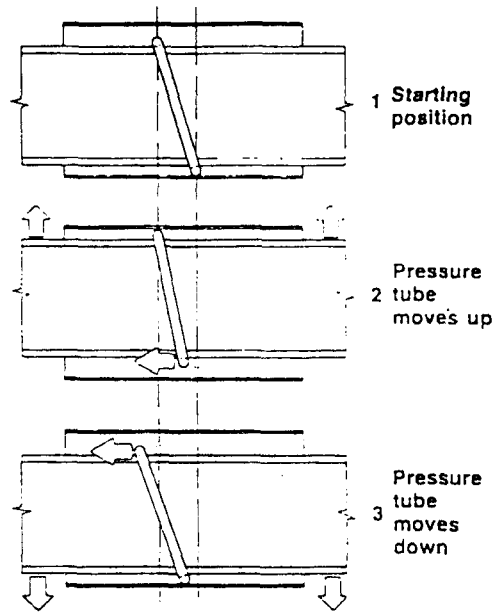
- (a) The outlet garter spring moved about 1 m inboard from its design location probably during

Fig. 6. Illustration of the Movement of Garter Spring by Vibration.

installation. This movement and pressure tube sag led to contact between the pressure tube and the calandria tube. This problem could be prevented by using Inconel X750 as garter spring material rather than a zirconium alloy and having an integral internal girdle wire inside the toroid that provides detectability using eddy current techniques (Fig.12)[13].

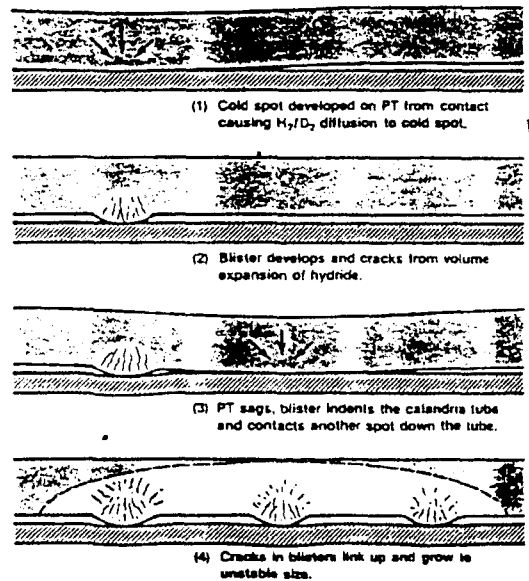
Fig. 7. Probable Sequence of Crack Development from PT/CT Contact.

- (c) The temperature gradients in the pressure tube wall caused the hydrogen and deuterium to diffuse to the cooler contact area initiating the formation of the blisters.
- (d) The enhanced corrosion and deuterium pickup accelerated the growth of the blisters creating high local stresses in an area of high hydride content and initiated a defect.
- (e) The defect grew by delayed hydride cracking to form a partial through-wall crack about 100

- (f) When the crack reached a critical size, it suddenly broke through the wall and extended to the 2 m length

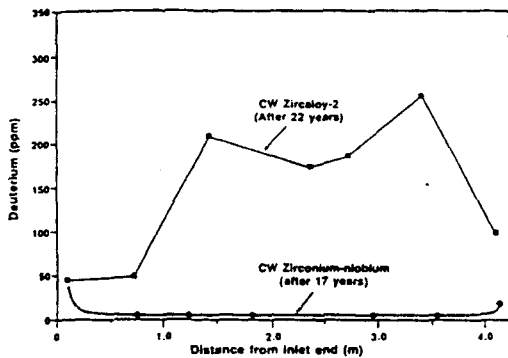
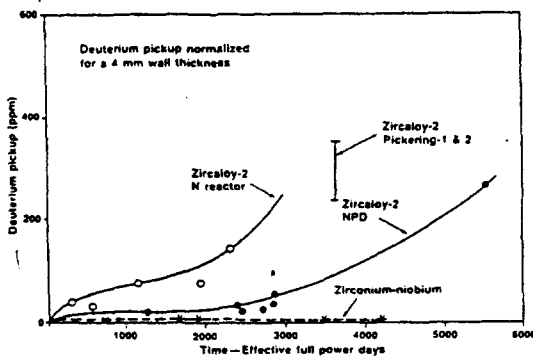
**Fig. 8. Deuterium Pickup in Two Pressure Tubes.**  
**a) Removed from the NDP Reactor**  
**b) Removed from the Different Reactors**

There are three essential factors - stress, hydrogen, time - to initiate DHC. If one of them is absent, a crack caused by DHC may not occur. Examination of several Zircaloy-2 and Zr-2.5Nb pressure tubes[6-10] had shown that the heavy water pickup rate of the Zircaloy-2 is much higher than that of Zr-2.5Nb(Fig. 8). Accordingly, all the Zircaloy-2 pressure tubes installed in Pickering unit 2 were replaced with Zr-2.5Nb tubes after the accident.
