A Guide for Analyzing Fault Causes of Pole Transformers

Jong-Wook Jung, Byung-Sung Lee, Il-Keun Song and Hee-Ro Kwak

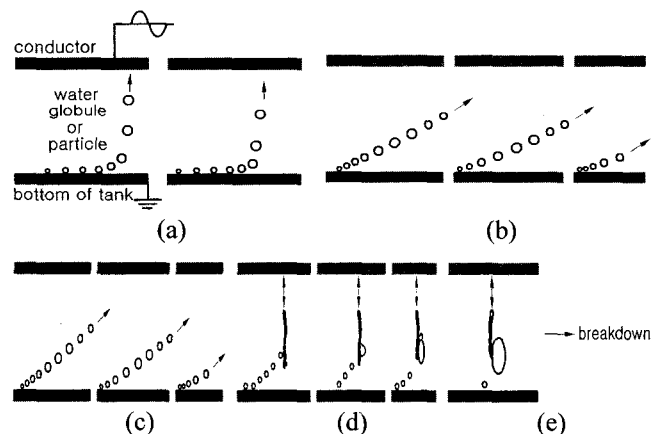
Fig. 1 Fault mechanism due to water globule on tank bottom

As shown in Fig. 1, as the field strength increases, the water globules on the tank bottom are arranged in the direction of the field to ultimately make a bridge between the conductor and the tank[7].

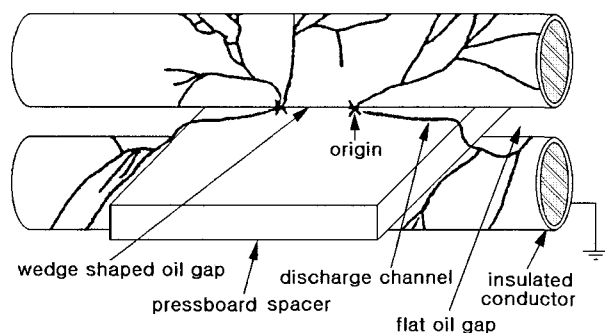
Fig. 2 Surface flashover paths due to surge

As shown in Fig. 2, according to the experiment simulating the transformer conductors subjected to the surge, the discharge mostly appears to be surface flashover[6], and the discharge channels are originated from a small oil wedge. Similar to most surface flashovers, however, the breakdown due to the discharge channels does not inflict damage on the insulations. Generally, the follow current flowing through the channels formed by the surge causes larger faults.

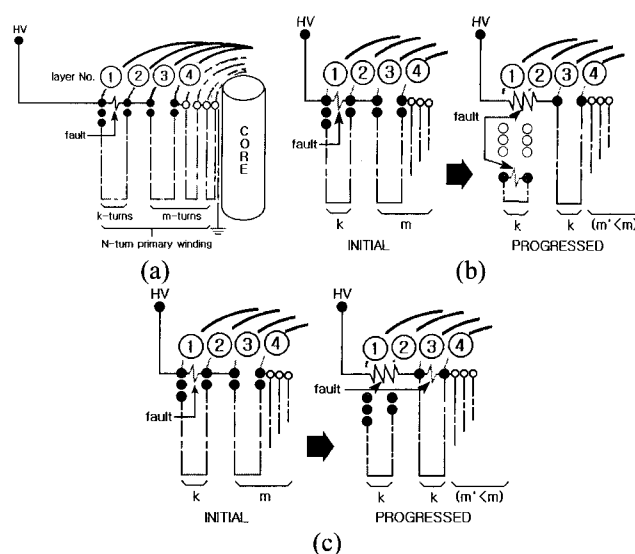
As shown in Fig. 3(a), the faulted high voltage winding can be divided into two parts: the faulted turns(k turns) and the remaining turns(m turns) and analyzed as a two winding transformer. The unfaulted turns will be energized at the system voltage and act as a "secondary" winding with a turns ratio of m/k . The voltage induced in the shorted turns will be k/m times the source voltage and the current in the shorted turns will be m/k times the high voltage side current(ignoring the magnetizing current). The fault current on the high voltage side is limited by the leakage reactance between the faulted and unfaulted windings(not the same as the short circuit reactance) and the effective high voltage side resistance.

Fig. 3 Short circuit analysis of winding; (a) faulted high voltage winding (b) progressed to short circuit between turns (c) progressed to short circuit between layers

Fig. 3(b) schematically describes the progression of a fault within initially faulted layer 1 and 2. The fault involving k shorted turns turns into layers 1 and 2 bypassing some of the turns and reducing the number of shorted turns to k/k .

Fig. 3(c) schematically describes the progression of a layer 1 to 2 fault to an adjacent layer-to-layer fault(layers 3 to 4). The involvement of the 3rd and 4th layer can occur without the original layers because the turns are simply burned off by the fault current. This type of progression is observed during transformer tear-down[5].

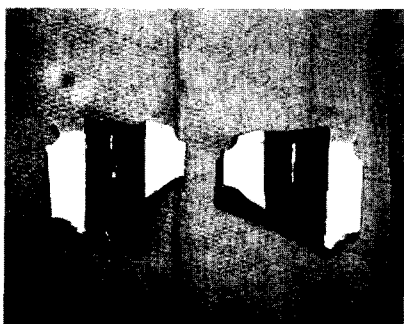
Photo. 10 Permeation of fuchsine solution into ceramic due to poor material
