# A Study on the Collision Accident between *Ferry Golden Jindo* and *Ferry Princess*

**Abstract :** *Ferry Golden Jindo* collided with *Ferry Princess* near the No.7 light buoy of Incheon Port No.1 Passage in restricted visibility due to dense fog. The result was that *Ferry Golden Jindo* got a hole at the starboard midship section shell plating and *Ferry Princess* sustained damages at the starboard bow and 25 persons injured. The aim of this paper is to investigate this collision accident, to clarify its causes, and to prevent such accident from occurring again. In short, this collision resulted from *Princess'* high speed in restricted visibility, *Golden Jindo's* carelessness of watchkeeping, lack of proper safety training of crew, lack of instruction of supervisor, carelessness of PTMS Center and indifference of Korea Shipping Association, etc.

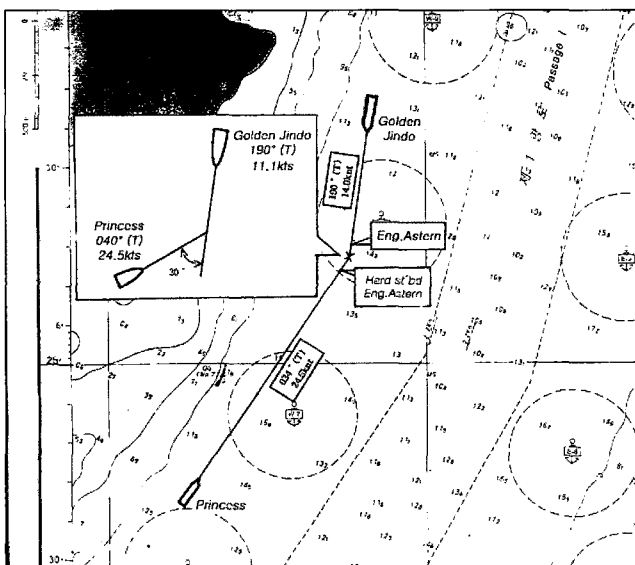
After passing *Century Forest* at W-9 anchorage with  $210^\circ$  true course, *Golden Jindo* avoided the shoals area on her starboard side and altered course to  $190^\circ$  for approaching to Palmido North-West Sea Route. At that time, the master found *Princess* approaching quickly to his ship from 1 o'clock direction and in about 50 meters distance and stopped the main engine. Eventually, at about 1430 on 3 August, *Golden Jindo* collided with her starboard midship against the starboard bow of *Princess* by the crossing angle of  $30^\circ$  at Lat.  $37^\circ 25' 12''$  N Long.  $126^\circ 33' 45''$  E, near No.7 light buoy of Incheon Port No.1 Passage.

Fig. 2 Track plot of *Golden Jindo* and *Princess* collision
