## Application of the Ultrasonic Detection System for the Power Transformer

權 東 震<sup>†</sup> · 具 教 善<sup>\*</sup> · 金 載 哲<sup>\*\*</sup>  
(Dongjin Kweon · Kyosun Koo · Jaechul Kim)

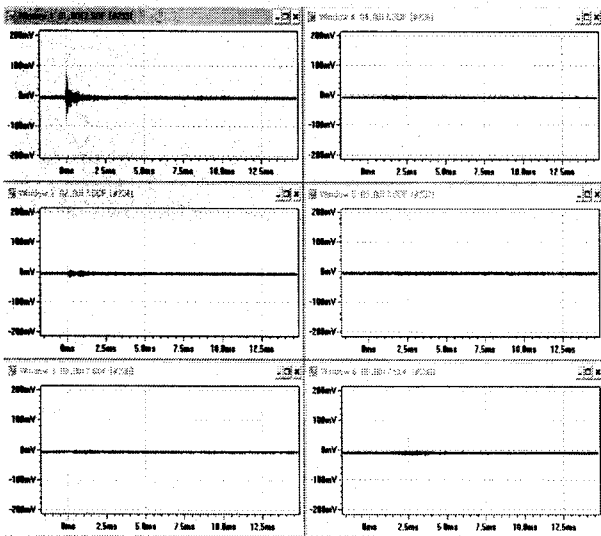
Fig. 4 Ultrasonic signals of the first test

Fig. 4 showed the ultrasonic signals of 6 sensors measured by the first test. In the results of the first test, the order of the ultrasonic signal amplitude appeared as ①>②>⑥>③>④>⑤ and the largest ultrasonic signal was detected by sensor ①. This result illustrates that the partial discharge was the closest to the sensor ①. From the result of analyzing the amplitude and arriving time of the ultrasonic signals, it was estimated that the partial discharge occurred at the upper part of A phase near the OLTC side. Therefore, a second test was done replacing 3 sensors around sensor ① to estimate the position of partial discharge in detail.

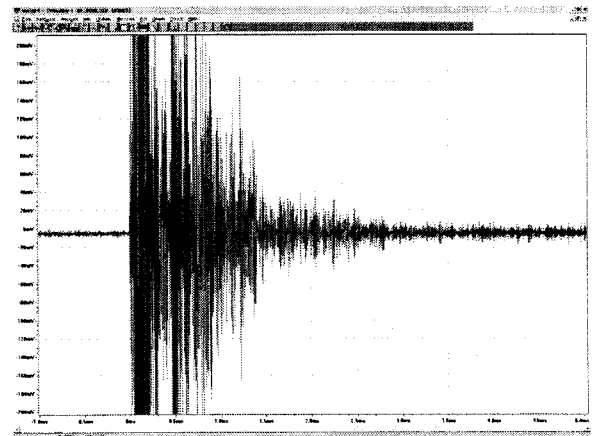
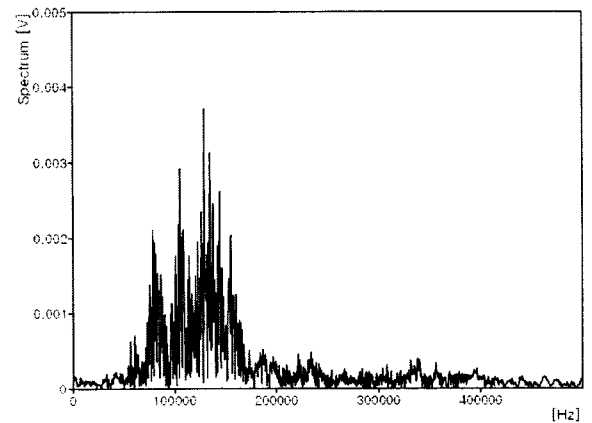
Fig. 6 The detected ultrasonic signal and its FFT signal of the second test

Fig. 6 shows the ultrasonic signal and its FFT signal of the second test with sensor ①. As shown in Fig. 6, the signal shows a typical ultrasonic signal due to partial discharge and the bandwidth of the frequency spectrum was 80~160kHz. This also coincides with the ultrasonic signal by partial discharge in transformers in general.

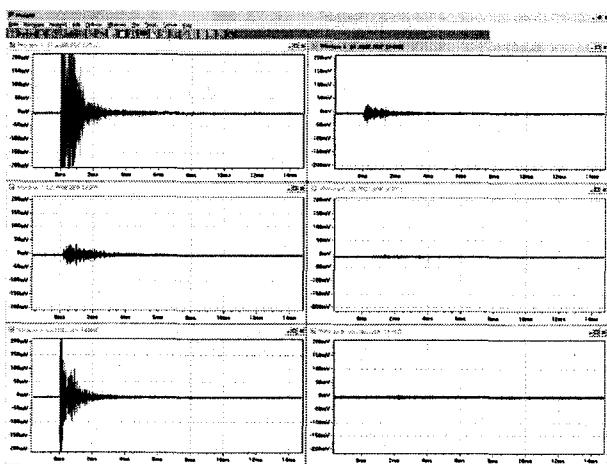
Fig. 7 Ultrasonic signals of the second test

Fig. 7 shows the ultrasonic signals of the second test. From the results of the second test, the order of ultrasonic signal amplitude appeared as ①>③>②>④>⑥>⑤, and the arrival time of each signal was ①>③>④>②>⑤>⑥ in order. The difference in the arrival time between sensor ① and sensor ③ was about 15.6μs. Therefore, it is estimated that the position of the partial discharge is located closer to sensor ① than sensor ③. Also the arrival time of sensor ④(54μs) is 72μs faster than sensor ②(126μs). Therefore it is assumed that the partial discharge occurred at the middle-upper position of the transformer near the OLTC side. Based on the ultrasonic signal of sensor ② and ④, arrive signals can be estimated through internal structures such as the core and the winding in the transformer. From the amplitude and arrival time of the signals, it was inferred that the partial discharge occur around sensor ① and ③, that is, the middle-upper position of phase A in the transformer.

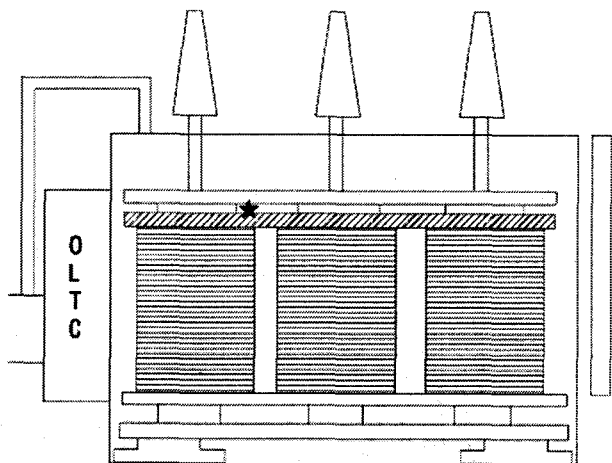
Fig. 8 Estimated location of partial discharge

Based on the results of the first and second ultrasonic tests, it was estimated that a partial discharge exists at the middle-upper position of phase A near the OLTC side. Fig. 8 shows the estimated location of the partial discharge
