Tunneling in Severe Groundwater Inflow Condition

지하수 과다유입 조건하에서의 터널굴착

Lee, Young-Nam* · Kim, Dae-Young**

Abstract

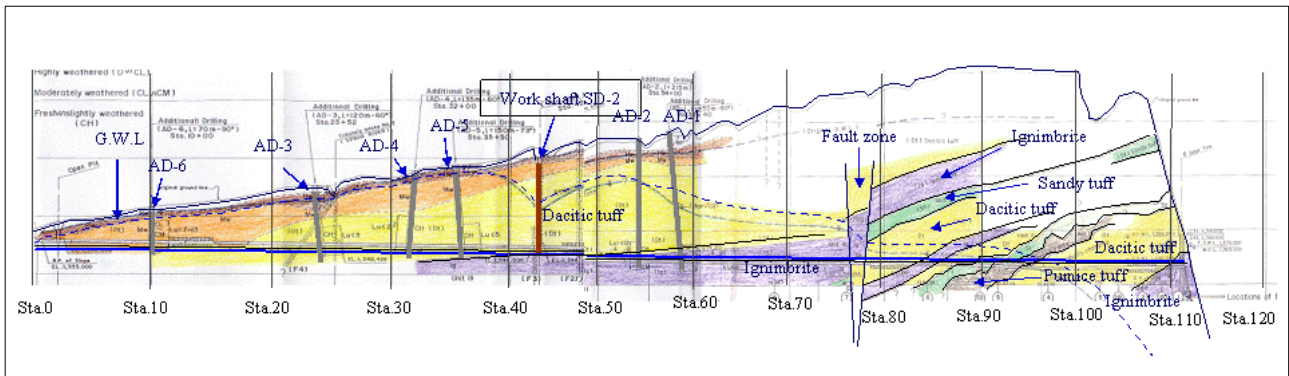
Figure 3. Geological Section of DHT Side Based on the Results of Additional Investigation and TBM Excavation
(The dashed line represents GW table when tunnel face was at Sta.56+00)

As shown in Figure 3, rock formations along the tunnel alignment turned out to be much more complex than those obtained during the tender design stage. However, the mechanical behaviour of rock core sample tested was in general competent and in good agreement with the results of compression wave velocity measurement from the tender design, as can be seen in Table 1. The most important geological feature encountered from tunnel excavation was the presence of vertical fault zone at Sta. 76, found to be a hydro-geological barrier. The hydro-geological condition, 3.5 years after the excavation started, for a section between this fault zone and Surge Tank area may be classified as dry(see Figure 3). The dry condition, that is, the initially-low groundwater table, may have been resulted by the presence of well-developed vertical tension cracks. As shown in Table 1, Lugeon values obtained from horizontal boreholes, in which the influence of vertical joint could be easily measured, were much higher than the design value of 1,

On March, 2002, the tunnel face reached at Sta. 56+00 and the groundwater table for the upstream side of the fault zone at that time was established from the measurement of water table inside vertical boreholes AD1 to AD6, as shown in Figure 3.

The excavation of tunnel from Surge Tank to fault zone took about 1.5 years and that from fault zone to Sta. 56 another 2 years. As shown in Figure 3, the influence of the excavation on the groundwater level is clearly shown in the lowering of groundwater level between the fault zone and Sta. 56 due to the presence of well-connected vertical fractures. The lowering of high groundwater table was made possible by draining high pressure groundwater to the tunnel excavated and resulted in the large inflow of water to the tunnel.

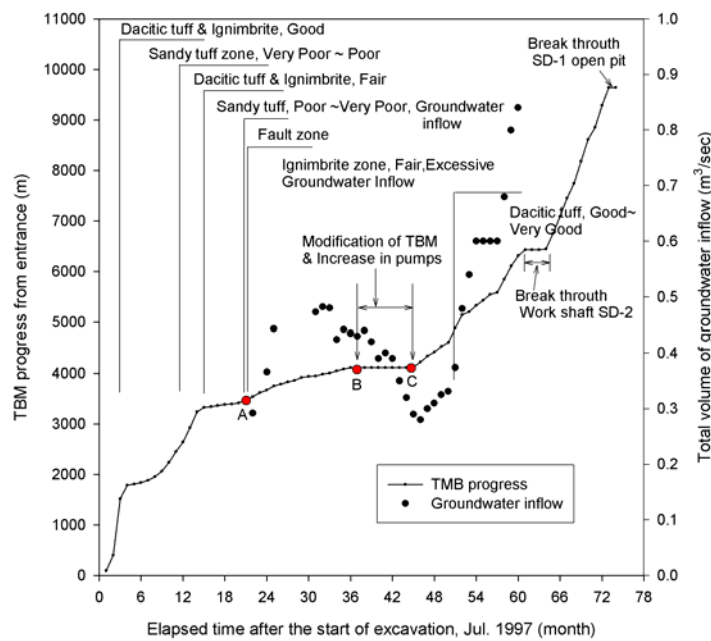
Figure 4. TBM Progress and Volume of Groundwater Inflow with Time

excavation and the progress was rapid, as shown in Figure 4. However, as the tunnel face reached at Sta. 96, the bedrock changed from dacitic tuff to weak sandy tuff, but groundwater condition was still dry, resulting in the slower progress of excavation. As soon as the tunnel face passed through the fault zone at Sta. 76, excessive amount of groundwater poured into the tunnel from the area between crown and springline, as shown in Figure 5. Soon after the tunnel face passed the fault zone, the groundwater having the head of 200m spouted through open vertical joints and the amount of groundwater measured at the tunnel entrance near Surge Tank area was as high as 292liter/sec. As the tunnel face moved away from the fault zone and the excavated length of tunnel became longer, the water head decreased, but not the amount of inflow.

As shown in Figure 4, TBM progress significantly decreased as the inflow of groundwater became excessive after TBM passed through the fault zone at Sta. 76(point A). As the tunnel excavation progressed, groundwater discharge rapidly increased up to 482 liter/sec from 292 liter/sec and decreased slowly when the tunnelling work stopped for the modification of TBM and

As can be seen in Figure 4, after the improvement in TBM and discharge capacity(point C), the monthly progress of TBM significantly increased and the excavation of tunnel was completed without further delay. Once the tunnel face passed large water inflow zone between Sta. 59 and Sta. 52 and reached a

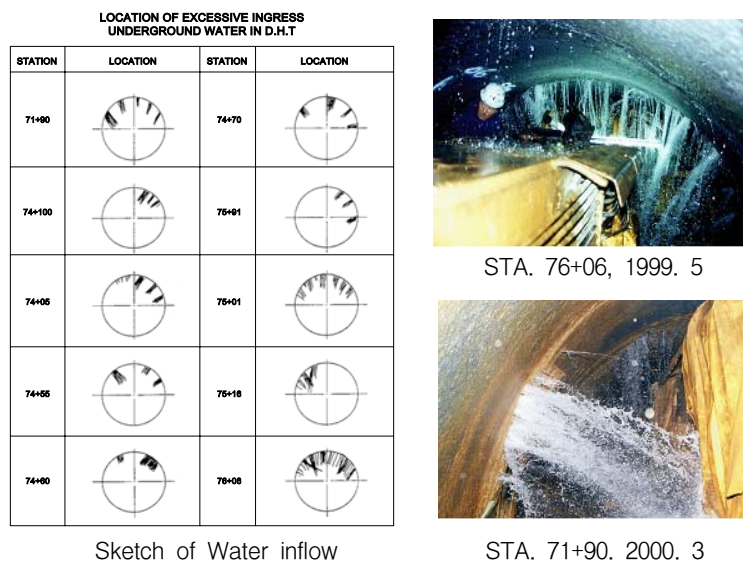
Figure 5. Sketches and Photos Showing Excessive Groundwater Inflow

drainage system(point B). The excessive inflow of groundwater slowed down the progress of TBM due to the slime. The excavated rock fragments broke down to gravel size or smaller when mixed with water and became slime. This material could not be easily removed by the fork-type scraper and hence piled up at the back of TBM head to an approximately 20 to 30cm thickness at the invert. The crew had to remove this material manually with shovels to allow the

power unit trailer to pass and permit the installation of the railway tracks on the tunnel invert. Removing the slimetook on average 23 % of the available working time during the period May to October 2001. Due to the excessive water inflow and the material piled up at the invert, the water level inside the tunnel rose to the maximum of 70 cm. Due to the water and dirt conditions, the locomotive and mucking cars derailed frequently. As the rolling locomotive ran on debris-laden tracks, it resulted in high wear of wheels, breaks and bearings. The adverse operating conditions for TBM, power unit trailer and the locomotive in this tunnel led to a high percentage of down time caused by the equipment failure and net boring and re-gripping time on average 10% of the available working time.

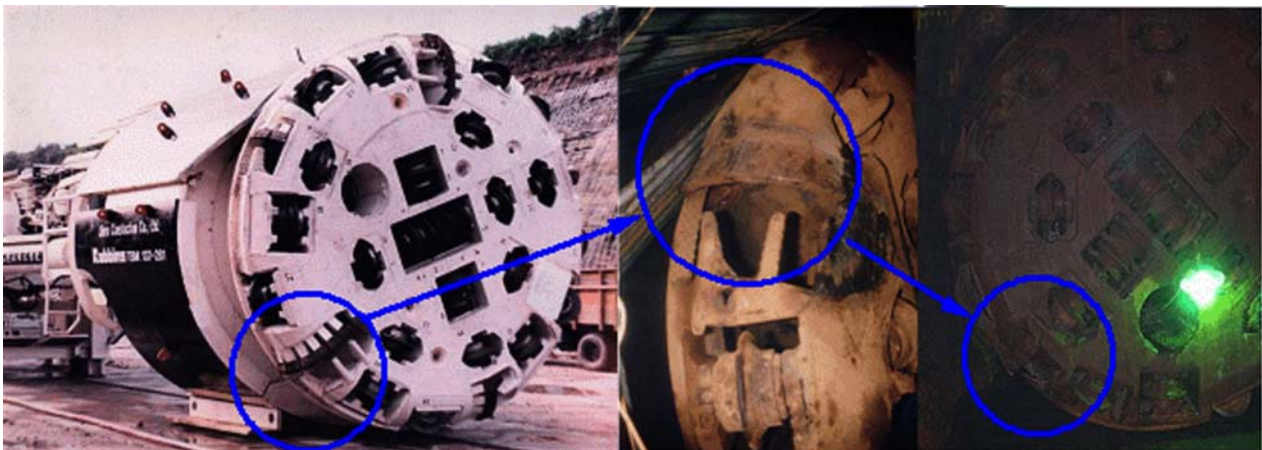
Figure 6. Modification of TBM Scraper; Before Fork-Type(Left), After Bucket-Type(Right)

Since the initially-adopted fork-type scraper could not remove the slime efficiently, the unremoved slime travelled to the back of TBM head through the space between the rock surface at the invert and the bottom part of TBM head. To improve the efficiency in the removal of slime, the scraper was modified from

the fork-type to bucket-type, as shown in Figure 6, and a slime-proof cover was installed at the space between TBM head and rock surface at the invert, as shown in Figure 7. The locomotive was modified for a better operation inside the tunnel by re-locating the engine upward, so that the engine would not be submerged. Besides, all the wheels were sealed and all rotational parts replaced with O-ring and oil seal, resulting in the longer life of these parts.

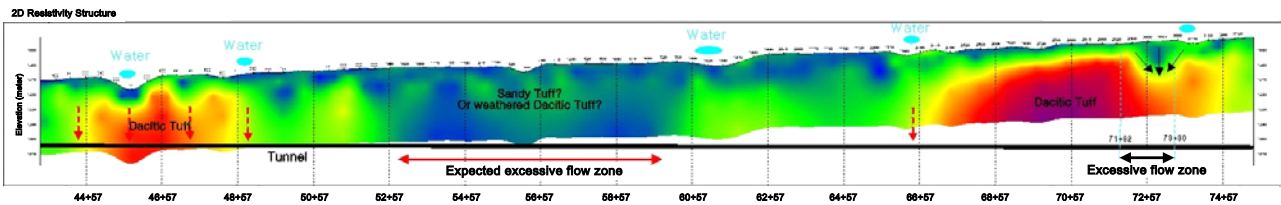
Figure 8. Result of Electrical Resistivity Survey Showing the Excessive Inflow Zone to be Expected

In order to make the excavation work as dry as possible, it was decided to employ additional pumps, considering the extra amount of groundwater to be discharged from the subsequent tunnel excavation. On April, 2000, electric resistivity survey was performed to investigate the groundwater regime along the 4 km section of tunnel from shaft SD 2 (Sta. 42+40) to downstream side and the results are presented in Figure 8. As can be seen from this Figure, the excessive inflow zone would be encountered at the section between Sta. 59 and Sta. 52. Using Goodman's equation with the measured coefficient of permeability from the area, it was predicted that the groundwater of 371 liter/sec would be added from a tunnel

section between Sta. 60+52 and Sta. 45+47. The predicted inflow was in good agreement with the actual groundwater discharge measured during excavation, about 390 liter/sec.

Initially, eleven 55kw pumps were installed to discharge the inflow and then the number was increased to 20 units, when the tunnel face was at Sta. 56. Based on the predicted amount of groundwater inflow from the section beyond Sta. 56, a total of 32 pumps were installed and 7 sump pits were excavated for pump operation.

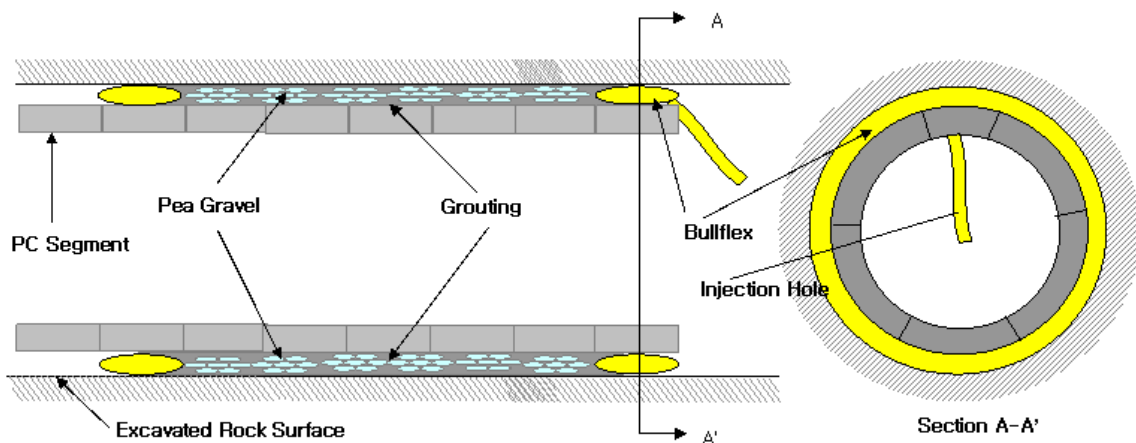
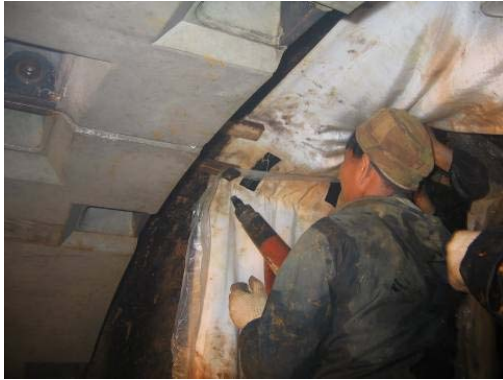
Figure 9. Bullflex and Backfill Grouting for Cut-Off of Water

The total amount of groundwater inflow, measured at the completion of excavation, was up to 1,120liter/sec. Under this circumstance, it was almost impossible to meet design requirement with the cast-in-situ RC lining unless the overall grouting for surrounding rock was performed to reduce the inflow substantially. Considering that the grouting of surrounding rock under high pressure would be very difficult, if not possible, and very expansive, it was decided to change the lining method from the cast-in-situ to precast concrete(PC)segment lining. PC segment lining was adopted mainly because the erection of segments would make the construction easier and the quality of work might not be influenced by the excessive groundwater inflow. The other

The lining segment adopted had a thickness of 200mm, a width of 1200mm and the strength of 500kgf/cm² at 28days. After the break-through of tunnel, segments were installed using an erector of shield. The excessive groundwater inflow was isolated using Bullflex, a fabric bag of doughnut-shape, installed at every 50m interval

between the excavated rock surface and segment, as shown in Figures 9 and 10.

Cement milk was injected to Bullflex to block the space between segment and ground and hence make the groundwater for a 50m section isolated and flowed into the tunnel through the drainage hole in the segment at the crown section. For a section between two Bullflexes, pea gravel and mortar were injected at the space between segment and ground to obtain the grouted material having the compressive strength of more than 10MPa.
