Identification on Fatigue Failure of Impeller at Single Stage Feedwater Pumps During Commissioning Operation

단단 주 급수 펌프 임펠러에서 시운전 중 발생한
피로 절손에 관한 규명 연구

Yeon Whan Kim[†], Kye-Yean Kim^{*}, Chun Hee Bae^{*} and Young Shin Lee^{**}

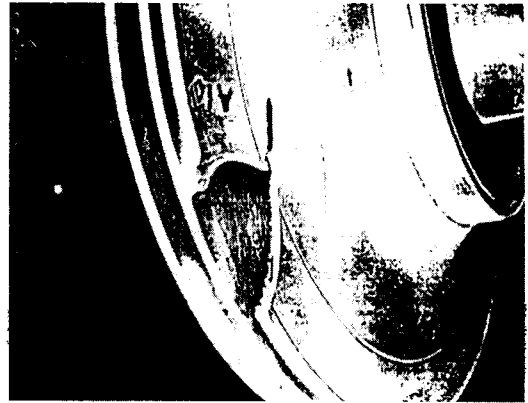
Fig. 2 View of impeller showing failed section at vane

Figure 2 shows the failed section of pump impeller. The impeller was examined visually and the fractographic detail of the failed section was typical of a fatigue crack which had initiated at the vane tip. The impellers failed due to high cycle fatigue with significant cracks being initiated at impeller vane trailing edge tips at areas where the vane trip dressing had been blended into the “as cast” surface on the suction side of the vanes.

Metallurgical examination of the “as cast” surfaces revealed an abnormal surface layer with a coarse grain structure varying in thickness. The cause of the surface layer formation had been attributed to an unanticipated abnormality that occurred during the heat treatment. All cracks were associated with a deleterious surface layer which had been produced during the manufacture process. The pump was manually stopped after a high vibration alarm went off.

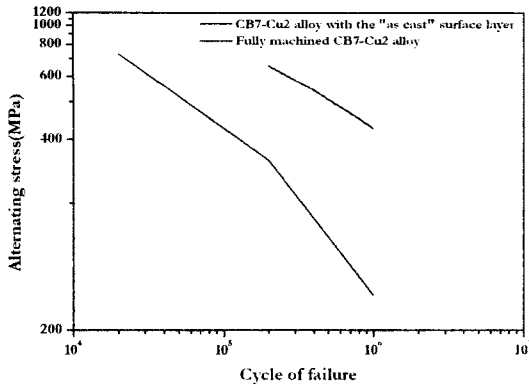
Fig. 3 S-N curves of impeller materials

testing of the samples of materials from the failed impellers with the "as cast" surface layer together with samples of fully machined CB7-Cu2 alloy. The results of the failed impellers samples were shown an order of magnitude lower than the fully machined CB7-Cu2 alloy in Fig. 3. Figure 3 shows that the fatigue limit reduced from 210 MPa to 170 MPa.

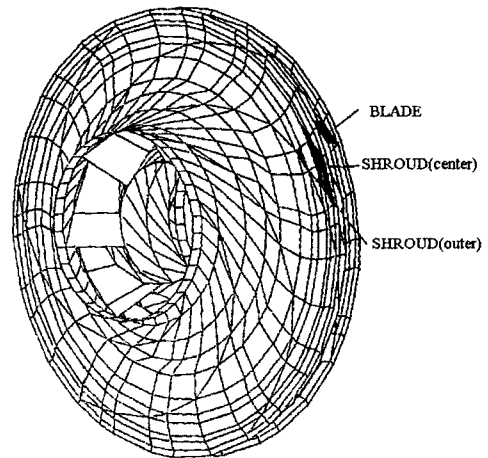
The pump impeller was subjected to worst pressure of 510 kPa and centrifugal loads of 3580 rpm, as steady state loading, and pulsation load applied to the blade outlet and adjacent shroud area. The pressure pulsation involves the interaction of the impeller pressure field with the stationary circumferential pressure field generated by a volute tongue. This is confirmed experimentally and is a function of tip gap and blade configuration. This value is indicative of the unsteady forces acting on the volute tongue. The magnitude of pulsation load is 375 kPa by the pump manufacturer. The mean and alternating stresses at each point of impeller was computed by finite element analysis method. Figure 4 shows the positions of maximum fatigue stress in the outer shroud, blade and central shroud.

The maximum dynamic stress was 129.0 MPa under pulsation loading. There was high stress at the blade tip where the pulsation is applied. The maximum mean stress is 179.0 MPa at mid

Fig. 4 View of positions of maximum fatigue stress on impeller

The fatigue stress was a peak value of 199.8 MPa at blade tip of the failed impeller. This value was over 170.0 MPa, which is the fatigue limit of the impeller materials with the "as cast" surface layer in Fig. 3.

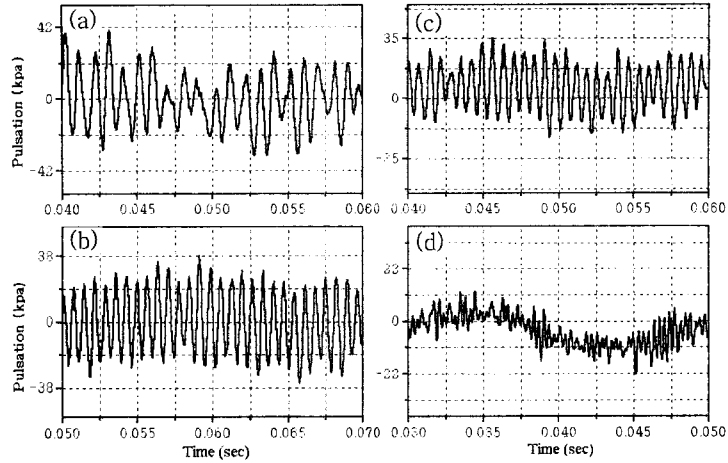
Fig. 8 Pulsation waves measured at discharge pipe of “type I” volute pump; (a) 100 % recirculation flow, (b) 70 % recirculation flow, (c) 60 % recirculation flow and (d) <3 % recirculation flow

shape of the impeller blade trailing edge. Fig. 8 is shown the pulsation waves obtained from recirculation operation tests for the pump system with “type I” volute.

Detailed of test which summarized in Fig. 8 are given in Table 1. During the changeover from one pump to the standby pump it was obtained pulsation frequencies shifted at recirculation conditions at type I volute pump system.

The 1st mode frequency of pulsation was shifted from 712.5 Hz to 825 Hz. The 2nd mode frequency of pulsation was shifted from 1431 Hz to 2038 Hz. These data show the possibility that the impeller’s natural modes, 3rd, 4th, 5th could have been coincide with the 1st frequency or the 2nd frequency of pressure pulsations

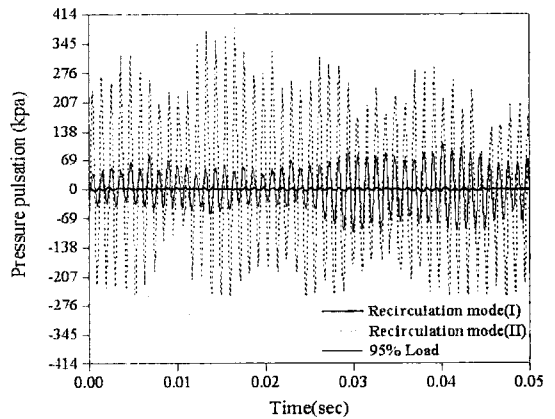
Fig. 9 Pulsation waves measured at discharge pipe of “type II” volute pump; mode (I): >60 % recirculation flow, mode (II): <60 % recirculation flow

The pressure pulsation measured depends strongly on the characteristics of the pump system. Part load recirculation at the impeller outlet leads to an increase of the pressure pulsation at distinct frequencies as well as broad band pulsations. Figure 9 shows the pulsation waves which were measured by piezoelectric pressure transducers installed at discharge pipe for “Type II” in Fig. 7.

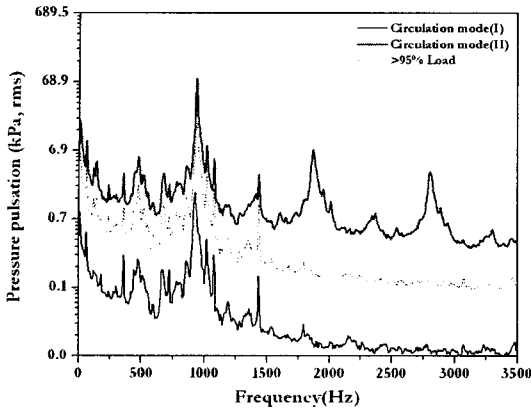
Figure 10 shows the pulsation spectra measured at discharge pipe of “type II” volute

Fig. 10 Pulsation spectra measured at discharge pipe of "type II" volute pump; mode(I): > 60% recirculation flow, mode(II): <60% recirculation flow

pump. The acoustic resonance phenomena were occurred when the magnitude of the pressure pulsation wave suddenly increased at part load recirculation condition in the impeller outlet pipe. $8\times$ rotation frequency's harmonics and 928 Hz's harmonics were amplified 100 times as many as these of recirculation (I). These results show the possibility that the impeller had been failed by amplified pulsation. It is assumed that maximum pressure pulsation amplitude in impeller could be increased more than that of the pulsation in the discharge pipe. It could be assumed that the real magnitude of pulsation load at impeller was not less than 375 kPa of the pump manufacturer.
