# Metallurgical Failure Analysis on a Suspension Clamp in 154kV Electric Power Transmission Tower

Jaehong Lee, Nam-gun Jung  
이재홍, 정남근

Failure of a suspension clamp made of hot dip galvanized cast iron in 154kV transmission tower was investigated. Metallurgical analysis of a crack of the clamp was performed using a digital microscope, an optical microscope, and a scanning electron microscope. It was revealed that the crack surface was covered by continuous zinc layer. Distinctive casting skin was found underneath both the outer surface and crack surface. The result showed that pre-existing crack had been formed in the fabrication, and liquid metal embrittlement during hot dip galvanization may assist crack propagation.

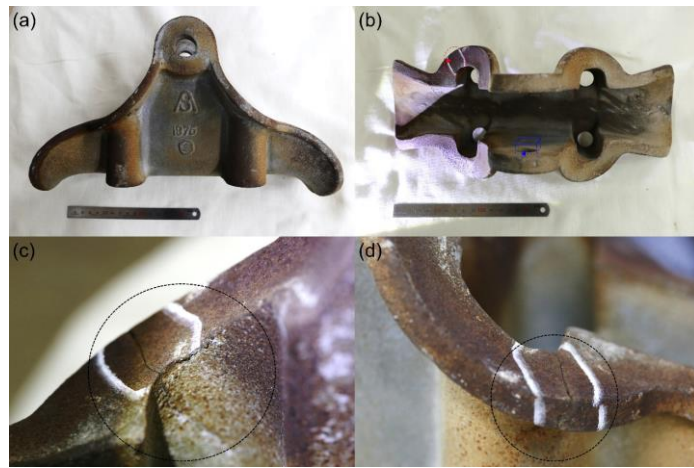
Fig. 1 shows fractured suspension clamp. About 50mm transverse crack was found in a shoulder where a U-bolt clamp being inserted into nearby as shown in Fig. 1(d). The product was corroded to some extent overall.

Fig. 1. A cracked suspension clamp (a) Front view (b) Top view (c) Inner view of a shoulder (d) Outer view of a shoulder

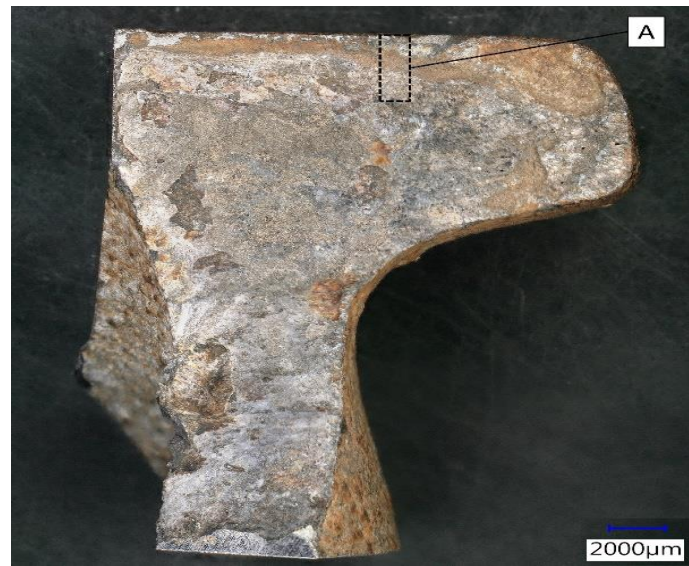
Fig. 2. Fracture surface obtained by digital microscope

Fracture surface was entirely covered with oxides as shown in Fig. 2, so that the traces of crack propagation were not sensible. For assessing metallurgical characteristics of the fracture surface beneath the oxides layer, cross-section of a black rectangular 'A' in Fig. 2 was sectioned. The analysis will be addressed in the following section.

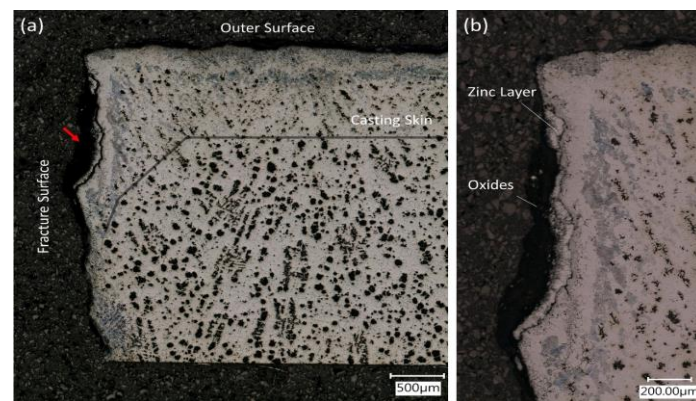
Cross-section of fracture surface 'A' in Fig. 2 was observed by microscope as shown in Fig. 3. Note that the fracture surface was covered with continuous white colored layer under black layer indicated by the red arrow in Fig 3(a). The chemical compositions of the white and the black layer using EDS are listed respectively in Table. 2 and 3. It was revealed that the white layer consists mostly of zinc while the black layer zinc and oxygen. In morphology, the columnar layer in white below the black seems zinc-iron intermetallic compounds comprising zeta ( $\zeta$ ) phase which features numerous tiny crystals [8, 12, 15] in Fig. 3(b) and 4.

Fig. 3. Digital micrograph of cross-section of fracture surface etched by 4% nital solution (a) low magnification (b) Higher magnification of the region indicated by red arrow in Fig. 2(a)

Furthermore, the distinctively decarburized zone near the surface was noticeable in Fig. 3(a). In Fig. 3(b), The covering layers on the fracture surface and microstructure beneath the layer were more visible in detail. The microstructure of the sub-surface consists of ferritic rim, pearlitic layer and depleted graphite. These features

are clearly distinctive in comparison with microstructure of the base metal. All the features can be formed through decarburization of the inner matrix microstructure, which are composed of casting skin in the casting. The casting skin exist beneath not only outer surface but also fracture surface. Fig. 4 shows the microstructure of the surface and sub-surface of the crack more in detail.

It is known that casting skin such as ferritic rim, graphite depletion is generated in the casting process by metal-mold interaction due to oxidation [3]. The casting skin appearing on the subsurface beneath the crack clarify that the crack occurred during casting process. Furthermore, the uniformly distributed zinc layer on the fracture strengthens our hypothesis that the initial crack had existed before hot dip galvanizing.

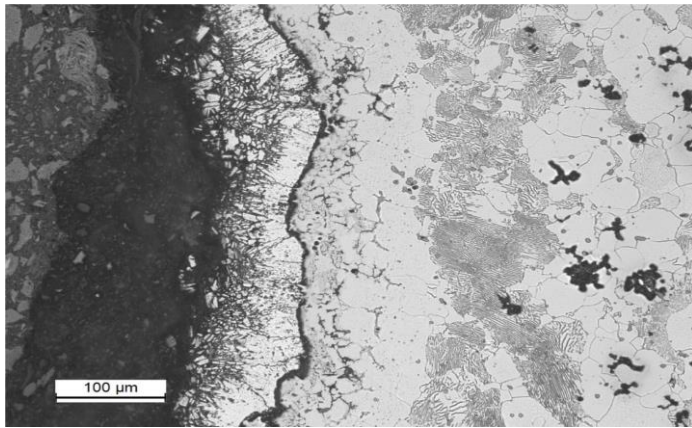
Fig. 4. Microstructure of cross-section of the fracture surface obtained by optical microscope which shows covered with zinc compound layer and oxides.

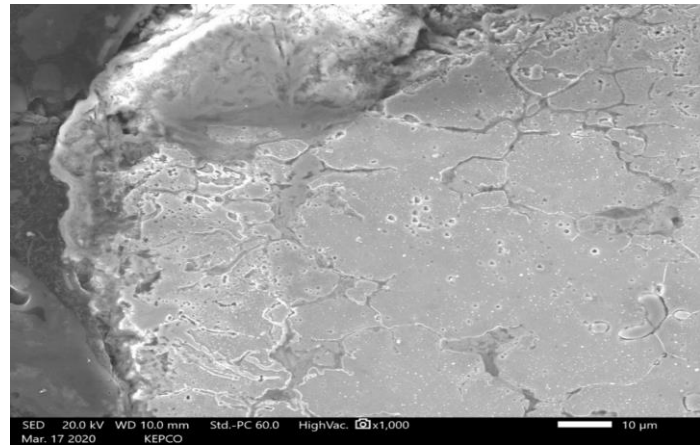
Fig. 6. Scanning electron image of cross section of the fracture surface near outer surface which reveals multiple intergranular cracks

More interestingly, intergranular cracks filled with zinc were found as shown in Fig. 6 and 7. Filled zinc in the intergranular crack tells us that crack was generated after casting process, and before/during hot dip galvanizing. These intergranular cracks can occur by hydrogen embrittlement, liquid metal embrittlement [16, 17], or temper embrittlement [16, 18, 19]. Hydrogen embrittlement is related to acid pickling and fluxing with  $ZnCl_2$  and  $NH_4Cl$ . However, it only happens in high strength steel and iron. When surface crack is related to galvanizing, liquid metal embrittlement (LME) is important degradation factor [17]. LME often features the crack filled with zinc layer. The pre-requisite for the LME cracking includes material susceptibility, stress concentration factor, high level of residual stress, and the presence of molten metal such as zinc in this case [1, 7]. High roughness generated by sand casting followed by fluxing in galvanizing can contribute to liquid metal embrittlement as high stress concentration factor [8, 17]. High stress concentration factor due to micro-crack by metal-mold interaction or pre-existing crack boosts LME significantly. However, LME mostly occurs with high tensile strength steel and iron [12, 21, 22]. Relating to LME in mild strength material, it happened when the significant residual stress had existed [23]. LME is principally only crack propagation phenomenon [16, 24]. For complex shaped structure, stress due to differential thermal expansion during hot dip galvanizing can be the driving force to the LME [21]. In mild strength material, an

intergranular crack was not driven by LME but by other embrittlement such as temper embrittlement [21]. Hot dip galvanizing temperature which is about 450°C corresponds to the typical range of temper embrittlement [18-20]. Especially for cast iron, high silicon and sulfur which usually manipulated in casting as carbon manipulator can influence temper embrittlement in severity [20]. It had not been reported that liquid metal cracking in hot dip galvanizing made the sub-surface beneath the crack decarburized. In the contrast to this, the cracking with filled zinc have been reported many times which is attributed to pre-existing crack irrespectively of the LME [12, 21, 25]. Subsequently, the importance of LME mechanism in this case is limited because it was not the root cause to main crack initiation. Nonetheless it might influence not only secondary crack propagation in Fig. 6 but also propagation of pre-existing crack. For remedial action of the root cause of failure, casting defects such as hot tear, cold shut should be prohibited by casting simulation which can perform residual stress analysis [27], and optimize the design of gate, feeding, and mold [26]. Furthermore, every pre-existing crack would be filled with molten material after hot dip galvanizing. Afterwards non-destructive testing would not be effective for the crack except several expensive methods for instance, X-ray inspection. Consequently, it is important that the foundry manufacturer inspect the casting defect prior to galvanizing and prevent from damaging in the galvanizing process through reliable quality control process in the procedures. Roughness enhancement through elimination as-cast skin by machining [28] or mold coating improvement [29] would be beneficial in lowering stress concentration for liquid metal embrittlement. Temper embrittlement during hot dip galvanizing can be alleviated by some heat treatment. Low cooling rate during hot dip galvanizing and pre-treatment before galvanizing which heated the product up to about 650°C and quenching prevent embrittlement [18-20].

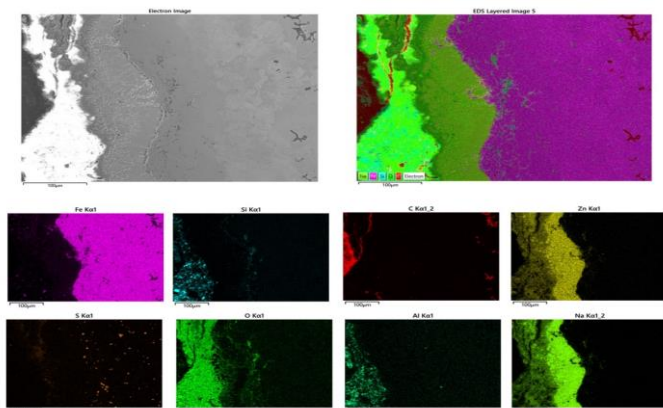
Fig. 5. Elemental mapping of the cross-section of the crack surface which shows thick zinc coated layers on the S curve shaped iron surface and graphite depletion zone beneath the zinc coated layer.

Fig. 5 shows the distribution of the chemical elements in the vicinity of the crack surface. The iron abundant area must be base metal. Carbon was detected partially in the inner region where graphite exists in Fig 4 while sulfur was distributed in condense manner. Above the iron region, there is a continuously distributed zinc and sodium layer which is probably a hot dip galvanized coating layer. The outer layer is composed of environmentally abundant mixtures such as aluminum, silicon, and oxygen.

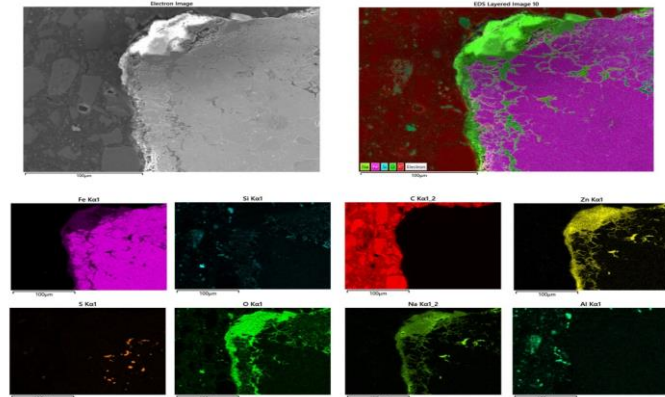
Fig. 7. Elemental mapping of the cross-section of the crack surface in the vicinity of the outer surface at which zinc was penetrated in the intergranular cracks.
