# Analysis of Tensile Strength Characteristics of ACSR due to White Rust

백화현상에 따른 ACSR 송선선로의 인장강도 특성 분석

Dae Keun Park, Jung Hwan Ahn, Minjun Kwak, Mihee Jung, Cheol Choi 박대근, 안정환, 곽민준, 정미희, 최철

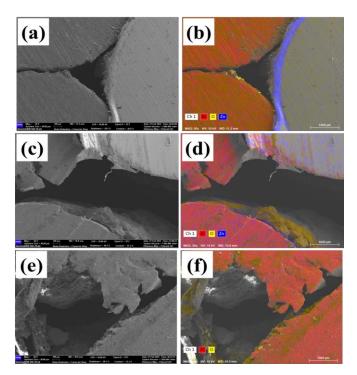
Fig. 5. SEM(left) and EDS mapping analysis(right) images of ACSR

As a result of analyzing the normal samples and partial white rusted wires using SEM and EDS (Fig 5), it was observed that the samples with partial white rusted wires had significantly more oxygen species than the oxygen molecules present on the surface of the normal ACSR.

Figure 5 shows SEM (left) and EDS (right) images of the cut surface of the sample determined as normal (a, b) and defective samples ( $c \sim f$ ) respectively. In the case of normal sample, it was verified that aluminum wire (yellow color) exists next to steel wire (blue part in EDS image) coated with zinc on the right side of each image.

Figure 5 (c~f) shows the SEM and EDS results of the sample recording the normal tensile strength among the samples judged to be defective. In fig 5(d), it can be seen that the zinc coated part has been completely removed unlike the normal sample, it could be confirmed that the oxide species are significantly greater than that of the normal samples through the yellow colored portion(fig 5d,f) of the EDS images.

The reason why the difference in tensile strength was not discovered even though a part coated with zinc was removed and an oxide species were increased more compared to the positive sample is that the wire was not damaged in advance and the mechanical strength of the steel wire was maintained. Furthermore, the reason that the tensile strength is maintained above a reference value even though the surrounding wire is partially white rusted(corroded) could be seen that the steel wire contributes the most to determining the mechanical strength of the ACSR.
