A Study on Fp Z/8 of Anti-Backlash Gear in an Engine

^{*}R&D Dept., Zhejiang Shuanghuan Driveline Co., LTD., China

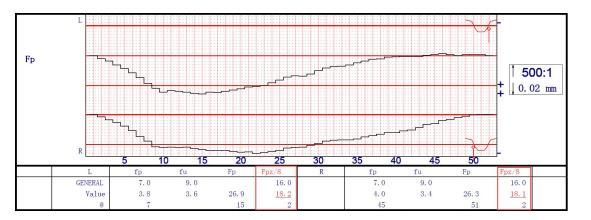
As shown in Fig. 4, this project was carried out to the SOP (Standard Operating Procedure) stage. In the OTS (Off Tooling Samples) stage, the deviation was not found due to the lack of full inspection of Fp Z/8. In the PPAP (Production Part Approval Process) stage, three out of five products were found to be out of tolerance (the general requirement is 16 um) during the sampling inspection by the customer, and 300 products were immediately returned to sort again, with a rejection rate of about 8% after sorting.

Fig. 4 Fp Z/8 inspection of Bias gear

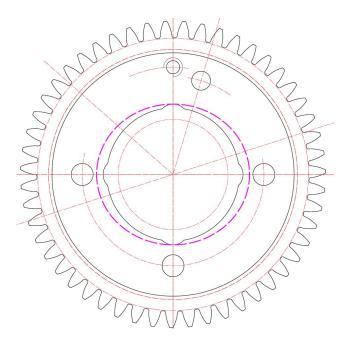
1. A high degree of roundness of the inner hole of the workpiece is shown in Fig. 9.

After clamping, Fp changes before grinding and shrinks after grinding. The roundness of the inner hole causes the center point to shift during the detection.

Fig. 9 The schematic for large roundness of the inner hole of the bias gear workpiece

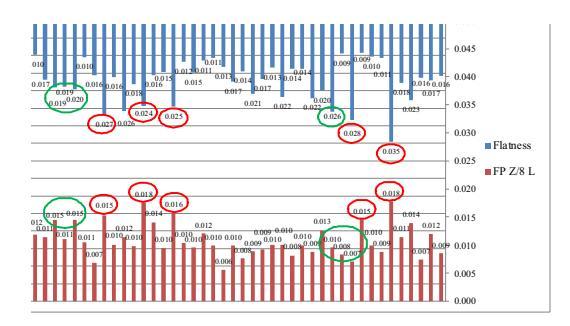
Fig. 12 The correlation analysis between the flatness and Fp Z/8 (Left tooth flank, unit: mm)

For the correlation analysis between end warping and Fp Z/8, there is no direct relationship between the flatness and Fp Z/8 of the left and the right tooth, as shown in Fig. 12 and Fig. 13.

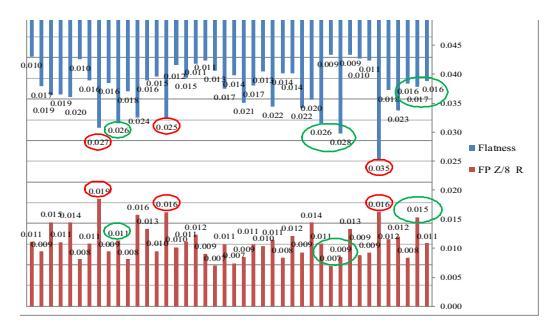
Fig. 13 The correlation analysis between the flatness and Fp Z/8 (Right tooth flank, unit: mm)

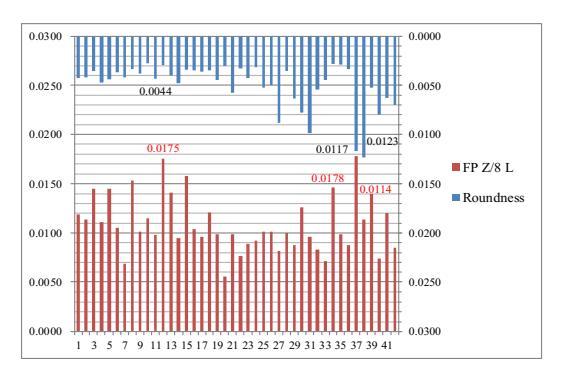
It can be seen from Fig. 14 that the overall roundness of the bias gear grinding hole is good and is not strongly correlated with Fp Z/8, which means that a roundness of 0.0044 mm corresponds to Fp Z/8 of 0.0175 mm, and a roundness of 0.123 mm corresponds to Fp Z/8 of 0.011 mm. This suggests that the roundness of the normal grinding ability has no direct influence on Fp Z/8.

Fig. 14 The correlation analysis between the roundness and Fp Z/8 (unit: mm)

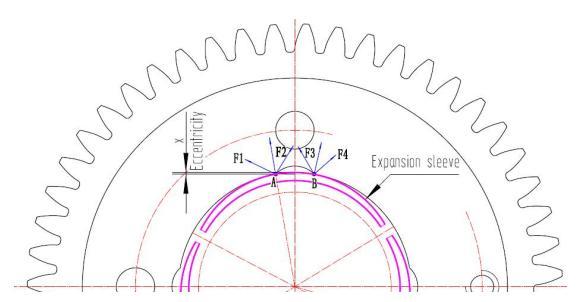
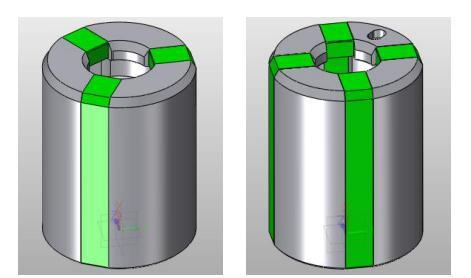
As shown in Fig. 15 and Fig. 16, when the 1-lobe of the 3-lobe expansion sleeve is aligned with the four slots of the bias gear, of which the first slot is positive, the clamping force generates the components F1, F2, F3, and F4 at points A and B. At the same time, the eccentricity of the workpiece is caused by the absence of contact at the highest point of one lobe of the expansion sleeve. The eccentricity can be calculated by the width of the groove and the diameter of the inner hole X, 0.16 mm. Because the diameter of the actual eccentricity is larger than the calculated value.

However, since the contact points are A and B, and the component forces are generated at A and B, the eccentricity also generates a transfer, which is not fully reflected in the radial run-out Fr. The decomposition of force and eccentricity can be used to calculate the clamping force and the tensile strength of the workpiece after carburizing and quenching. Points A and B are the positions at the junction of the inner hole and broaching groove after grinding. These two points are involved in positioning and are bound to affect the grinding quality.

The test was carried out with the workpiece in the canceled slot, and all of the tested products meet the requirements of the drawing, as shown in Fig. 17. Finally, the replaced four-part expansion sleeve was used to meet the process capacity requirements.

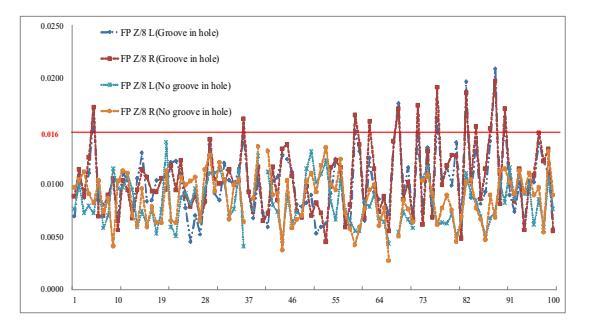
Fig. 17 The test of Fp Z/8 between groove in hole and no groove in hole (unit: mm)
