Plasma-Sprayed Al_2O_3 - SiO_2 Multi-Oxide Films on Stainless Steel Substrate

Korobova N.*, Soh Deawha**

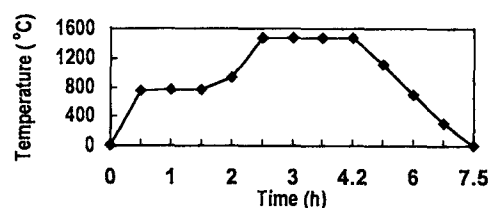
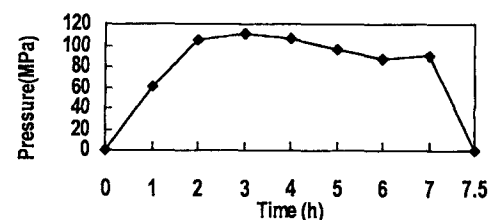
Fig.1 Temperature (a) and pressure (b) profile of HIP treatment

particles. Distinction between γ -Al₂O₃ and γ -Al₂O₃ was examined by the presence of splitting in the (400) and (440) reflections for γ -Al₂O₃. After HIPing, phase constitutions were converted to γ -Al₂O₃ having a trace of (9Al₂O₃ · 2B₂O₃), included in the BN capsule as a binder. There was no change in Al₂O₃-SiO₂ phase composition after plasma spraying nor after HIPing except for the appearance of a small amount of γ -Al₂O₃. Temperature and pressure profile of HIP treatment is shown in Figs. 1(a) and 1(b) respectively.

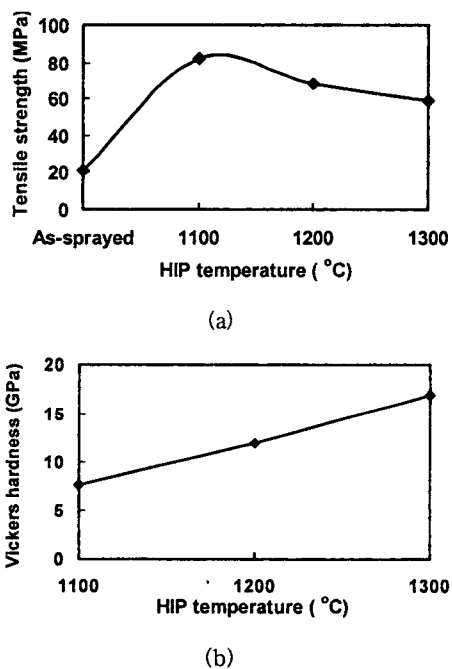
Fig. 2. Variations of Vickers hardness (b) and tensile strength (a) of Al_2O_3 coating HIPed at various temperature

Vickers hardness and tensile strength of Al₂O₃ and Al₂O₃-SiO₂ coatings before and after HIP treatment are shown in Figs. 2-3 respectively. The Vickers hardness of as sprayed Al₂O₃ and Al₂O₃-SiO₂ coatings could not be measured because of their rough surfaces with a lot of pores even after polishing. The Vickers hardness of the Al₂O₃-coated surface showed an improvement to 12.2GPa after HIPing at 1300°C. This value reaches to 60 % of the hardness of sintered Al₂O₃. The tensile strength also increased from 5MPa to > 40MPa. The fracture path in the as-stayed specimen was close to the interface between the coated layer and metal substrate. However, after HIPing the fracture occurred mostly at the edge area within the coated layer. The

maximum tensile stress seemed to appear in the edge area due to a thermal expansion mismatch between the coated layer and the metal substrate during HIPing. Consequently, the decrease of maximum value of each tensile strength with increasing HIP temperature, as seen in Fig. 2 would be ascribed to the increase of thermal stress with HIP temperature. It is considered that the above mentioned HIP effects would be further improved by introducing some interlayer which can relax the thermal stress. The range of temperature and pressure in HIP treatment was limited, owing to the properties of substrate metal, so the efficient densification of coated $\text{Al}_2\text{O}_3\text{-SiO}_2$ could not be completed.

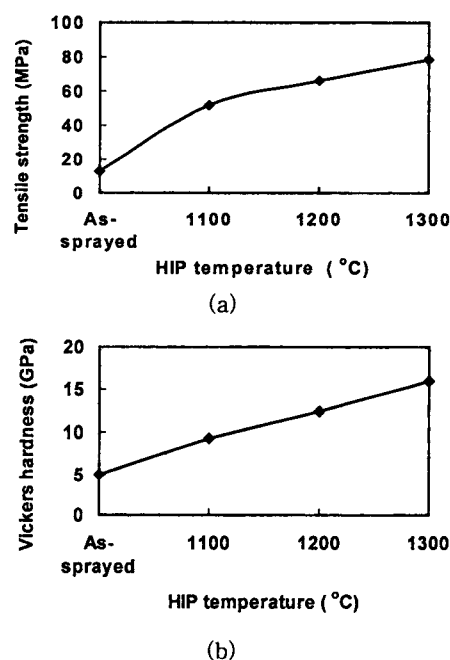
Fig. 3. Variations of Vickers hardness (b) and tensile strength (a) of $\text{Al}_2\text{O}_3\text{-SiO}_2$ coating HIPed at various temperature

In case of $\text{Al}_2\text{O}_3\text{-SiO}_2$ coating, Vickers hardness and tensile strength were remarkably improved, from 5GPa to 13.3GPa and from 5MPa to $> 60\text{MPa}$ after HIP treatment at 1300°C , respectively. The fracture positions before and after HIPing were similar to those of Al_2O_3 coating. In such an interface a coating strength is expected to increase by a mechanical interlocking. The substrate metal infiltrated deeply into the coated layers after HIP treatment at 1300°C . The deep infiltration of metal should reduce resistance against wear, heat, and oxidation.
