Study on the damage of Bearings due to failure of Oil Supply System at turbine

Koo-Jae Raeyang, Lee-woo kwang, Koo-woo sik,
Kim-yeon hwan, Park-Kwang ha

Abstract

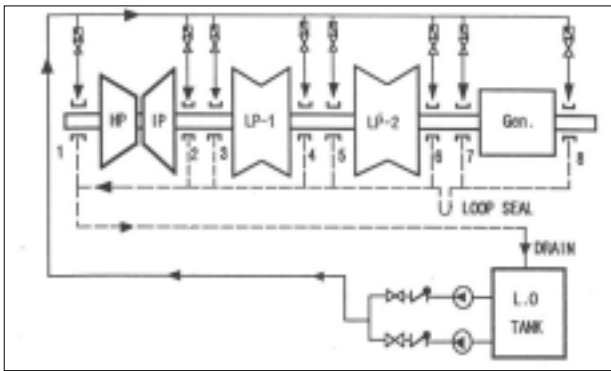
Fig. 1 Lubricating oil supply system

2.1
Fig.1
(Tank)
2.0kg/cm²

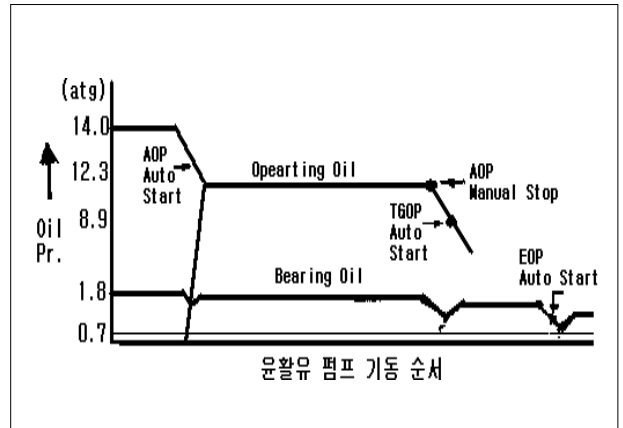
Fig. 2 Starting Sequence at Lubricating Oil Pump (Babbit Metal)

Fig.2

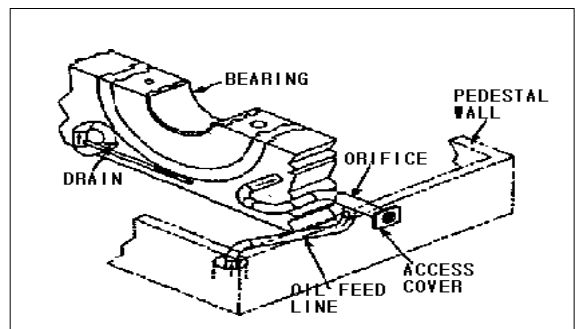
Fig. 3 Lubricating Oil pipe arrangement

Fig. 3

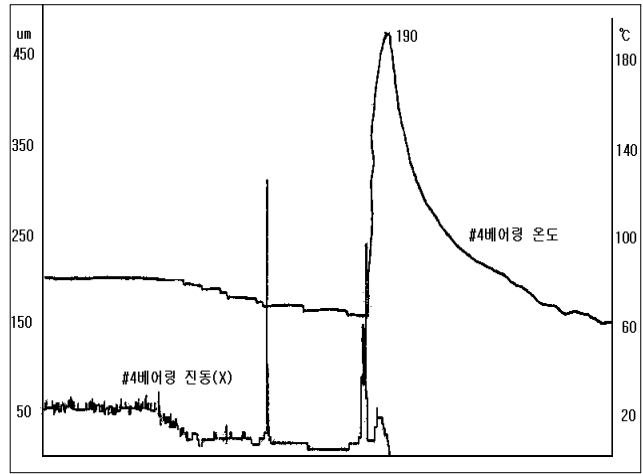
Fig. 4 Vibration and Metal Temperature of #4 Bearing at Shut-Down

Fig. 4 #4

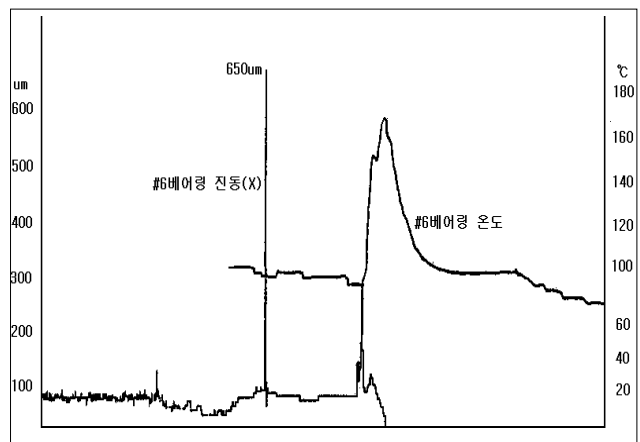
Fig. 5 Vibration and Metal Temperature of #6 Bearing at Shut-Down

Fig. 5 #6

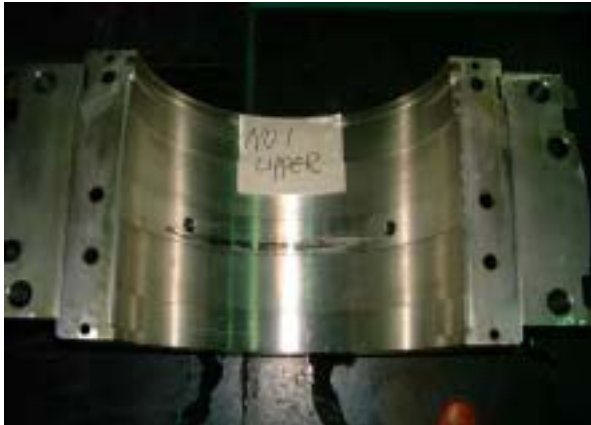
Babbitt가

Fig. 6 Disassemble of No. #1 Upper Bearing

Fig. 6

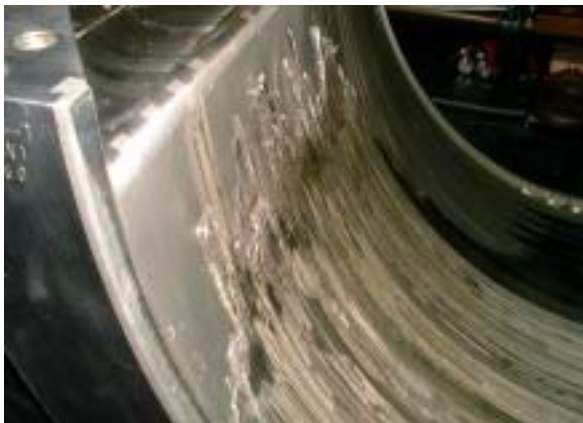
Babbitt

Babbitt가

Fig. 7 Disassemble of No. #3 Lower Bearing

Fig. 7

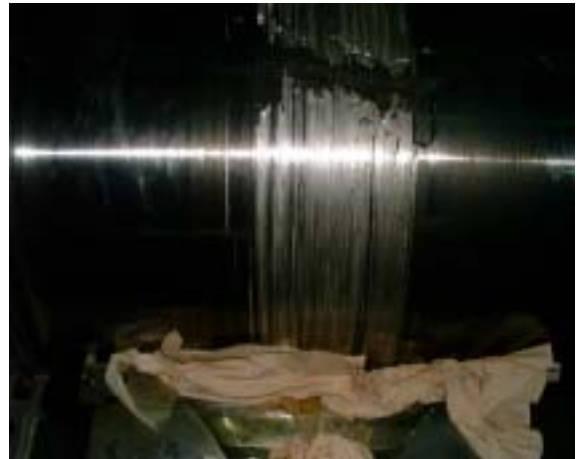
Babbitt가

Fig. 8 Journal of No. #4 Bearing

Fig.8
