IMPROVING HABITAT OF FORMOSAN LANDLOCKED SALMON BY DAM REMOVAL

CHAO-HSIEN YEH and HUI-PANG LIEN

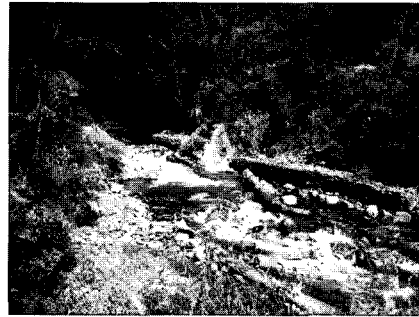
Photo 1. Dam No.4 (April, 1999)

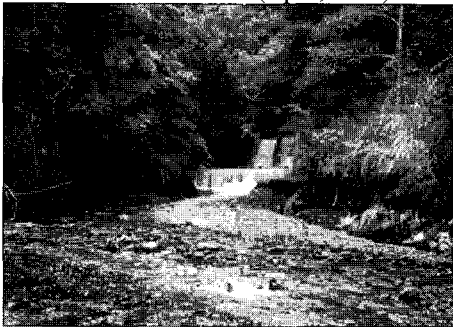
Photo 2. Dam No.4 (October, 2001)

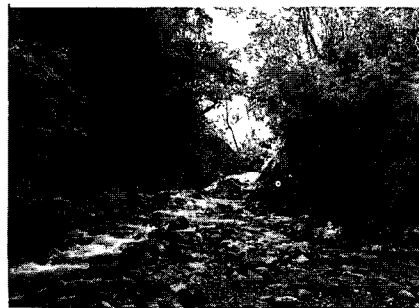
Photo 3. Dam No.3 (October, 1997)
