철골좌대에 설치되는 타워크레인의 주변 오픈 구간에 의한 사용성 영향 분석

Analysis of the Usability Effect of the Open Section Near the Tower Crane Installed on the Steel Frame

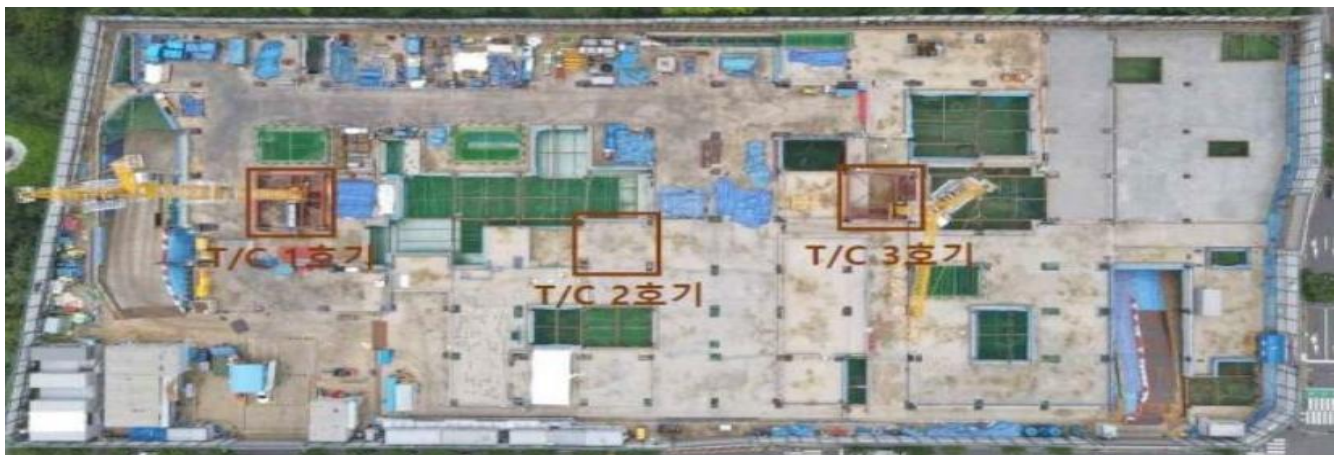
그림 1. 현장 사진 사례

타워크레인 주변부 오픈 구간에 대한 시공중 검토를 위해 그림 1과 같이 조사를 하였고 그림 2와 같이 3차원 모델링을 통해 토압에 의한 철골부재 변위 및 처짐을 확인하였고 슬래브에 작용하는 압축응력 및 변형율을 검토하여 균열 발생여부를 확인하였다.
