# Electrical Treeing Deterioration and Dielectric Breakdown Phenomena in Polymeric Insulator

Y.S. Cho and S.W. Kim

Dept. of Chem. Eng., The Univ. of Seoul, Seoul 130-743

**Abstract** Studies on the electrical treeing deterioration and dielectric breakdown phenomena in the polymeric insulator of polyethylene and epoxy resin were carried out. Block type samples with needle-plane electrode geometry were electrically stressed and the tree pattern from the needle tip was observed. In LDPE the density of electrical tree was very high and its pattern was bush type. For the case of XLPE, branched tree was observed. As temperature and SN content increased, the dielectric breakdown voltage decreased and the treeing phenomena became more complicated. Fan type cracks were observed around the conducting tree path in the brittle DGEBA/MDA system.

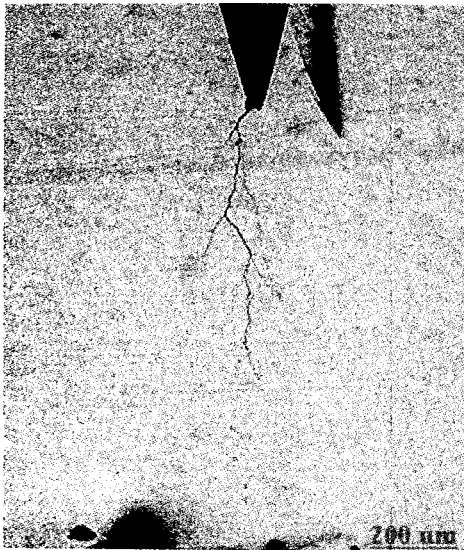
Fig. 3. Electrical treeing deterioration phenomena in the conventional epoxy resin system DGEBA/MDA.

Fig. 3 is the electrical tree in the conventional epoxy resin DGEBA/MDA system which is brittle and has high density of cross link. The tree propagated from the needle tip and is very thin. The treeing phenomenon is very differ from those observed in PE which is flexible. Electrical tree is a long deterioration phenomenon in

the electrical insulating material which is subjected under several kinds of stresses such as electric field, high temperature, compression, vibration, and so on. Electrical tree is initiated from the most highly stressed local region. At the tip of protrusion, conducting inclusions, voids, cracks, etc., the combined stresses are concentrated and magnified. When the electric field goes over the maximum limit of the elastic breakdown, the material is distorted and physical crazes are generated and propagated. It is clear the treeing resistance of DGEBA/MDA system is very high.

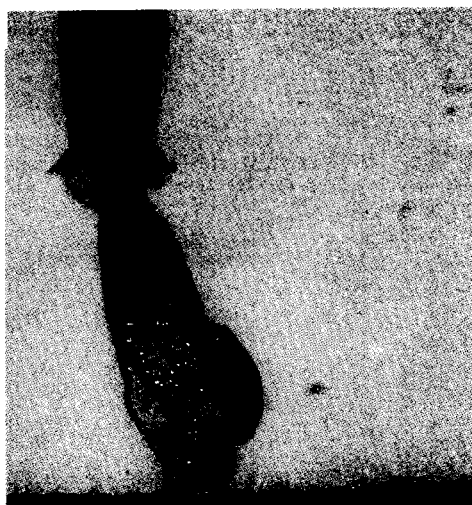
Fig. 7. Dielectric breakdown phenomena in DGEBA/MDA/SN system.

The dielectric breakdown phenomena in the modified system showed small cracks and it indicates the system is very flexible and broken down at lower electrical stress. The flexibilized system could efficiently absorb the impact shock and showed a little crack around the channel. The surface of tree channel was rapidly carbonated at the both systems. At higher temperature than  $T_g$ , the dielectric breakdown pattern of DGEBA/MDA system was similar to DGEBA/MDA/SN system. At the elevated temperature the polymer chain segment moves freely by the thermal stress and free volume is arranged along the direction of electric field. The electrons can fly into the deep inside and form the space charge. Also the electrons are accelerated under high electric field, and crashe against the polymer chain. As the flight distance of the carriers increases the impact stress by the accelerated hot electrons increases and the polymeric chain is cut under the stress. By this way, pits are formed at the tip of needle electrode and propagated. When the tree reached the counter electrode the electron could emitted more easily and conduction current increased and the insulator was broken down, finally. The flexibilized epoxy resin system could absorb the impact shock and one or two fan type cracks were observed around the bridged channel.

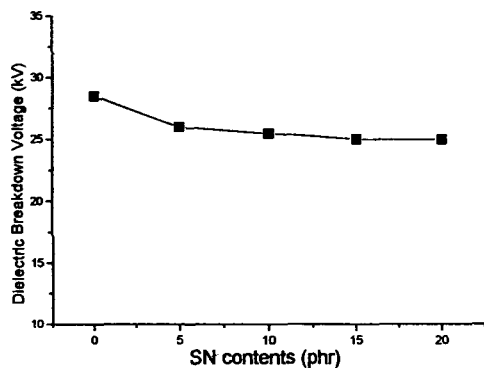
Fig. 9. Effect of SN content on dielectric breakdown voltage of DGEBA/MDA system.

Fig. 9 shows the effect of SN content on dielectric breakdown voltage ( $V_b$ ) of the DGEBA/MDA system with needle-plane electrode geometry. As the content of reactive additive nitrile increased the dielectric breakdown strength (DBS) decreased at the initial content and then saturated to 24.0 kV/mm until the SN content of 20 phr. The dielectric breakdown mechanism can be described by electrical conduction mechanism. As the nitrile content increases the trap depth of carrier increases because the cured polymeric chain loosens.<sup>10)</sup> Also the work function of electron decreases and electrons and holes are emitted easily from the metal electrode under the ac high electric field. The decrease of DBS relates with the decrease of thermal properties

and space charge behaviour.<sup>13)</sup>
