Characteristics of Thermo-Acoustic Emission from Composite Laminates during Thermal Load Cycles

The thermo-acoustic emission (AE) technique has been applied for nondestructive characterization of composite laminates subjected to cryogenic cooling. Thermo-AE events during heating and cooling cycles showed a Kaiser effect. An analysis of the thermo-AE behavior obtained during the 1st heating period suggested a method for determining the stress-free temperature of the composite laminates. Three different thermo-AE types classified by a short-time Fourier transform of AE signals enabled to offer a nondestructive estimation of the cryogenic damages of the composites, in that the different thermo-AE types corresponded to secondary microfracturing in the matrix contacting between crack surfaces and some abrasive contact between broken fiber ends during thermal load cycles.

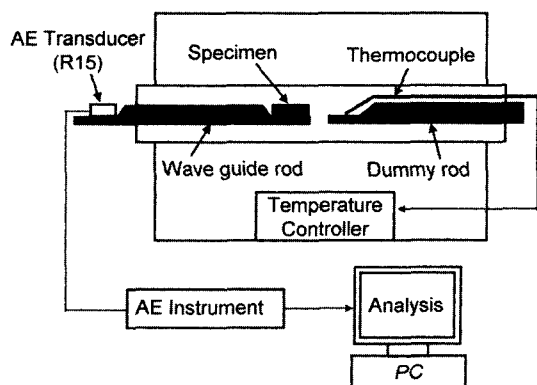
Fig. 3 Schematic of thermo-AE experimental apparatus

Thermo-acoustic emission during heating and cooling cycles was measured by an apparatus consisting of an electric furnace, a wave guide and the AE measuring system (Mistras-2001, Physical Acoustic Corp.), as shown in Fig. 3. A specimen in the furnace was heated from room temperature to 170°C at the rate of $+4.3^\circ\text{C}/\text{min}$ and then was naturally cooled in the open furnace to room temperature. The cooling time was 1.5 hour. The thermal heating and cooling cycles were repeated three times. The AE measurement conditions were as follows: Pre-amplification 40 dB and threshold level 35 dB. The acoustic emission ring-down count rate, hit event counts, amplitude distribution, and time-amplitude signals were obtained from this measurement.

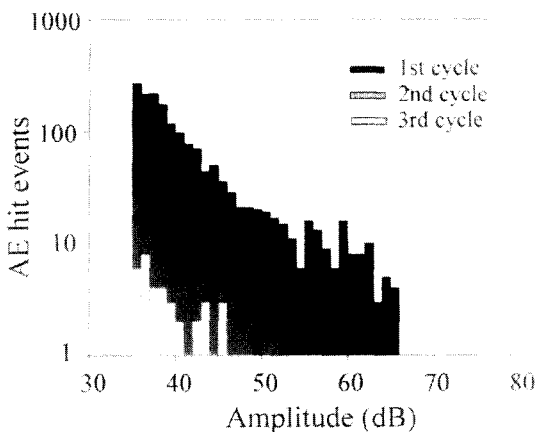
Fig. 7 AE hit events versus amplitude distributions during the repetitive thermal load cycles

the ring-down count rate in each thermal cycle had a tendency to decrease as an exponential function of the negative order number of thermal load cycles. Amplitudes of AE also fell below one-tenth during the repetitive thermal cycles (Fig. 7). Considering that the respective thermal cycles have the same thermal loading conditions in the temperature range as well as in the heating and cooling rates, the reduction in the ring-down count rate due to the repetitive heating and cooling indicates the thermal Kaiser effect. This behavior of thermo-AE may represent that through the repetitive thermal cycles, first, cracks in the specimen did not propagate further and, second, weakening of frictional contact forces between crack surfaces due to relaxation of accumulated residual stresses brought about a decrease in secondary abrasive microfractures.

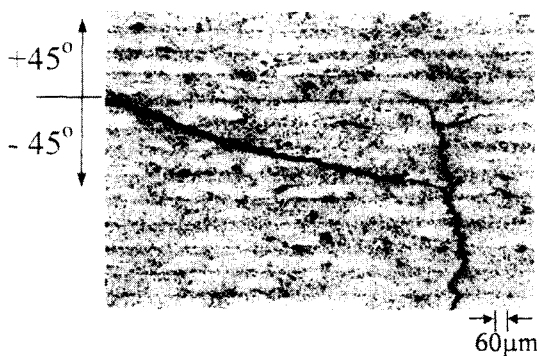
Fig. 9 Microscopic photograph of the cross-section near the free edge of a $[+45_6/-45_6]_s$ laminate. Several transverse cracks and delaminations are revealed

micrograph of the cross-section of the damaged free edge region (near $x = -50$ mm, $y = -5$ mm) in Fig. 8, exhibiting an interlaminar region between the skin layer with $+45^\circ$ fibers and the core layer with -45° fibers. Due to the cryogenic cooling, the delamination crack near the $+45^\circ/-45^\circ$ ply interface took place inducing a biased local crack propagating into the core layer, which joined with the transverse crack arisen from the core layer. Those cracks propagated in a zig-zagged way through the matrix resin and around the fiber-matrix interfaces, which might cause fracture of fibers bridged across the crack path.

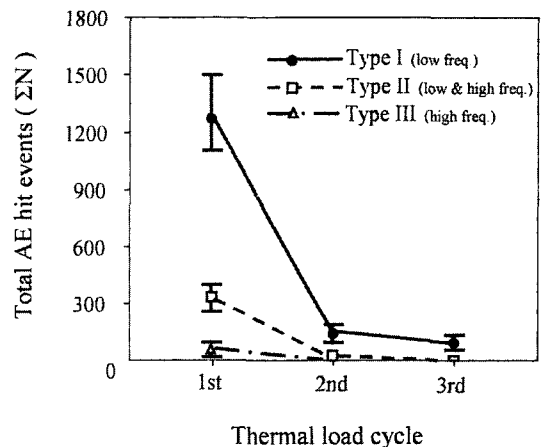
Fig. 12 Total AE ring-down counts (ΣN) obtained from cryogenically-treated $[+45_6/-45_6]_s$ laminates according to the three types of AE signals for each repetitive thermal load cycle. Type I signals were very dominant, but largely decreased in number during the repetitive thermal cycles

Fig. 12 shows that the type-I signals were very dominant in the total AE hit events detected during the 1st thermal cycle. As the same thermal cycle was repeatedly applied to the cryogenically-treated specimen, the number of the type-I hit events decreased almost exponentially. The repetitive cycles caused the type-II events to occur far less frequently. Most secondary abrasive microfractures seem to have not been any further propagated. It may be understood that the type-I events correspond to some secondary abrasive

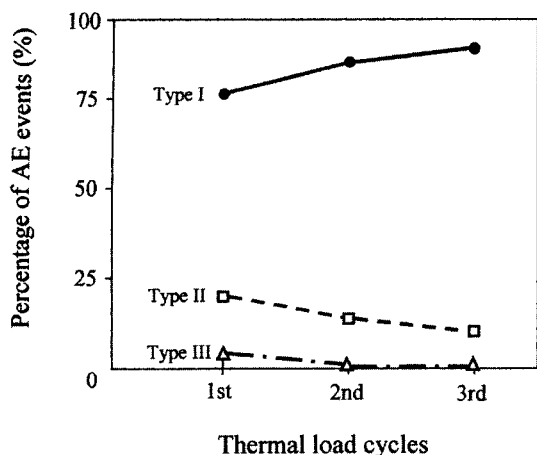
Fig. 13 Relative percentage of the total AE hit events according to the three types of AE signals detected during each thermal load cycle. These data were calculated from those in Fig. 12. Percentage of the signal type may be a nondestructive indicator for the amount of each type of fractures in cryogenically-treated composites

microfractures in matrix, since such high percentage (about 76%) of the type-I signals shown in Fig. 13 is related with a large fraction of cryogenically-fractured portion of matrix over the total fracture surface as shown in Figs. 9 and 10. The repetitive cycles caused the percentage of the type-I signals to increase from 76% to about 87%. The type-II events were minor in quantity, but they occurred to a degree in the 1st thermal cycle. This may be a nondestructive indicator for how many fiber breakages had been formed during the cryogenic cooling.
