Development of Using Technique of Impregnating Alkalization Agent to Recover Durability of Carbonated Reinforcement Concrete Structures by Fire Damages

화재로 인해 중성화된 철근콘크리트구조물의 내구성 회복을 위한 침투성 알칼리성부여제의 이용기술개발

Moo-Han Kim[†] · Young-Jin Kwon* · Yong-Ro Kim** · Jea-Bong Jang***

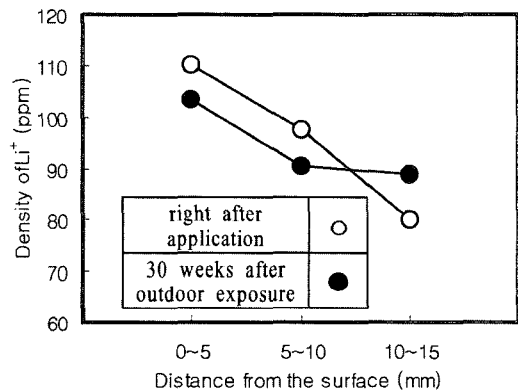
Fig. 5. Li^+ density according to the depth.

For a more quantitative evaluation of the penetration of impregnating alkalinization agent, we shows the result of ICP analysis of Li^+ (the main ingredient of impregnating alkalinization agent) after its application in Fig. 5.

The density of Li^+ just after application according to the depth was highest at the surface, as measured 110.4 ppm at 0~5 mm, 97.6 ppm at 5~10 mm, and 80.2 ppm at 10~15 mm, and it is considered Li^+ reached more than 15 mm in depth. After 30 weeks of outdoor exposure, they showed 103.5 ppm, 90.5 ppm, and 89 ppm of Li^+ density similar to those of the moment of application, promising practical effectiveness when applied on a actual structure.

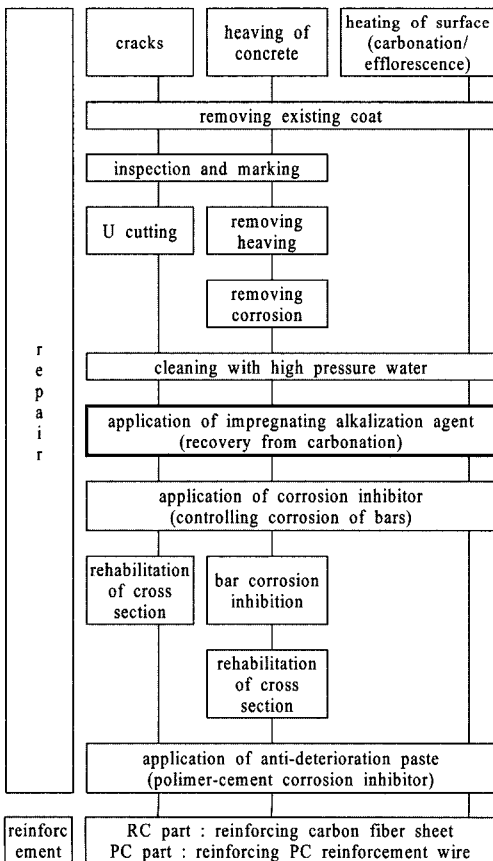
Fig. 6. Flow diagram of repair construction.

Fig. 6 show the flow diagram of construction according to the deteriorated situation of the structure. Especially, impregnating alkalization agent was applied to the parts which carbonation is accelerated after a fire to recover their alkalinity.

On the other hand, for parts suffering or promising corrosion of bars, sprinkling corrosion inhibitor was applied to control corrosion of bars, and for parts missing surfaces, polymer cement material was used to restore the surface, both to increase durability of concrete.
