Case Report

# Multiple Intracranial Calcifications as a Complication of External Ventricular Drain Placement

The authors present a case of multiple intracranial calcifications after the procedure of external ventricular drain placement in a 50-year-old man with pericallosal artery aneurysm. We believe that calcifications formed dust that had fallen into the track during the external ventricular drain procedure. The clinical features and radiological findings are presented with review of literature.

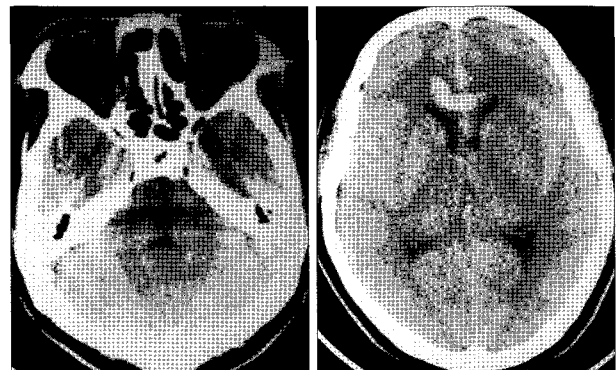
**Fig. 1.** Preoperative non-enhanced brain computed tomography shows a diffuse subarachnoid hemorrhage in the basal and sylvian cisterns without intraventricular hemorrhage and intracranial calcifications.

A 50-year-old man was admitted on emergency basis with complaints of sudden bursting headache and vomiting. The brain computed tomography (CT) demonstrated a diffuse subarachnoid hemorrhage in the basal and sylvian cisterns and an obliteration of the cortical sulci, but there was no evidence of abnormal calcification in brain parenchyma and ventricles (Fig. 1). The cerebral angiography showed a saccular aneurysm on the left pericallosal artery.

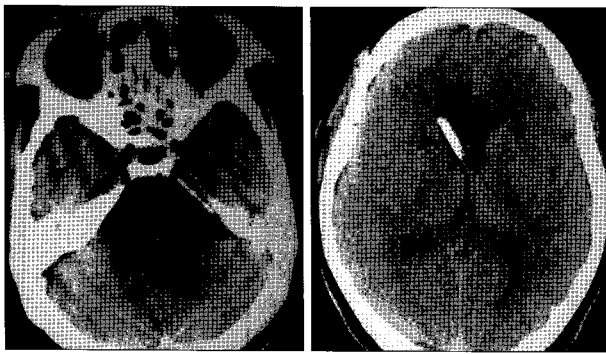
**Fig. 2.** Postoperative follow-up computed tomography demonstrates resolution of subarachnoid hemorrhage and part of external ventricular drainage tube (black arrow) in frontal horn of the lateral ventricle, but radiopaque structures are not present.

We made a rectangular shaped craniotomy on the left fronto-parietal area to perform the conventional interhemispheric approach. To achieve relaxation of the left hemisphere, a right frontal burr hole was made 1cm anterior to the coronal suture in the midpupillary line by using a Hudson's drill. The EVD tube was then introduced into the frontal horn of the right lateral ventricle. We kept the EVD tube for 7 days. Before removal of the EVD tube, axial non-enhanced CT was checked. The CT scan demonstrated resolution of subarachnoid hemorrhage and part of EVD tube in frontal horn of the lateral ventricle, but radiopaque structures were not present (Fig. 2). Following surgery the patient made an excellent recovery without any signs of

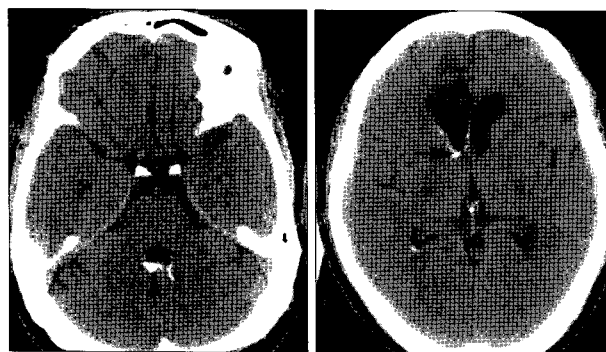
**Fig. 4.** The follow-up brain computed tomography obtained 18 months after surgery shows that the calcification mass did not change in size and shape (black arrow).

A contrast enhanced brain CT on 12 months following the surgery revealed the development of non-enhancing radiopaque lesions in the right frontal horn of the lateral ventricle, 3rd and 4th ventricles (Fig. 3). After 18 months, a follow-up brain CT showed that these lesions did not change in size and shape (Fig. 4).
