Clinical and scanning electron microscopic analysis of fractured dental implants: a retrospective clinical analysis

Abstract (J Korean Assoc Oral Maxillofac Surg 2012;38:371-8)

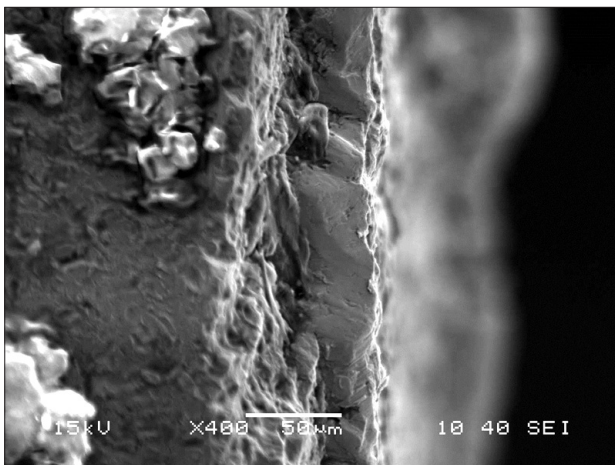
Fig. 1. Scanning electron microscopy views of the fracture. High power view of the fractured surface of titanium implant; magnification x400. Fracture cross-section has a different plan. *Kyung-Hwan Kwon et al: Clinical and scanning electron microscopic analysis of fractured dental implants: a retrospective clinical analysis. J Korean Assoc Oral Maxillofac Surg 2012*

Scanning electron microscopy revealed striations on the fractured surfaces of the clinical specimens similar to those seen on the laboratory-fatigued specimens and in contrast to the dimpled surfaces of the overloaded specimens.(Figs. 1-3) There were no porosities within the titanium, and the fracture lines were situated in different planes. The fractured surfaces exhibited a dimpled aspect characteristic of tensile fracture.

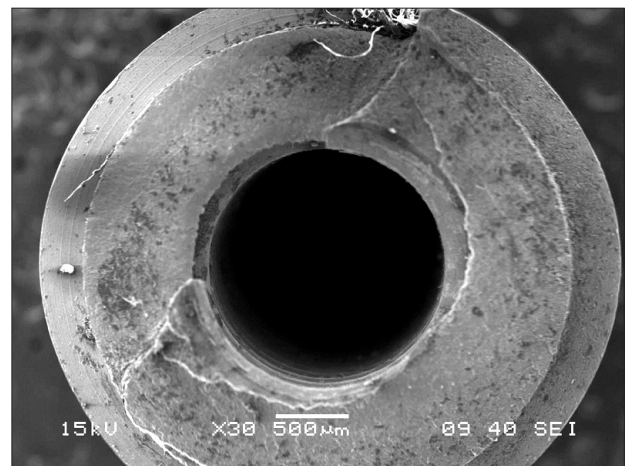
Fig. 3. At low-power scanning electron microscopic magnification (original magnification x30), it is possible to observe that no porosity is present inside the titanium and that the fractures appeared in different planes. The fractured surface exhibits a dimpled aspect, characteristic of a tensile fracture. *Kyung-Hwan Kwon et al: Clinical and scanning electron microscopic analysis of fractured dental implants: a retrospective clinical analysis. J Korean Assoc Oral Maxillofac Surg 2012*

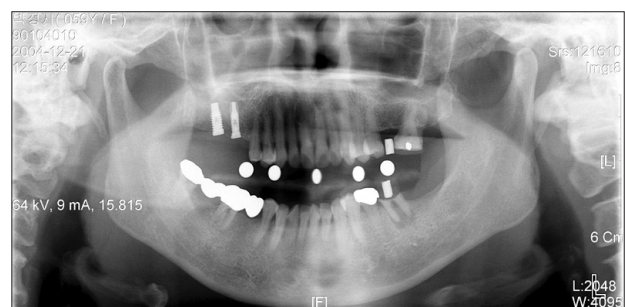
Fig. 4. Initial panoramic radiograph. This view shows missing state (#26, #36, #37) where implant is placed. *Kyung-Hwan Kwon et al: Clinical and scanning electron microscopic analysis of fractured dental implants: a retrospective clinical analysis. J Korean Assoc Oral Maxillofac Surg 2012*

In December 2004, a partially edentulous 59-year-old female patient underwent placement of single titanium implants (Osseotite; Biomet 3i) in the site of the maxillary posterior molar (#26). The implant was placed to occlude with #36 and #37 simultaneously. One 4.0×11.5 mm titanium implant was placed in the molar region of the left maxilla. The empty space was slightly narrow mesiodistally, and no distal cantilever was present.(Fig. 4) The patient showed no evidence of bruxism, and the condition of her alveolar ridge

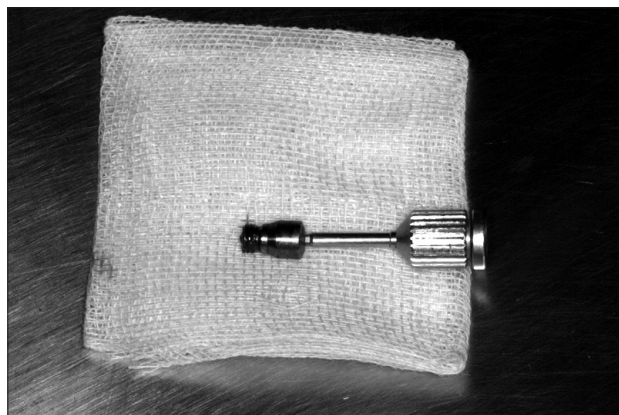
Fig. 5. Removal finding of healing abutment and coronal fragment of implant.

periapical radiograph showed the presence of fracture. The fractured implant was retrieved with a trephine.

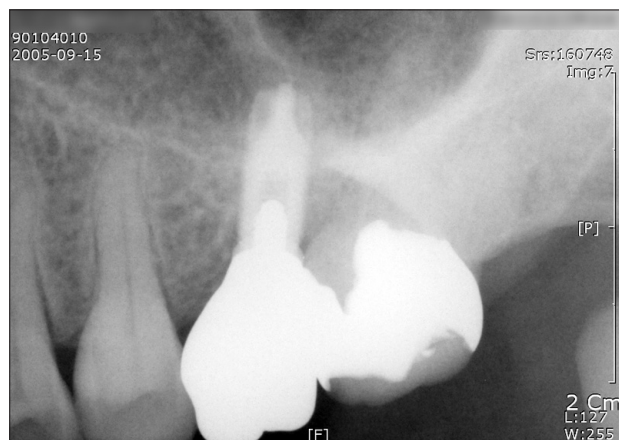
Fig. 6. Final prosthodontic view finding (Patient 1).

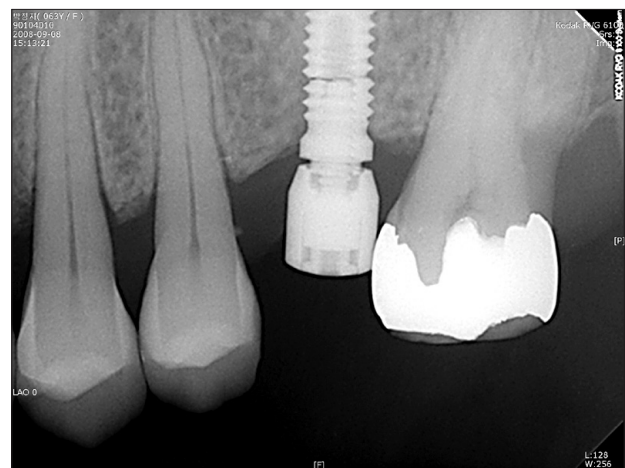
Fig. 7. At 3-year follow-up radiograph after final prosthodontic restoration, implant fixture fracture was evident.

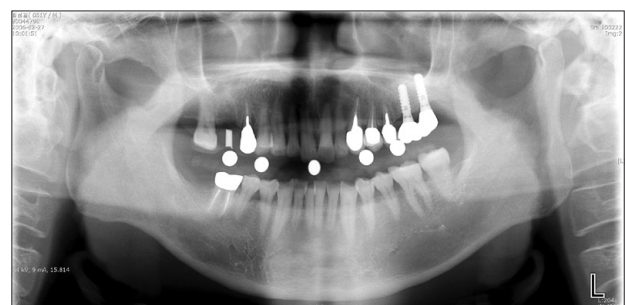
Fig. 8. The panoramic radiograph of a 50 year old male with existing restoration were 2 ITI implant system on left maxillary posterior molar area. These had been extracted 1 month ago (2006 Jan 20) previously possibly due to endodontic or structural problem.

A 50-year-old male reported that a single maxillary posterior molar had been extracted due to an endodontic problem and a periodontal disease.(Fig. 8) The patient had no relevant medical history; he was a non-smoker with no history of parafunction. Note, however, that he had a high-stress occupation.

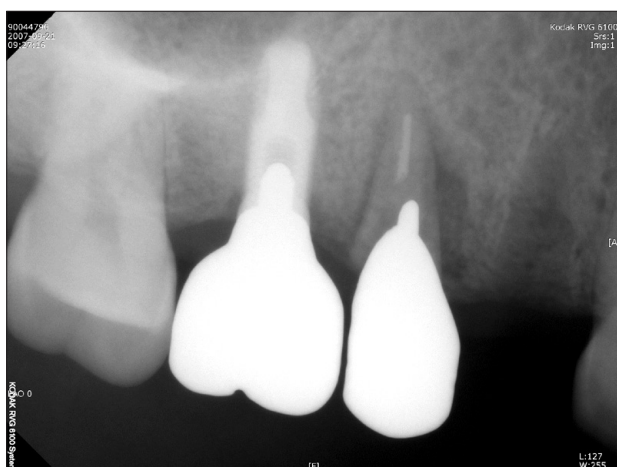
Fig. 9. Upper second premolar was demonstrated mobility and fractured at cervical area. Overload-induced bone resorption seemed to precede implant fracture (Patient 5). There was no fracture sign in implant fixture.

Regular standard follow-up checks were uneventful until September 2007 (Fig. 9), at which time prosthetic screw loosening was noted but no problem was detected with the abutments. Unfortunately, 3 months later, the patient complained of crown loosening. He described "screw loosening similar to the mobility of the implant crown". Upon removal of the prosthesis part of the abutment, the screw came off along with the gold crown and 2nd premolar. A panoramic radiograph showed fractured maxillary first molar implant and extraction of the 2nd premolar. This implant was fractured in the area of the 3rd thread (border of the machined surface and rough surface-hybrid implant surface). The prosthesis was removed again when the distal fixture was observed at the same visit to have fractured at the alveolar bone margin, leaving the abutment screw intact within the abutment SEM showed metal-tearing striations on the cross-sectional surface of the fractured fixture. Porosities were present within
