Study on Reliability of Water Absorption Diagnosis through Precise Water Absorption Test

Keywords: Generator, Stator windings, Insulation breakdown, Precise water absorption test

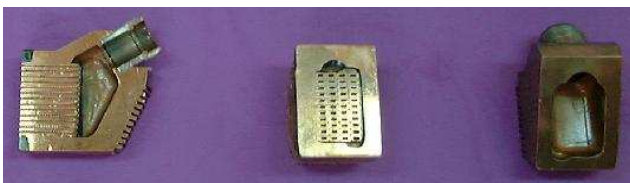
(a) Left side (b) Front side (c) Inside of water-clip

Fig. 2. Section of clip to strand of stator

In stator windings, many coolant passages are formed in order to cool down the heat generated by the inside copper conductor with flowing electrical current, and the outside is covered by mica-epoxy insulating material, as shown in Fig. 2. The coolant supplied by the stator coolant supply pump flows into the stator winding clip, after passing through the Teflon hose, and cools down the windings that flow along the coolant passages inside the windings. The Teflon hose connection and stator winding clip are the locations in the generator stator windings from which the coolant frequently leaks during operation. The stator winding clip plays not only the role of a coolant chamber for each set of windings but also that of an electrical connector of the upper and the lower windings.

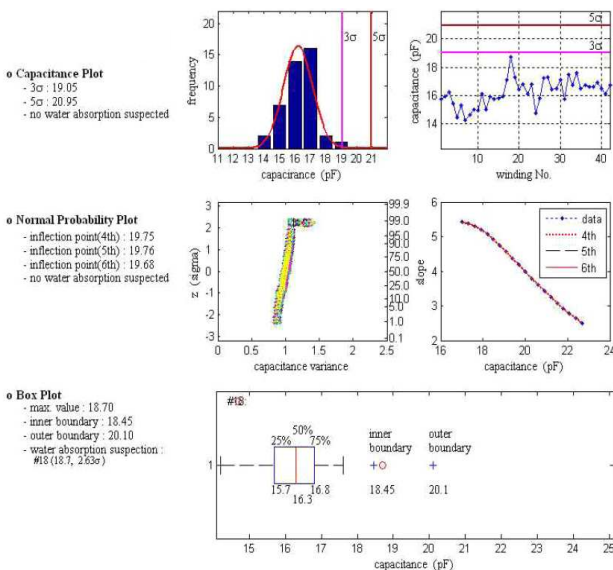
Fig. 5. Water absorption diagnosis results (CET-OUT)

(CET-OUT). Though we can see that the capacitance of winding No. 18 at the collector end side is comparatively higher than those of other windings, we know that this divergence is not sufficient to guide expensive and long repairs, because it has not exceeded 3σ .

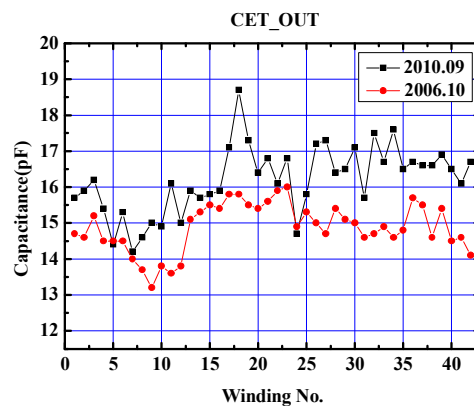
Fig. 6. Capacitance change due to operation (2010.09 vs. 2006.10)

Fig. 6 presents a comparison of the results of the tests performed in October 2006 and in September 2010. It indicates that the change in the capacitance of winding No. 18 has increased in comparison to those of the other windings. This change can be used to predict coolant water absorption in winding No. 18.

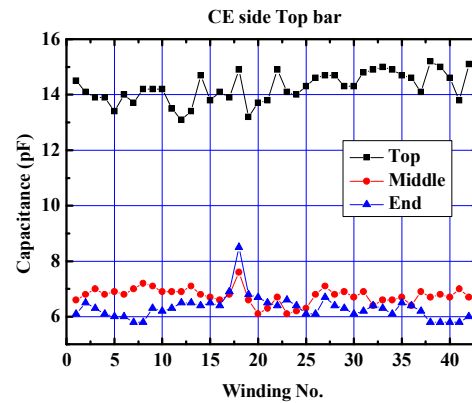
(a) Added measurement position

(b) Capacitance change

Fig. 7. Capacitance change at different winding positions

In the existing water absorption test, the diagnosis of water absorption is based on the change of capacitance at the top position that is shown in Fig. 7(a). Generator manufacturers recommend the replacement of windings within a year if water absorption is found at this top position. Thus, such detection indicates a significant

As shown in Fig. 7(a), the analysis of changes in capacitance can be utilized as an important tool to diagnose accurately the water absorption process along the water absorption route. Measurements of the capacitances at the same positions as the existing water absorption test, that is, at the end where coolant starts to leak, at the middle where water is very slowly absorbed by the capillary phenomenon, and at the top are periodically. Fig. 7(b) shows the capacitances measured at the top, middle and end sections in September 2010. They indicate that the capacitances at the middle and end sections of No. 18 are higher than those of other windings. From this, we can surmise that coolant has leaked from the water clip into the insulator and that water absorption is in progress. The higher capacitance at the end than at the middle means that the amount of water absorbed at the former is larger than that absorbed at the latter, if we disregard the possibility of capacitance variance stemming from differences in the roughness of the insulating paint and the thickness of that insulator from that of the copper conductor, even though the areas of the water absorption sensors are same. Thus, this method enhances the reliability of water absorption diagnosis by measuring capacitances not only at the top but also at the middle and end sections and by entering these findings into a database. In addition, when the water absorption of some windings is suspected, the reliability of its diagnosis can be further enhanced by measuring the capacitances of ± 2 normal windings, at the same position, as those of which water absorption is suspected and comparing the results, as shown in Fig. 8. Comprehensively speaking, the reliability of water absorption diagnosis can be bettered by minutely comparing (1) the results of the existing water absorption test, (2) the capacitances measured periodically at the same positions of windings, (3) the change in capacitance measured at each winding position with small water absorption sensors and, (4) the capacitances of windings in which water absorption is suspected.

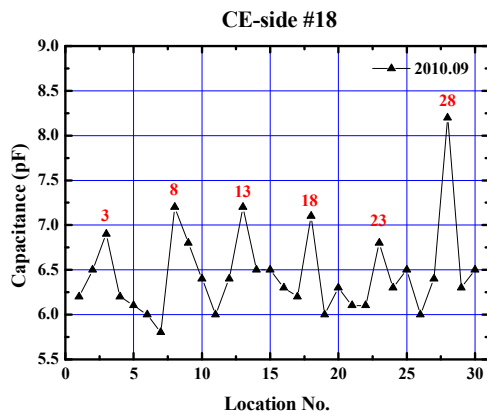
Fig. 9. Precise water absorption diagnosis result

Fig. 9 compares the capacitances of normal windings Nos. 16, 17, 19, and 20, measured with the above method at the same positions at the upper part of collector section as those of winding No. 18 end in which water absorption is suspected. As shown in Fig. 9, the capacitances measured at the positions of winding No. 18 are all relatively higher than the capacitances of windings Nos 3, 8, 13, 18, 23, and 28. Those measured at the end section are, in particular, far higher than those at other positions.
