Effect of lining application techniques on microleakage in class II composite restorations

Byung-Moon Hwang¹, Joo-Hyung Kim², Ji-Man Park¹, Philip Millstein³, Eun-Jin Park^{1*}

¹Department of Dentistry, School of Medicine, Ewha Womans University, Seoul, Republic of Korea

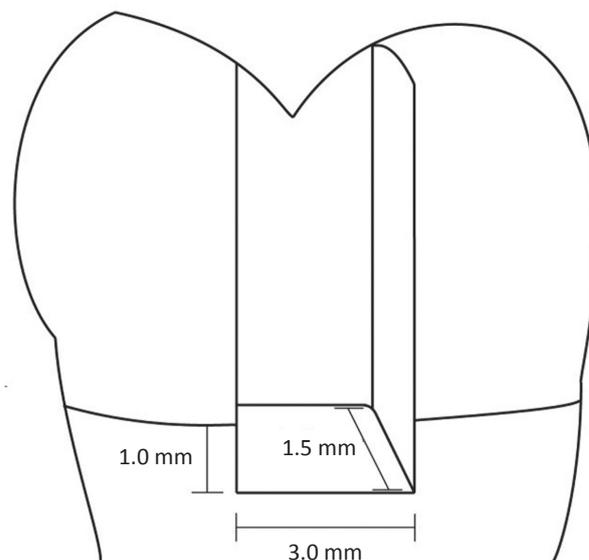
Fig. 1. Schematic view of the tooth preparation.

human teeth (premolars, 1st molars, 2nd molars, and the third molars) extracted for periodontal or orthodontic reason were selected for this study. The teeth were stored in distilled water after cleansing with scalers prior to preparation. The teeth were prepared for one class II box-only cavity on the mesial or distal surface of each tooth using a high-speed hand piece with diamond bur under air-water spray (959KR-018, Komet, Berlin, Germany) as shown in Fig. 1. A periodontal probe was used for measurement of the preparation. All teeth were prepared by a single operator. The teeth were randomly divided into three groups with 12 teeth in each group and restored by the same operator.

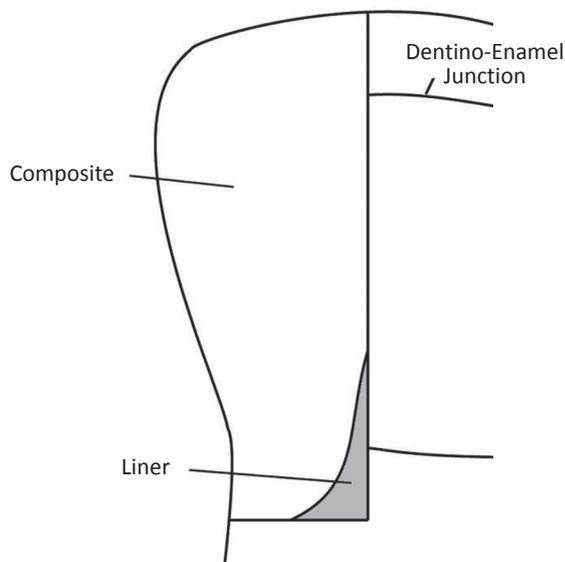
Fig. 2. Schematic view of liner placement for the closed sandwich technique.

of 1000 mW/cm². A second layer of ONE-STEP was applied in the same manner. Celluloid matrices were applied, and an oblique incremental technique was applied to place resin composite (Tetric N-Ceram, Ivoclar vivadent, Schaan, Liechtenstein) as shown in Fig. 2. Each layer was cured separately for 40 seconds. After the restorations were completed, extra thin discs of Sof-Lex (3M ESPE) were used to finish the margins except for gingival margins. The teeth were stored in distilled water before thermocycling.

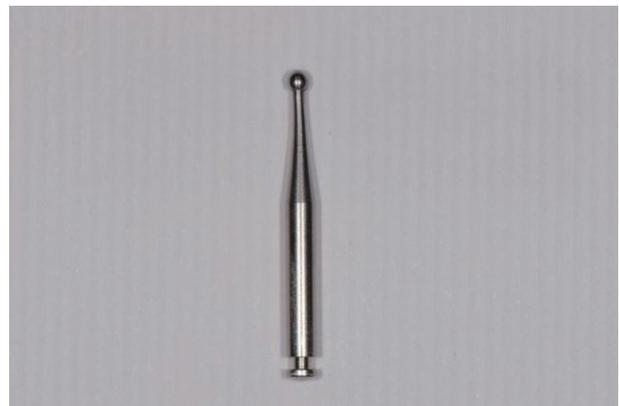
Fig. 3. The bur used in this study.

Group III: The bonding steps were the same as group 1. For applying the resin-modified glass ionomer liner, the rotating bur was used instead of an explorer in the same manner for the same amount of time in group II. The bur used in this study is shown in Fig. 3. This special round bur was made of stainless steel, and 1.5 mm in diameter (Maillefler/

Dentsply, Tulsa, OK, USA). It was made with a 5 degree bend in its shank so that it oscillated upon rotation. When the bur on a mass of composite rotates, it induces displacement oscillations on the composite surface at double speed of rotation.¹⁵ The speed of the bur was set at 300 - 500 rpm for each cavity, and the restoration procedure after this step was the same as in group I.

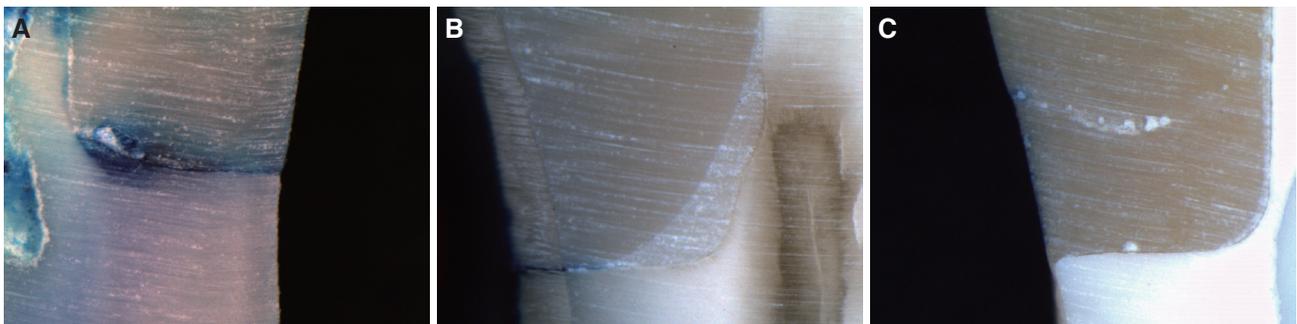
Fig. 4. Microleakage after staining with 2% methylene blue. (A) Control group, (B) RMGI LC liner using explorer, (C) RMGI LC liner using bur.

Each sectioned tooth was observed with a stereomicroscope (Fig. 4) and scored for the degree of dye penetration. Scoring was done by the operator who had no information as to which group each tooth belonged. The scoring scales borrowed from Kasraei et al. are shown in Fig. 5.¹⁰ The same examiner repeated scoring 24 hours later unaware of the previous score. The worst score was selected for compiling the final data.

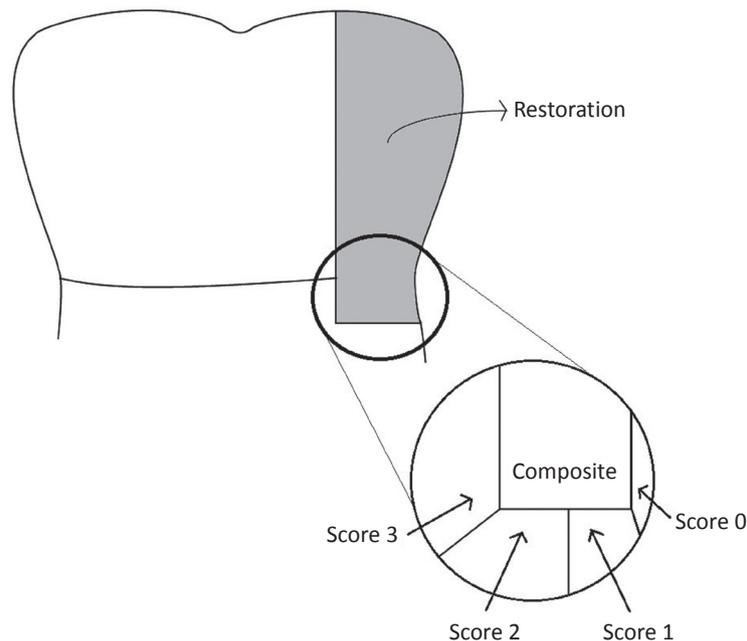
Fig. 5. Schematic view of the scoring scale for microleakage.

0, no leakage; 1, leakage extending to half of the cervical wall; 2, leakage to the full extent of the cervical wall but not including the axial wall; 3, leakage to the full extent of the cervical wall, including the axial wall.
