Evaluation of the effects of two novel irrigants on intraradicular dentine erosion, debris and smear layer removal

Objectives: To evaluate the effects of copolymer of acrylic acid and maleic acid (Poly[AA-co-MA]) and calcium hypochlorite (Ca(OCl)₂) on root canal dentin using scanning electron microscope (SEM). **Materials and Methods:** Twenty-four single-rooted teeth were instrumented and the apical and coronal thirds of each root were removed, leaving the 5 mm middle thirds, which were then separated into two pieces longitudinally. The specimens were randomly divided into six groups and subjected to each irrigant for 5 min as follows: G1, Ca(OCl)₂; G2, Poly(AA-co-MA); G3, Ca(OCl)₂ + Poly(AA-co-MA); G4, sodium hypochlorite (NaOCl); G5, ethylenediaminetetraacetic acid (EDTA); G6, NaOCl+EDTA. The specimens were prepared for SEM evaluation. Smear layer, debris and erosion scores were recorded by two blinded examiners. One image from G3 was analyzed with energy dispersive spectroscopy (EDS) on suspicion of precipitate formation. Data were analyzed using the Kruskal-Wallis and Dunn tests. **Results:** G1 and G4 showed the presence of debris and smear layer and they were statistically

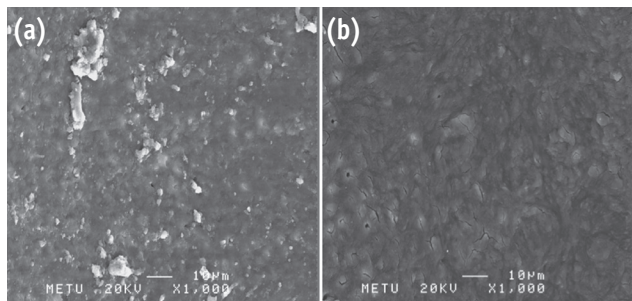
Figure 1. Photomicrographs showing the presence of debris and smear layer. (a) G1; (b) G4 (Bar = 10 μm; original magnification, x1,000).

The smear layer, debris and erosion scores are presented in Table 3. G1 and G4 showed the presence of debris, and heavy smear layer and there was no significant difference between them (Figure 1). The smear layer and debris

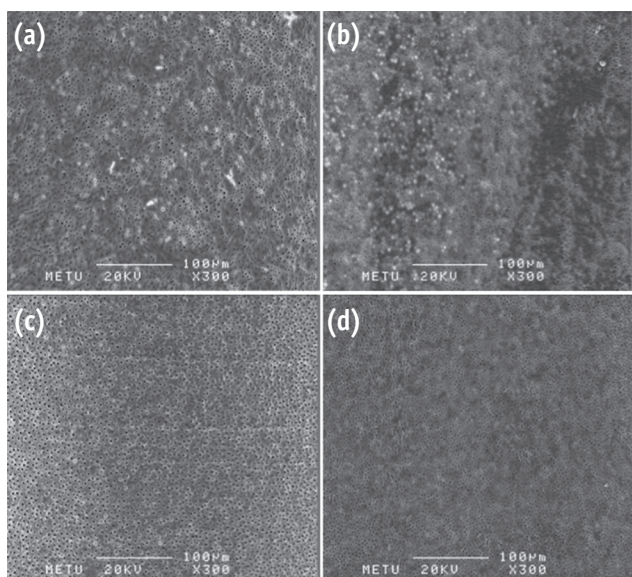
Figure 2. Photomicrographs showing the smear-free surfaces. (a) G2; (b) G3; (c) G5; (d) G6 (Bar = 100 μm; original magnification, x300).

were totally removed in G2, G3, G5 and G6 (Figure 2). The results indicated that G1 and G4 were statistically different from the remaining groups in removing debris and smear layer ($p < 0.05$). In G1 and G4, scoring for erosion could not be done because of the presence of debris and heavy smear layer. G2, G3 and G5 did not show any erosion, and there was no significant difference between them (Figure 3). G6 showed severe erosion and was statistically different from G2, G3 and G5 ($p < 0.05$, Figure 4). EDS microanalysis of a sample from G3 showed the presence of Na, P, and Ca elements on the surface of suspected precipitate (Figure 5).

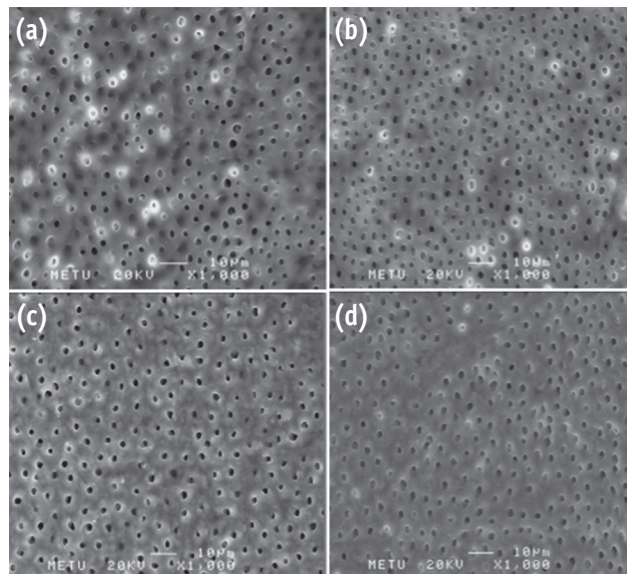
Figure 3. Representative photomicrographs for erosion evaluation. No erosion is present in (a) G2; (b) G3; (c) G5. Moderate erosion can be seen in (d) G6 (Bar = 10 μm; original magnification, x1,000).

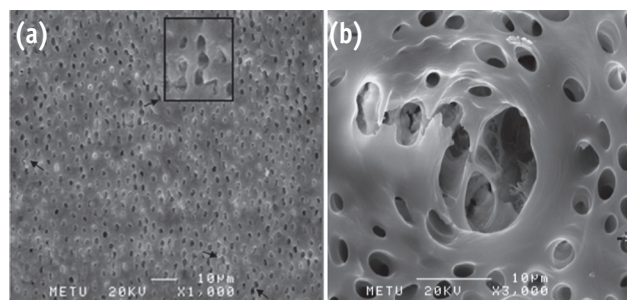
Figure 4. Representative photomicrographs of G6 showing severe erosion. (a) Bar = 10 μm, original magnification, x1,000; (b) Bar = 10 μm, original magnification, x3,000.

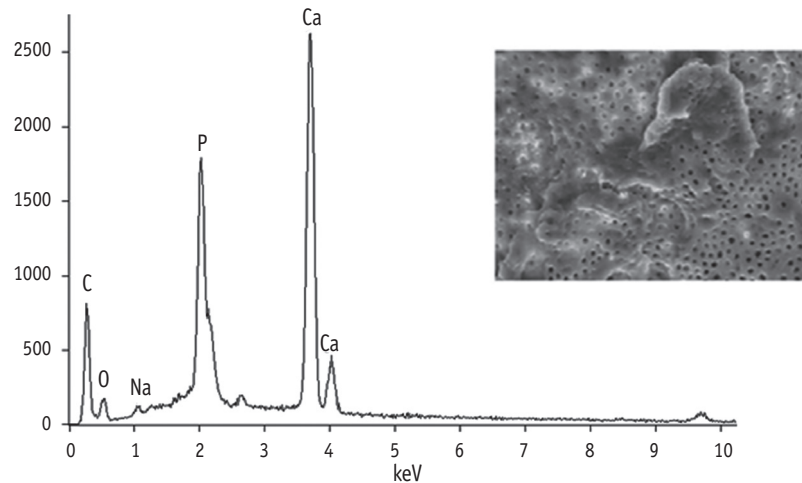
Figure 5. EDS microanalysis of a sample from G3.
