## 전치부 지르코니아 지대주의 축벽 두께

### Axial wall thickness of zirconia abutment in anterior region

**Purpose:** The purpose of this study was to evaluate the proper axial thickness of zirconia abutment applied to implant in the anterior region. **Materials and methods:** Zirconia abutments were prepared at different axial wall thickness by processing pre-sintered zirconia blocks via CAD/CAM to obtain equal specimens. The abutments were each produced with a thickness of 0.5 mm (Group 1), 0.8 mm (Group 2), 1.2 mm (Group 3), or 1.5 mm (Group 4). The implant used in this study was a external connection type one (US, Osstem, Pussan, Korea) product and the zirconia abutment was prepared via replication of a cemented abutment. The crowns were prepared via CAM/CAM with a thickness of 1.5 mm and were cemented to the abutments using RelyX<sup>TM</sup> UniCem cement. A universal testing machine was used to apply load at 30 degrees and measure fracture strength of the zirconia abutment. **Results:** Fracture strength of the abutments for Group 1, Group 2, Group 3, and Group 4 were  $236.00 \pm 67.55$  N,  $599.00 \pm 15.80$  N,  $588.20 \pm 33.18$  N, and  $97.83 \pm 98.13$  N, respectively. Group 1 s

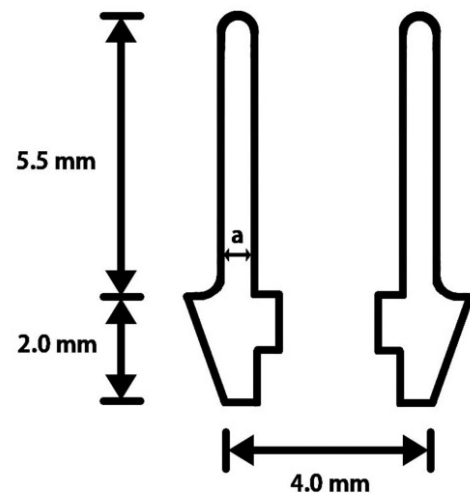
Fig. 1. Abutment design used in the study (a: thickness of axial wall of abutment).

The implant fixture was the external connection type implant (US, Osstem, Pusan, Korea) product of Osstem co. and the zirconia abutment was prepared via replication of the cemented abutment (CAR525, 4.0 mm D × 2 mm GH × 5.5 mm H, Osstem, Pusan, Korea). The zirconia abutment was made by increasing the thickness of the abutment lateral wall, and the emergence profile was

increased with increased axial wall thickness to maintain a fixed form of the finish line (Fig. 1).

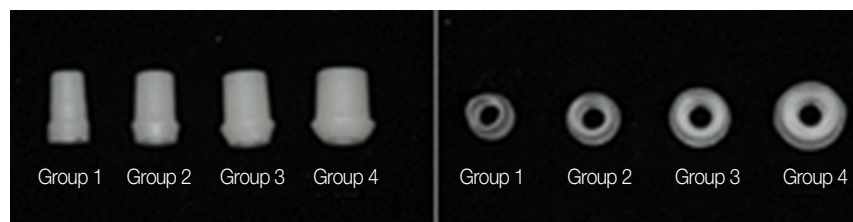
Fig. 2. Zirconia abutment for this experiment. (A) frontal view, (B) incisal view.

The Zirkonzhan CAD/CAM system was used for the production of abutments to create specimens of equal form and thickness for each group. The zirconia abutment was designed on consideration of shrinkage after sintering, and prepared by processing pre-sintered zirconia blocks (Transblock, Zirkonzhan, Gais/South Tyrol, Italy) (Fig. 2).

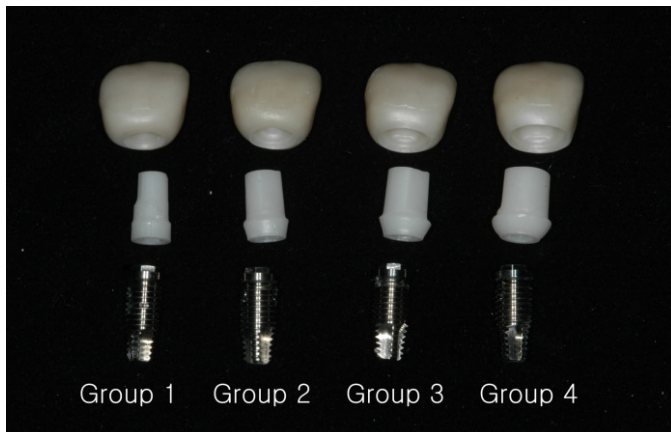
Fig. 3. Implant, zirconia abutment and zirconia crown used in the study.

Four different axial wall thickness zirconia abutments were produced (Fig. 3) i.e., 0.5, 0.8, 1.2, and 1.5 mm. Five abutments were made for each thickness with a total of 20 zirconia abutments. Each abutment was sorted to Group 1 (0.5 mm), Group 2 (0.8 mm), Group 3 (1.2 mm), and Group 4 (1.5 mm), based on its lateral wall thickness. Zirconia crowns were made for each abutment. The crowns were produced using the CAD/CAM system by scanning the zirconia abutments. Five per group with a total of 20 crowns were created with a thickness of 1.5 mm (Fig. 3). Prettau was the zirconia block (Prettau, Zirkonzhan, Gais/South Tyrol, Italy) used for the crowns

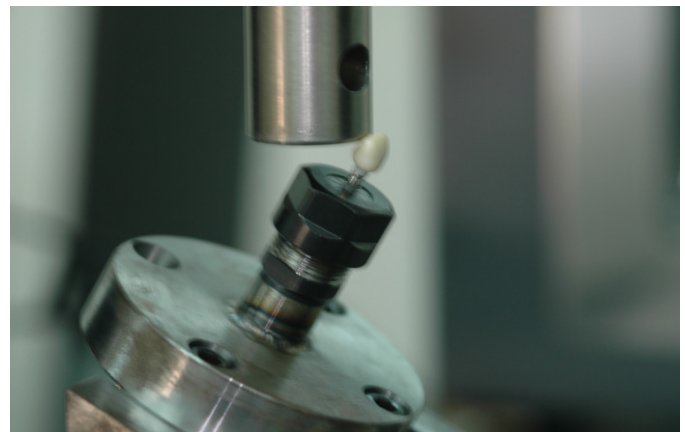
Fig. 4. Measurement of fracture strength. The load was applied 3mm below the incisal edge at an angle of 30°.

A universal testing machine (EXH 750, Lloyd instrument Ltd, Fareham Hants, England) was used to measure fracture strength of the zirconia abutment. A supporting device connected the implant-abutment-crown complex to the tester, as it was designed to apply load at 30 degrees to the long axis of the crown (Fig. 4). Subsequently, it was fixed such that the load was applied to the 3 mm lingual area below the incisal surface (Fig. 4). The amount of load was measured at a rate of 0.5 mm/min until the specimens were fractured.

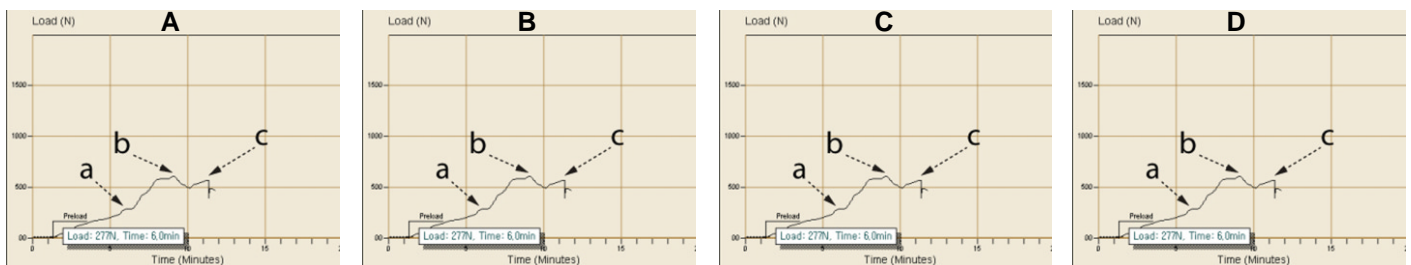
Fig. 5. Fracture aspect of zirconia abutment according to static loading. (A) Group 1: axial wall thickness of 0.5 mm; (B) Group 2: axial wall thickness of 0.8 mm; (C) Group 3: axial wall thickness of 1.2 mm; (D) Group 4: axial wall thickness of 1.5 mm.

The measurement of fracture strength for each group was shown on the following graphs (Fig. 5). Each graph showed the fracture pattern for each group over time. All groups showed a certain change in the pattern to load. A crack of the zirconia abutment appeared at point a, which shows a gradual decrease in applied load, and a deformation of the abutment screw and implant appeared at point b, which shows a sudden decrease in load. At the highest value, point c, the crown cemented to the zirconia abutment was separated from the

implant. None of the groups showed a fracture of the crown. All fractures were observed at the lateral wall area below the abutment screw.

The strength-load graph that represents the fracture pattern of the abutment starting from when the load is applied, shows that the load does not constantly increase. A pattern of a decrease after an increase was observed 2 - 3 times. Load at a rate of 0.5 mm/min resulted in a gradual increase in fracture strength. However, we observed a sudden decrease in load for 5 - 10 seconds. Some factors for the decrease in fracture strength may be fracture of the abutment, deformation and fracture of the screw, and deformation and fracture of the implant.<sup>15</sup> Deformation of the screw and implant would occur after a fracture of the abutment. Even though the screw may deform within its range of elasticity, since the load does not decrease without a fracture in the abutment, the first decrease (point a) in load would be due to a crack from the abutment. The following decrease (point b) in load was observed as a deformation of the screw or implant. A displacement of the zirconia crown-cemented abutment was observed visually, and the load started to increase again even after a certain time of displacement. Load was continually applied even after the deformation of the implant and screw, in order to observe the final failure pattern. A fracture pattern in which the crown cemented to the abutment was separated from the implant, was observed on the final load decrease (point c). However, since the load direction and the point of load application changed with the displacement of the zirconia crown and abutment caused by the deformation of the screw and implant, it may not be associated with the fracture strength of zirconia.
