# Housing Estate Developments and Earthquake Hazards

- Some recent cases in Japan -

Yoshiyuki Murayama\*

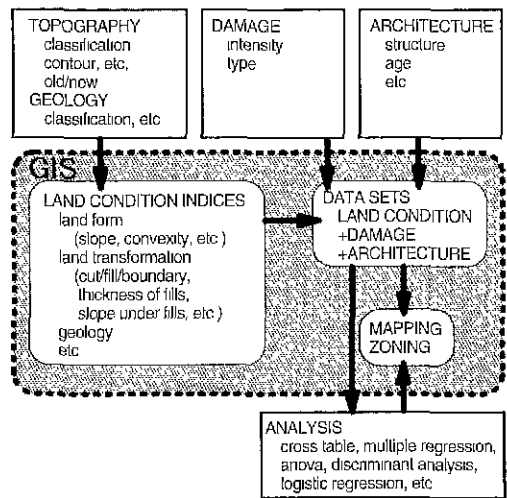
Figure 4. Framework for GIS assisted analysis of the damage to built environment by earthquake

The recent developments in GIS technology enabled a quantitative analysis of landforms and distribution (Figure 4). The relationship between artificial land transformation and damages caused by the Kushiro-oki Earthquake 1993 are examined.
