**(Technical Note)**

**A Review of Pressure Tube Failure Accident in the CANDU Reactor and Methods for Improving Reactor Performance**

**Ho-Sik Yoo and Jin-Gon Chung**

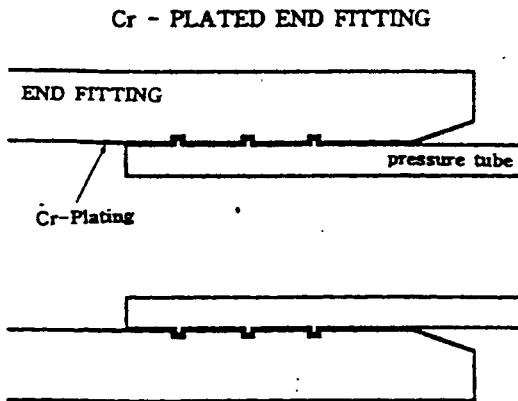
**Fig. 10. Schematic Diagram of a Rolled Joint Showing the Chromium Plating on the End Fitting.**

Hydrogen is absorbed at a higher rate in the rolled joint than in the main body of the tube due to the damage of the oxide barrier during the joint process[1]. Two kinds of methods are suggested to solve this problem. The first method is to put a barrier such as chromium plating between the pressure tube and the end fitting (Fig.10)[13]. Several designs of rolled joints using end-fittings chromium-plated by standard techniques are being tested in a heavy water loop at 300°C. Short term evaluation shows that the reduction in the hydrogen pick-up varies from about 30% to 70%, depending on the design. An alternative method for reducing the hydrogen at the joint position is

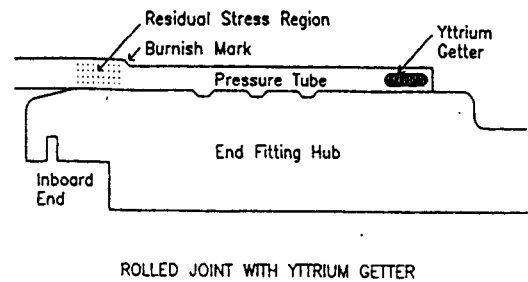
**Fig. 11. Schematic Diagram of a Rolled Joint Showing the Yttrium Ring Bonded to the End of the Pressure Tube.**

to place a sacrificial hydrogen getter in a stress free location. Yttrium is known to be an effective getter because it forms a more stable hydride than zirconium(Fig.11). Rings of yttrium are bonded to the ends of the pressure tubes using hydrostatic pressing. Tests on this method are in progress.

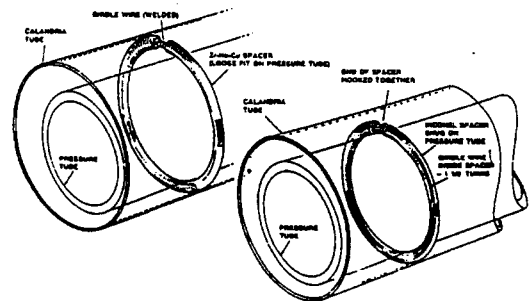
**Fig. 12. Schematic Diagram of the Two Designs of Garter Springs Used in CANDU Reactors.**

The garter spring has the function of separating a hot pressure tube from the cold calandria tube while allowing relative movement of the two tubes without causing wear to either tube[5]. However, the garter springs were designed to fit to the inside diameter of the calandria tube and this allowed them to move by vibration during

installation. This movement and pressure tube sag led to contact between the pressure tube and the calandria tube. This problem could be prevented by using Inconel X750 as garter spring material rather than a zirconium alloy and having an integral internal girdle wire inside the toroid that provides detectability using eddy current techniques (Fig.12)[13].

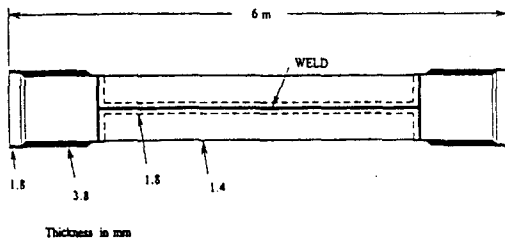
**Fig. 13. Schematic Diagram of the Seam-welded Calandria Tube with Thick Weld Region.**

Calandria tubes should be replaced when they are in danger of contacting with core components located below them or when pressure tube replacement will not be possible due to excessive curvature. Therefore, calandria tube life can be extended by reducing its sag rate. The sag rate can be halved by increasing the wall thickness about 2.5 times for about one meter length at both ends. The burnup penalty associated with such thick ends is only 2 to 4% because the material being added is located in a low flux region of the reactor core(Fig.13). Burst tests on thick-ended calandria tube demonstrated that it did not reduce calandria tube burst resistance, nor induce fracture in the circumferential weld. Currently, properties of thickend calandria tubes are being evaluated[13].
