## Application of the Ultrasonic Detection System for the Power Transformer

權 東 震<sup>†</sup> · 具 教 善<sup>\*</sup> · 金 載 哲<sup>\*\*</sup>  
(Dongjin Kweon · Kyosun Koo · Jaechul Kim)

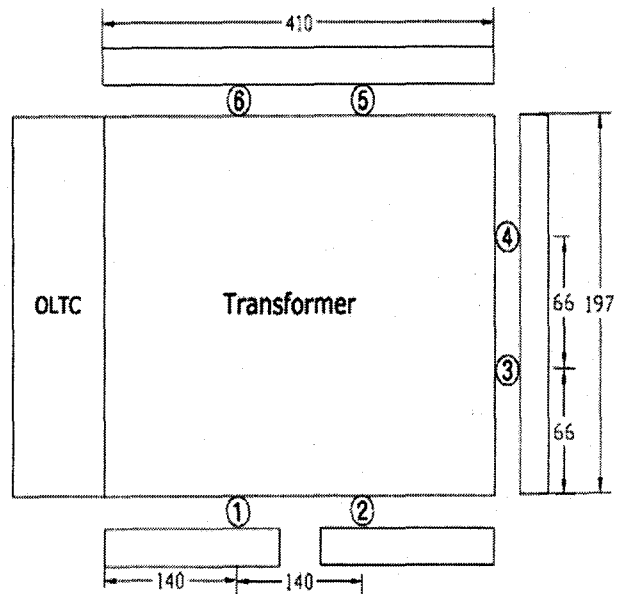
Fig. 3 The position of ultrasonic sensors attached on the wall for the first test

For the first ultrasonic test, the 6 sensors were attached at the same height on the wall of the transformer except for the OLTC side. The existence as well as location of partial discharge inside the transformer are assumed with this first test. Fig. 3 shows the position of 6 sensors on the wall of the transformer for the first test.

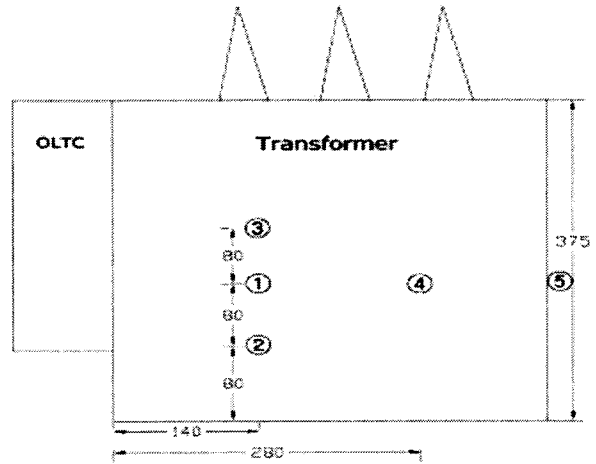
Fig. 5 The position of the sensors of the second test

Fig. 5 shows the position of each sensors for the second test. Sensors ②, ③ and ⑥ in Fig. 3 were moved around sensor ① to detect ultrasonic signals more precisely. Sensor ② was attached at the lower position of the transformer, and sensor ③ was attached at the upper position. Sensor ⑥ was attached at the opposite side of sensor ①.
