Identification on Fatigue Failure of Impeller at Single Stage Feedwater Pumps During Commissioning Operation

단단 주 급수 펌프 임펠러에서 시운전 중 발생한
피로 절손에 관한 규명 연구

Yeon Whan Kim[†], Kye-Yean Kim^{*}, Chun Hee Bae^{*} and Young Shin Lee^{**}

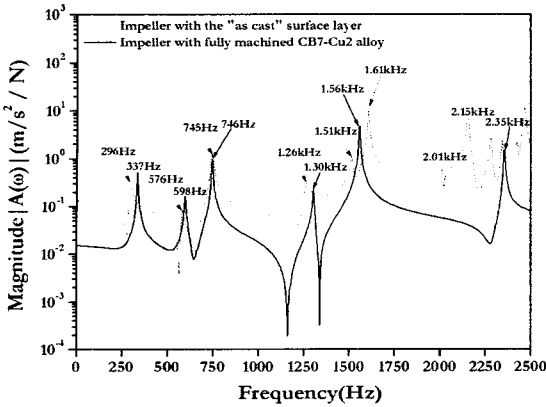
Fig. 5 Plot of impeller inertance in air

The measurement of natural vibration for pump impeller was required to diagnose the impeller failure problems and to specify counter-measures. Breakage of the impeller side plates due to dynamic loading of mostly associated with a resonance between a natural frequency of the impeller side plates and the exciting pressure pulsations(Florjancic, 1973). The impeller was investigated the possibility that impeller natural frequencies could have been excited. The inertance plot for the pump impeller is shown in Fig. 5. Modal test results are shown in Fig. 6. As can be seen from Fig. 6, the modes at 746 Hz, 130 kHz and 156 kHz are dominant modes for the impeller. In water all frequencies are reduced and become less responsive to the magnitude of the input force. In terms of

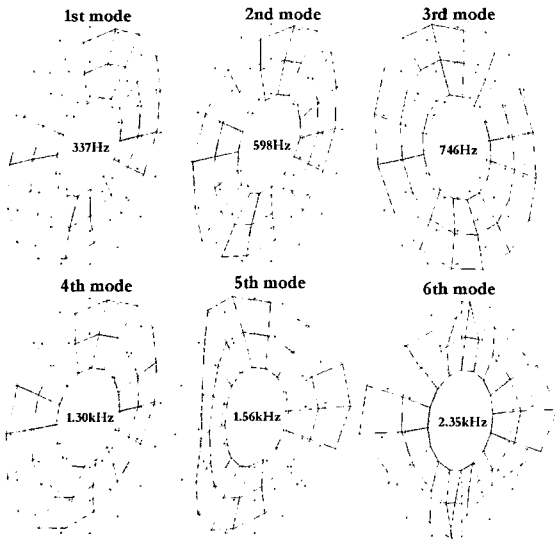
Fig. 6 Views of natural mode shapes for impeller with fully machined CB7-Cu2 alloy in air

excitation possibilities of these modes within the pump, the six impeller vanes and two volute vanes would be expected to produce a pressure distribution which would excite only two nodal diameter modes. Generally, It is said that single diameter modes would tend not be excited by 6 and 2 blade combinations.

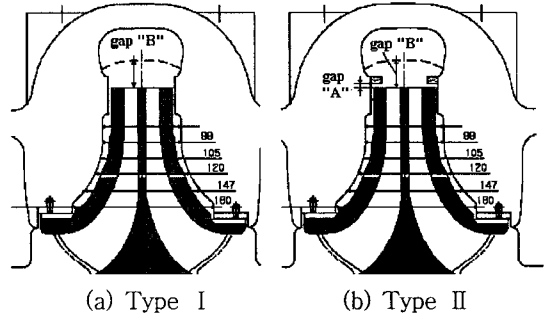
Fig. 7 View for comparison between two type volutes

in field as part of an investigation into the cause of damages. Normally the wake flow at the impeller outlet is the strongest source of pressure pulsation in a centrifugal pump. Broad band excitation forces are caused by large turbulence, flow separation, and flow recirculation. Recirculation between the impeller outlet and volute inlet with large eddies and strong velocity gradients always introduces additional dynamic loading forces on the rotor. Pressure pulsations were measured preferably by piezoelectric pressure transducers mounted in the suction and discharge branch of the pumps. The amount of pressure pulsations actually radiated into the piping system is only a small fraction of the variation of the total pressure at the impeller exit and depends on the acoustic radiation efficiency and the acoustic pipe impedance. Boiler feed water pump systems of two units have “type I” volute in nuclear power station and the pumps of other unit are “type II” as shown in Fig. 7. These tests were made in condition that the failed impeller be changed to new type impeller.
