A Study on Fp Z/8 of Anti-Backlash Gear in an Engine

^{*}R&D Dept., Zhejiang Shuanghuan Driveline Co., LTD., China

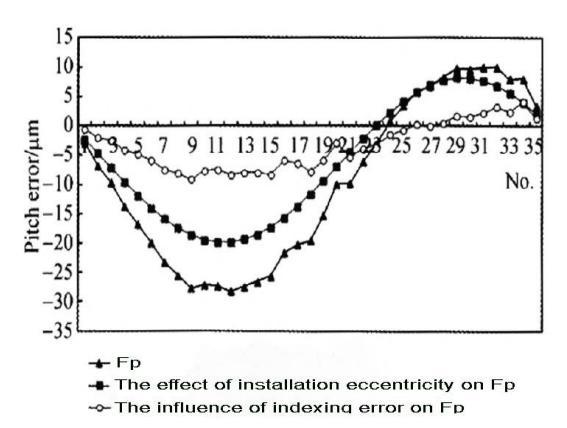
Fig. 5 The influence factors on Fp

As shown in Fig. 5, there are several influence factors of grinding precision on Fp:

- The number of grinding wheels cannot be divisible by the number of teeth.
- The indexing mechanism of the gear grinding machine is not accurate enough^[7].

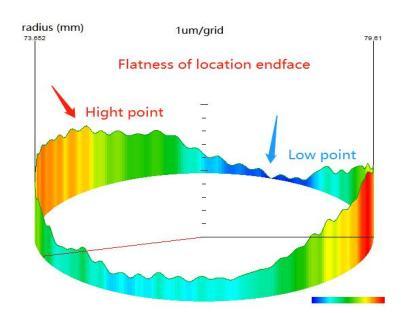
Fig. 6 The plane shape of the positioning

The plane shape of the position is shown in Fig. 6, and the locations of the grinding teeth are shown in Fig. 7.

- The warped workpiece is pressed straight during processing, Fp is stretched, the pressure is released after processing, the workpiece returns to the warping state, and Fp contracts.
- 2) The problem of fixture positioning the end face or upper gland is that it leads to warping of the workpiece during processing, and Fp is stretched. After processing, the pressure is released, and Fp shrinks.

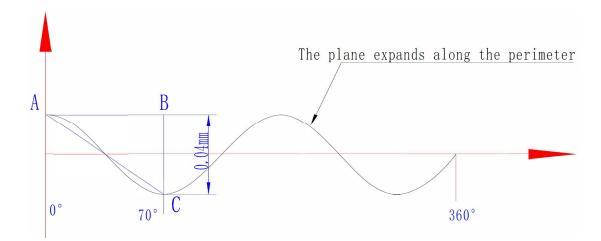
Fig. 8 The schematic of the flatness detection

According to the gear parameters, the diameter of the indexing circle d is 76.28 mm, the flatness detection value is 0.04 mm (as shown in Fig. 8), the flatness wave peak and trough are line segment BC, and the expansion length of the wave peak and trough at the dividing circle is AB=70°X π /180°X(0.5X76.28)=46.6 mm. After the plane is flattened, the extension length at the dividing circle is AC-AB = 1.7X10⁻⁵ mm.

It can be seen from the calculation that the planeness has very little influence on Fp. The defect caused by the fixture problem should be batch, unless the upper gland cross float is intermittent failure.

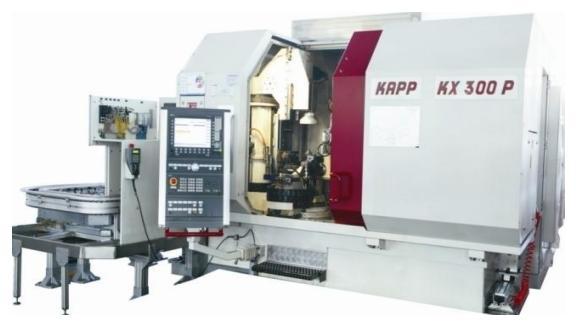
Fig. 11 KAPP300P gear grinding machine

A German KAPP300P gear grinding machine was used. It meets the requirements for manufacturing

accuracy, as shown in Fig. 11, and equipment problems lead to a bad batch, so this factor is excluded^[8].
