머신 비전을 이용한 카 시트 쿠션 프레임 검사 시스템 개발

Development of an Inspection System for Car Seat Bottom Cushion Frame Using Machine Vision

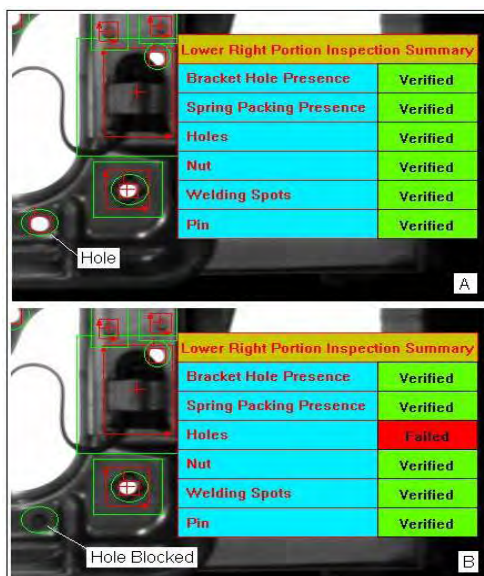
Fig. 2 MVIS Sample Test Results: (a) GQRT for lower right portion all returning "VERIFIED", (b) MPRT sample for lower right portion of the car seat bottom cushion frame.

The first test is the Good Quality Recognition Test (GQRT). It consists of acquiring an image of a good product then running the inspection. The inspection algorithm then is expected to return a decision of "VERIFIED" (Figure 2a).

The second test for the algorithm is the Missing Portion Recognition Test (MPRT). It is done by blocking one or more portions of the product expecting the inspection steps to recognize the missing portions by returning a "FAIL" decision (Figure 2b).
