Health Monitoring of a Composite Actuator with a PZT Ceramic during Electromechanical Fatigue Loading

Keywords: Electromechanical Fatigue, Composite Actuator with a PZT Ceramic, Acoustic Emission, Degradation

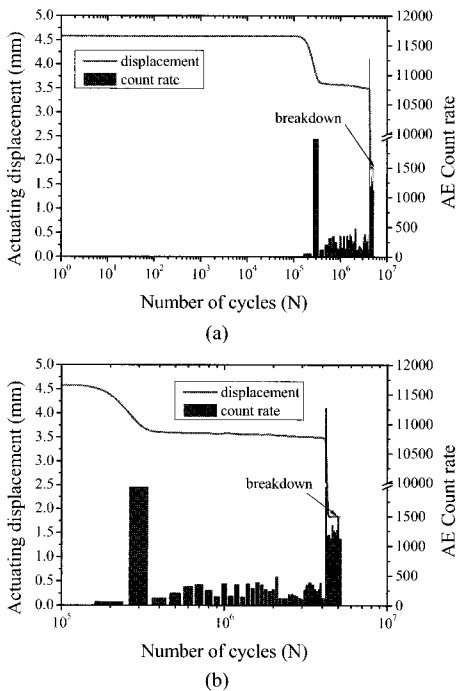
Fig. 7 shows a typical displacement-cycle curve as well as the behavior of the AE count rate for specimen-1. The AE count rate in Fig. 7 is defined as the number of AE event hits every 10^5 cycles. In the case of specimen-1, the initial actuating displacement was 4.58 mm. There is no displacement reduction and any AE signals while the number of cycles reaches 2.6×10^5 where the first AE event begins to appear. However, a high AE count rate occurred together with a 20 % reduction in actuating displacement at about 3.0×10^5 cycles, suggesting that fatigue crack began

to occur and rapidly grew only in the PZT ceramic layer. This is reasonable considering that PZT ceramic is a very brittle material. Subsequently, the actuating displacement degradation continued at a much slower rate until 4.3×10^6 cycles and the AE count rate was low level. After that, the actuating displacement decreased again immensely along with a maximum count rate at 4.3×10^6 cycles. Considering the high AE count rate and the large reduction in actuating displacement, the main cracking in specimen-1 might have initiated and propagated rapidly at this point as observed in Fig 4(c). In a range of $4.3 \times 10^6 - 5.2 \times 10^6$ cycles, a relatively intermediate AE count rate was detected. Specimen-1 reached the final failure at 5.2×10^5 cycles because of a short-circuiting caused by fatigue cracking in the PZT ceramic layer, which was visible to the naked eye. At the final failure of specimen-1, the

actuating displacement was 1.84 mm, which was approximately 60 % less than the initial actuating displacement of 4.58 mm. Hence, the use of specimen-1 without the bottom protecting layer yields a significantly lower actuating displacement under electromechanical cyclic loading.

Fig. 7 Actuating displacement versus the AE count rate with an increasing number of cycles for specimen 1: (a) the entire cycling loading range and (b) the loading range between 10^5 and 10^7 cycles.
