## **Preliminary PINC(Program for the Inspection of Nickel Alloy Components) RRT(Round Robin Test) - Pressurizer Dissimilar Metal Weld -**

**Abstract** After several damages by PWSCC were found in the world, USNRC and PNNL(Pacific Northwest National Laboratory) started the research on PWSCC under the project name of PINC. The aim of the project was 1) to fabricate representative NDE mock-ups with flaws to simulate PWSCCs, 2) to identify and quantitatively assess NDE methods for accurately detecting, sizing and characterizing PWSCCs, 3) to document the range of locations and morphologies of PWSCCs and 4) to incorporate results with other results of ongoing PWSCC research programs, as appropriate. Korea nuclear industries have also been participating in the project. Thermally and mechanically cracked-four mockups were prepared and phased array and manual ultrasonic testing(UT) techniques were applied. The results and lessons learned from the preliminary RRT are summarized as follows: 1) Korea RRT teams performed the RRT successfully. 2) Crack detection probability of the participating organizations was an average 87%, 80% and 80% respectively. 3) RMS error of the crack sizing showed

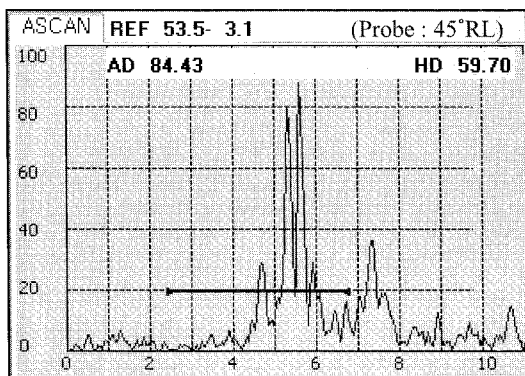
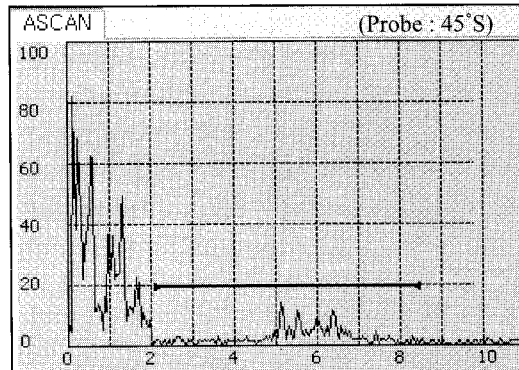
Fig. 4 The back echo signal from defect #1-2

If the transducer was located at 1, 2 or 4, defects #1-1 and 1-2 could be easily detected. It is important to keep in contact with the transducer properly during inspection. One solution would be proper application of couplant to occupy the examination space. Two teams had difficulties in examining because of the tilted surface and in-proper application of couplant. Fig. 4 shows the echo signals from defect #1-2, of which left one defected and right one from the area of non-defect. B team could not detect defects #1-3, 4 and 5. It was simply because the signal from boundary layer between weld and buttering was not separated well.

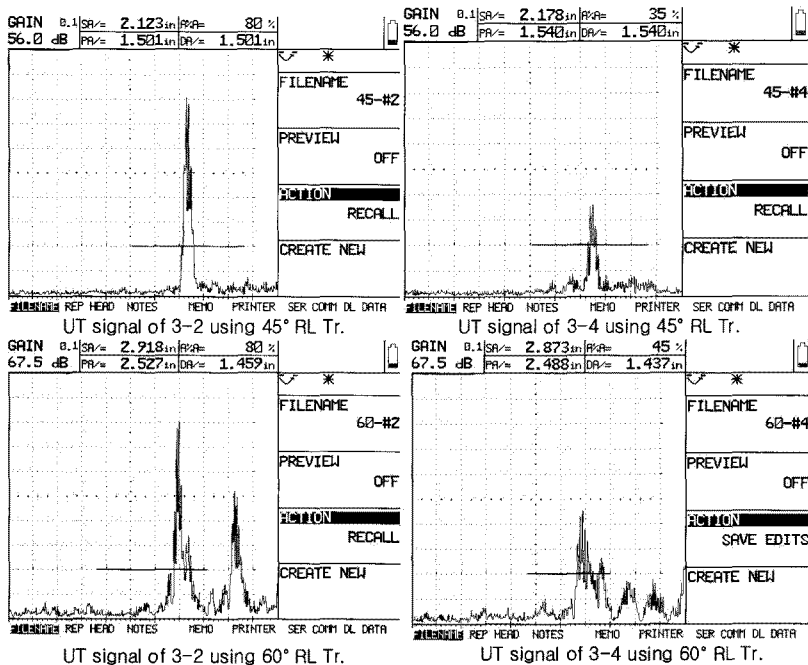
Fig. 6 The comparison between back echo signals and cracks #3-2 and #3-4

Table 8 shows the results of detection for mockup #3. Two teams could not find circumferential ID cracks below 12.7 mm in length and 7.3% and 10.4% of heights in buttering area of alloy 82/182. Three teams found crack # 3-2 of 10.9% height. Fig. 6 demonstrates the comparison of back echo signals of cracks #3-2 and 3-4. Cracks #3-1, #3-2, #3-3 and #3-4 were located in the inner part of buttering and cracks #3-2 and #3-3 were in the center of buttering. Crack #3-1 (9.83 mm in length and 2.44 mm in height) and #3-4 (12.95 mm in length and 3.45 mm in height) were very small and close to the weld root, which resulted in poor resolution and evaluation for the detection.
