Switching Impulse Flashover Tests and Analysis for 765kV Jumper V-strings with Damaged Insulators

Abstract – The 765kV transmission line will be maintained by live-line works for efficient operation. In order to maintain the 765kV transmission lines safely by live-line works, lineman has to know switching impulse flashover characteristics of the jumper V-strings with damaged insulators in advance. In order to know the flashover characteristics this paper carried out experimental flashover mockup tests for jumper V-string with damaged insulators in the outdoors. And it suggests flashover characteristics of the 765kV jumper V-strings also. The results will be used in estimating the safety of live working for 765kV transmission lines.

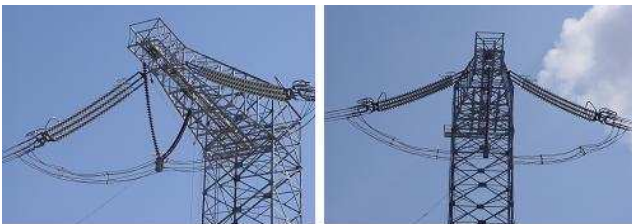
As shown in Fig. 2, the jumper V-string for the six-conductor bundles in the actual 765kV scale was installed together with the strain insulator set.

Fig. 2. Installation of the 765kV jumper V-string

The conditions of the jumper V-string on the test tower were as follows.

- V angle of the jumper V-string: 62°
- Jumper depth: 5.750 mm
- Insulator string length: 146 mm x 38EA = 5,548 mm

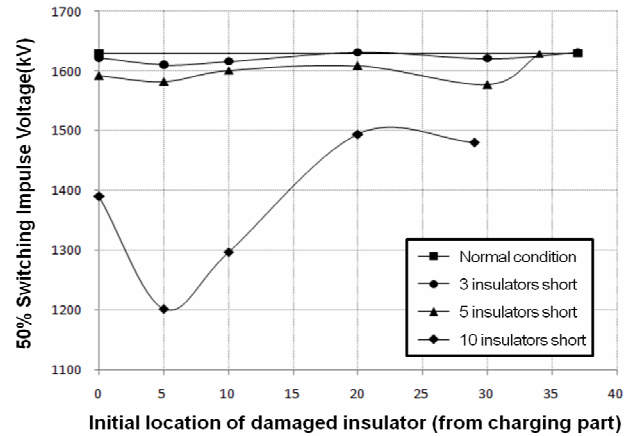
Fig. 4 shows the changing trend of the 50% switching impulse flashover voltage by the number of insulators and damaged insulator positions. The graph reveals the following.

As in the case of the suspension and strain insulator strings, the 50% switching impulse flashover voltage did not change much from that in the normal state when five or fewer insulators were damaged.

When 10 insulators were damaged, the flashover voltage was much lower than that in the normal state. As the

Fig. 4. 50% switching impulse flashover voltage according to the position of the damaged insulators

damaged insulator position was closer to the ground, the flashover voltage was higher.

Test Number	50% Switching Impulse Flashover Voltage (kV)	Standard Deviations (%)
Test 1	1,629	5.3
Test 2	1,622	2.5
Test 3	1,592	5.2
Test 4	1,390	5.3
Test 5	1,610	3.8
Test 6	1,582	4.4
Test 7	1,202	2.0
Test 8	1,616	2.5
Test 9	1,601	1.3
Test 10	1,297	8.7
Test 11	1,631	4.4
Test 12	1,608	1.9
Test 13	1,494	2.4
Test 14	1,621	2.1
Test 15	1,577	2.3
Test 16	1,631	8.0
Test 17	1,629	8.9
Test 18	1,480	2.1

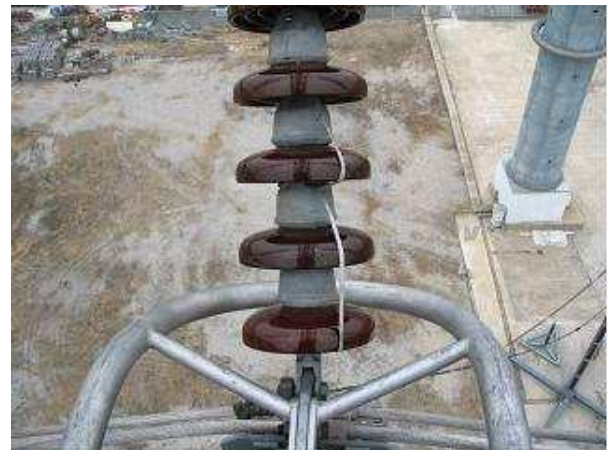
In this test, three insulators from the lowest part of the insulator set (the live part) were short-circuited (Fig. 5). The resulting flashover voltage was similar to that in the normal state. As in the normal state, the flashover occurred between the arcing ring and the arcing horn of the strain insulator set. The flashover also occurred three times between the arcing ring of the jumper V-string and the tower arm.

Fig. 5. Mockup for Test 2

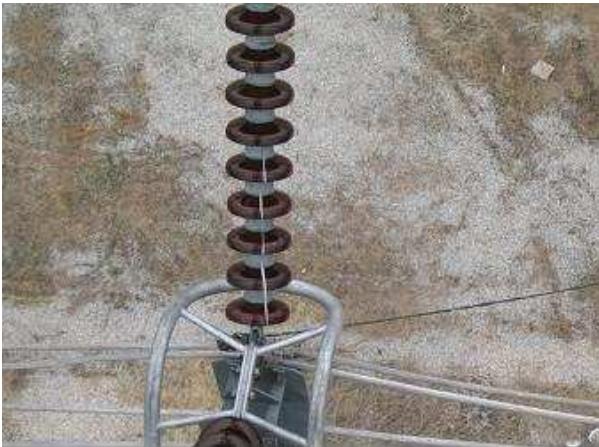
In this test, five insulators from the lowest part of the insulator set (the live part) were short-circuited (Fig. 6). The resulting flashover voltage was 1,592 kV, which was slightly less than 1,629 kV in the normal state. Approximately 70% of the flashover occurred between the arcing ring and the arcing horn of the strain insulator set, as in the normal state. The remaining 30% occurred between the arcing ring of the jumper V-string and the tower arm.

Fig. 6. Mockup for Test 3
