# Development of the Corrosion Deterioration Inspection Tool for Transmission Tower Members

Sangkyun Woo\*†, Inyeop Chu\*, Byongdon Youn\*\*, Kijung Kim\*\*\*

\* KEPCO Research Institute, Korea Electric Power Corporation, 105 Munji-Ro, Yusung-Gu, Daejeon, 34056, Korea

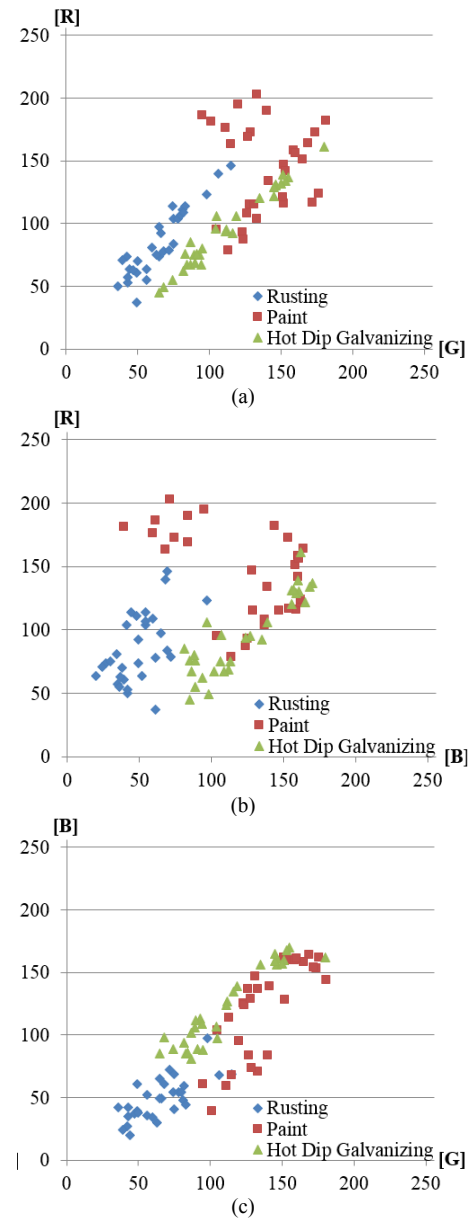
Fig. 2. RGB value of transmission tower steel member. (a) R-G Axis, (b) R-B Axis, (c) B-G Axis

By using the discoloration characteristics of the member surface according to the deterioration of the hot dip galvanizing coating and painting of the transmission tower to perform the color image processing for the evaluation of deterioration level, the color characteristics of the rust, painting and the hot dip galvanizing coating must be secured. In this study, the deterioration image of members in 30 transmission towers in use were filmed to analyze the RGB color value of the rust, painting and hot dip galvanizing coating, and the result is show in Fig. 2 and Table 3.

As shown in Fig. 2 and Table 3, The RGB value of rust can be distinguished to the RGB value of hot dip galvanizing coating

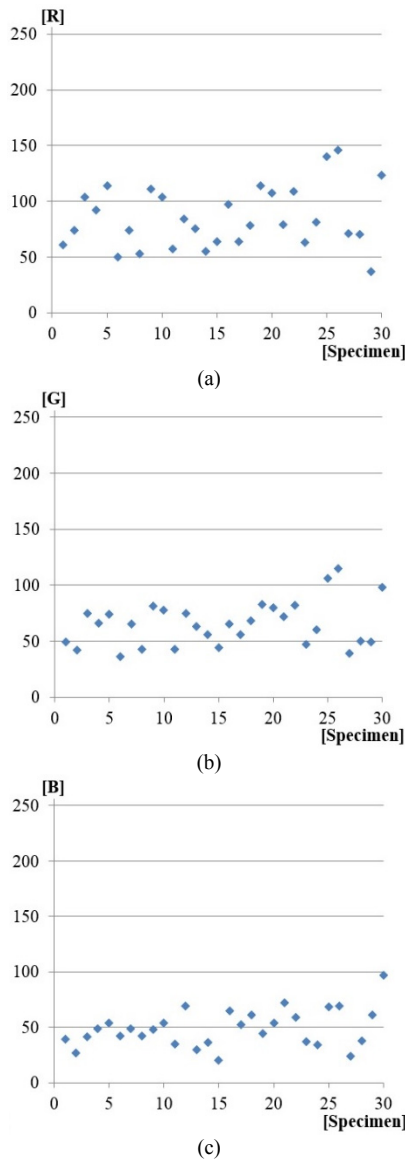
Fig. 3. RGB value of rusting for transmission tower steel member. (a) R value, (b) G value, (c) B value.

and painting. Also, the painting applied on the transmission tower are various, including green, orange, white and ivory according to its purpose, therefore, the RGB value is dispersed widely. Fig. 3 shows the dispersion status of the RGB value on rust. Therefore, regarding the color image processing for determining the level of deterioration level on the transmission tower, the key is to use the RGB value per pixel of the deterioration image of the hot dip galvanizing coating and painting on the member in Fig. 4 to select and extract the RGB value of the rust or painting based on the Table 3 result.

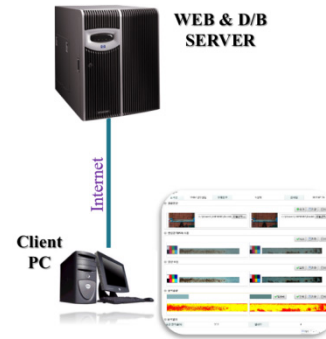
Fig. 5. Architecture of computer-aided diagnosis system for transmission tower steel member.

From the deterioration image of the hot dip galvanizing coating and painted member of the transmission tower, the color image processing corrosion & deterioration diagnosis system was planned for determining the level of deterioration. Also, the system was developed to be usable in web-based Windows environment to improve the use accessibility. The development and operating environment of the corrosion & deterioration diagnosis system is shown in Table 4 and Fig 5.

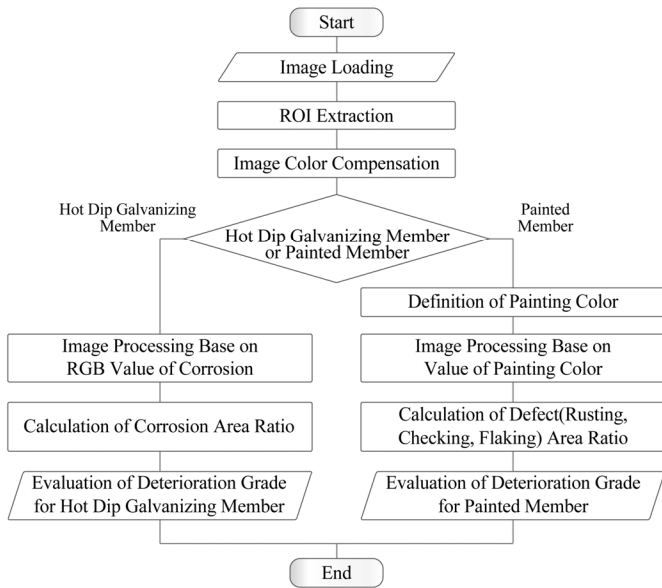
Fig. 6. Flow chart on the computer-aided diagnosis system of corrosion deterioration.

Fig. 6 shows the procedure of determining the level of deterioration on the transmission tower steel member by the color image processing based corrosion & deterioration diagnosis system. The process of determining the level of deterioration on

the transmission tower steel member by the corrosion & deterioration diagnosis system is separated between the hot dip galvanizing coated member and the painted member, but the main processing procedure are the same. In other words, the deterioration image of the transmission tower steel member is taken to be inputted in the corrosion & deterioration diagnosis system, and the ROI is extracted from the image that was inputted. On the ROI, RGB chart is used to perform image calibration, and the hot dip galvanizing coated member and the painted member are divided to perform the color image processing. The area rate of rust and damage are calculated, and the level of deterioration is determined by the criteria of deterioration grade on the hot dip galvanizing coated member and the painted member.

The reason that the decision procedure of deterioration level on the hot dip galvanizing coated member and the painted member is divided is because the RGB value of the hot dip galvanizing coated member and rust are inherent, but the RGB value of the painted member exists diversely according to the applied paint. Therefore, in the color image processing for the deterioration level evaluation of the transmission tower painted member, the procedure of defining the RGB value of the paint is required, and based on the RGB value of the paint determined, to perform the color image processing, the damaged site can be processed into an image.

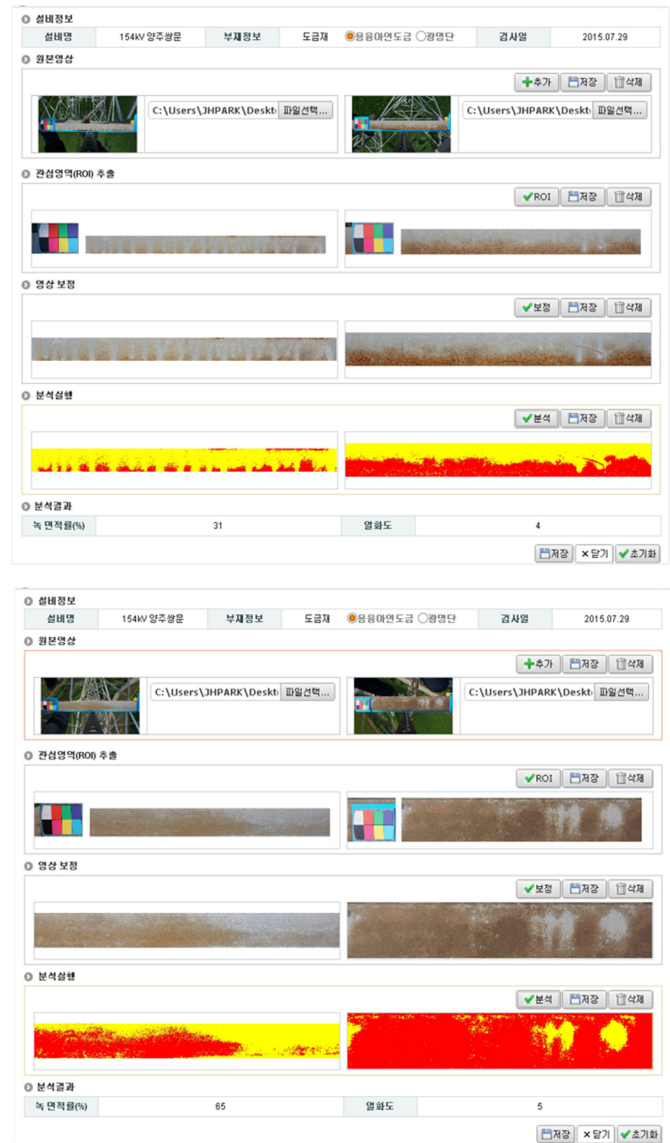
Fig. 7. Analysis result of corrosion deterioration for transmission tower hot dip galvanizing member.

The cases of the result of determining the deterioration level of the hot dip galvanizing coated and painted transmission tower steel member using the corrosion & determination diagnosis system developed in this study are shown in Fig. 7 and Fig. 8. As shown in Fig. 7, the deterioration image of the hot dip galvanizing coated and painted transmission tower steel member acquired from the camera equipment was performed with digital color image processing to convert the rust region pixel into red and the normal region into yellow to enable intuitive recognition on the region of deterioration. Also, in the digital deterioration image, the number of pixel on the red was divided with the number of pixel on the overall deterioration image to calculate the area rate of the rust. As shown in Table 1, the grade is determined by the criteria of deterioration level on the transmission tower of

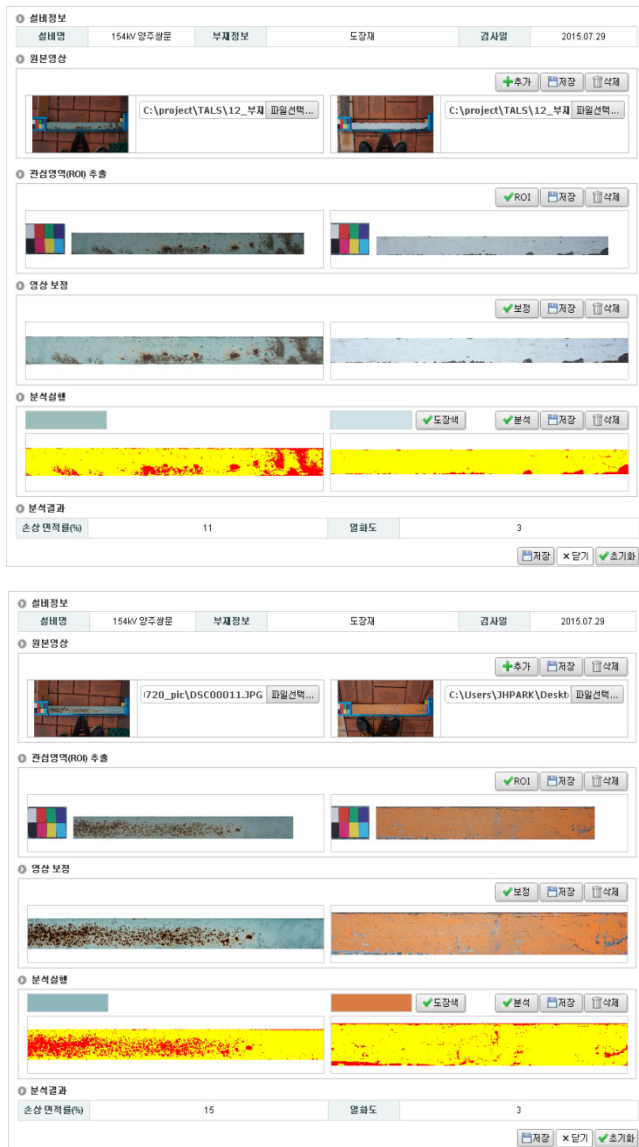
Fig. 8. Analysis result of corrosion deterioration for transmission tower painted member.

KEPCO. For the transmission tower painted member shown in Fig. 8, the damaged region of rust, crack, exfoliation and swelling from the original color of coating and painting are past processed into red to calculate the area rate, and as shown in Table 2, the grade is determined by the criteria of deterioration level.
