# Perception Survey on the Necessity of Improvement for the Standard Buoys Fouling Maintenance

**Abstract** : In 2001, about 20 years after the introduction of the standard buoys, the natural environment and maritime traffic flow changes in the waters near Korea and the necessity of improvement of the AtoN (Aids to Navigation) maintenance was suggested. The IALA provides guidelines for maintenance and management of AtoN, and Korea provides guidelines for the management and operation of standard buoys by means of the Enforcement on the AtoN laws. The objective of this study was to investigate the installation status and the repair status of the standard type buoys by sea area in order to improve the management and operation of the steel standard buoys. In addition, a survey was conducted on the improvement of the steel buoy fouling and the improvement of the lifting inspection cycle towards on the AtoN managers and producers of the representative authority by sea area. In the case of LL-26 (M) buoy type, the standard type buoy installation status of Korea in 2017 was 57.1%, and the LL-26 (M) type was 58.9% showing the highest repair rate. According to the results of the survey on b

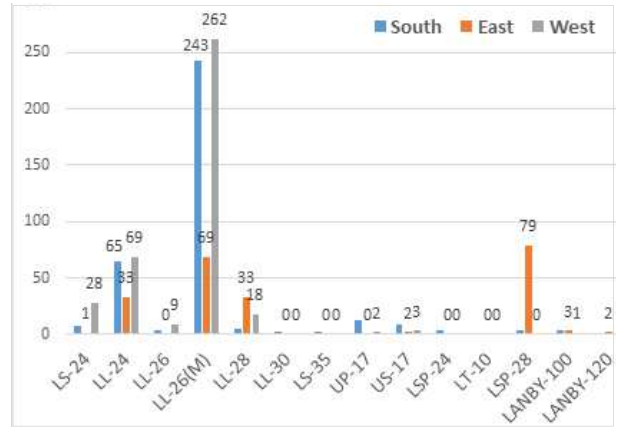
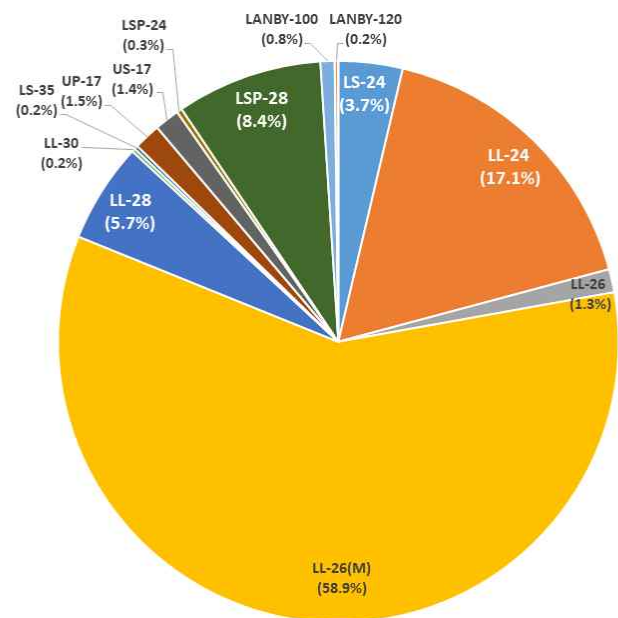
(a) The repaired buoys by sea area

(b) The repaired buoys rate by buoy types

Fig. 1 The number of repaired buoys by sea area, and the rate of repaired buoys by buoy types

LL-26 (M) was the most commonly used buoy type in the whole watershed area, with 262 in the west sea area, 243 in the south sea area, and 69 in the east sea area. The buoy type, which showed the next highest repair rate, was the LSP-28, which had a high repair rate in the east sea with 79 units. The LL-24 buoy type was followed by LL-26 (M), with 69 in the west sea, 33 in the east sea, and 65 in the south sea. The results of the repair rate according to the buoy type and by the sea area are shown in Fig. 1(a), (b).

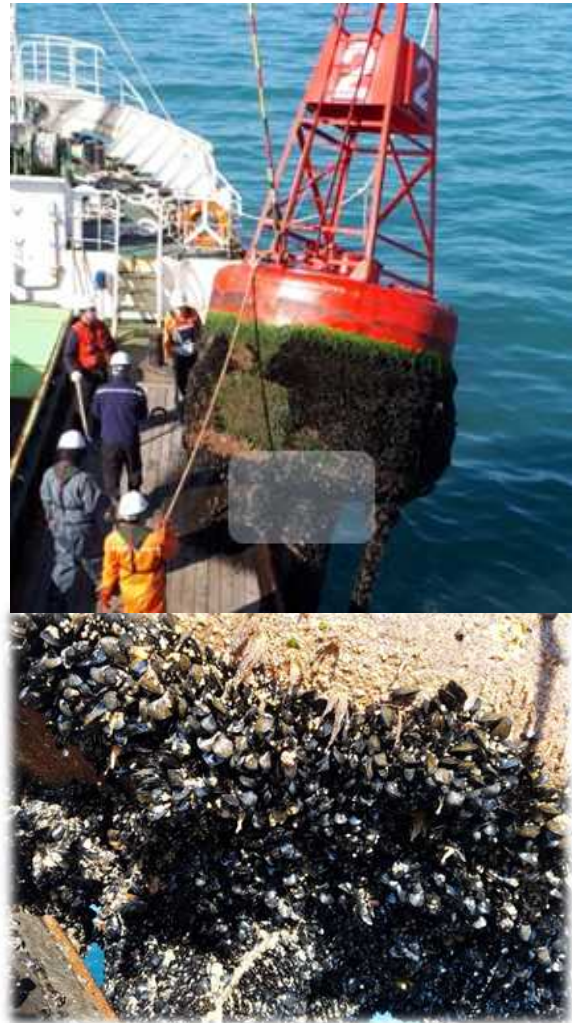
Fig. 2 LL-26(M) type buoy lifting work(top) and attached shellfish(bottom)

Fig. 2 is the LL-26 (M) buoy type, which is the most installed in the whole waters of Korea, and shows the condition of the shellfish attachment of Busan New Port No. 2 lighted buoy during the lifting work performed for the regular inspection in 2017.

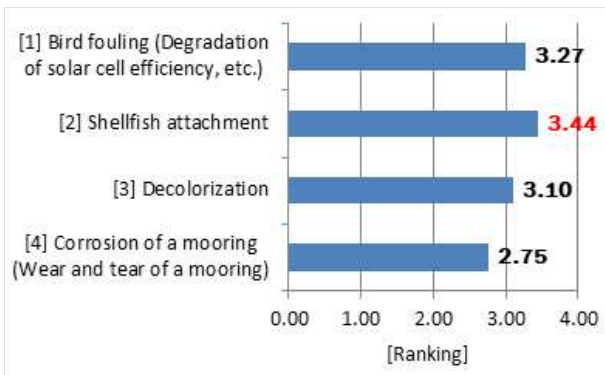
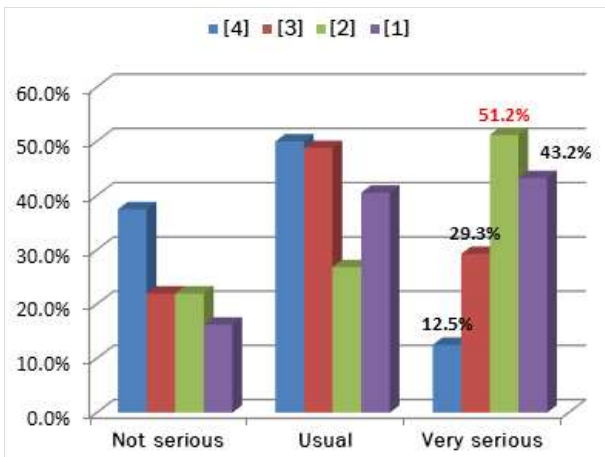
(a) Rank of fouling cause

(b) Fouling severity

Fig. 3 Buoys fouling cause and severity

First, 41 specialists who responded to the questionnaire were asked about the seriousness of corrosion (abrasion), decoloration, attachment of tidal flats and deterioration of solar cell efficiency due to contamination of bird droppings. As shown in Fig. 3 (b), 51.2% of shellfish attachment among the four fouling sources were found to be very serious, followed by 43.2% of pollution caused by avian excreta. As a result of measuring the priority level of the degree of severity of the four pollution factors, the factor of the shellfish attachment (3.44) was the most serious, followed by the decrease of the solar cell efficiency due to pollution of the bird excrement (3.27) > decolorization (3.10) > wear and tear of a mooring (2.75) in that order as shown in Fig. 3 (a).

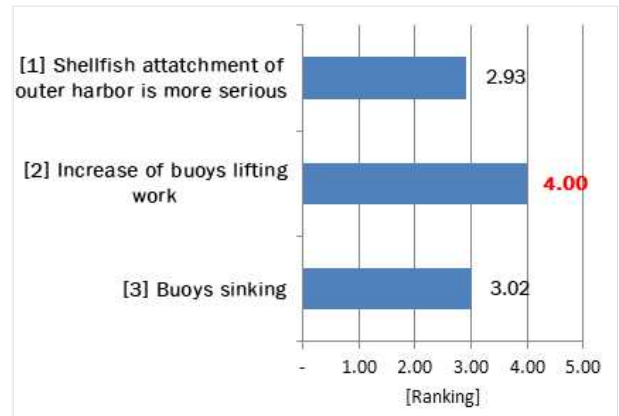
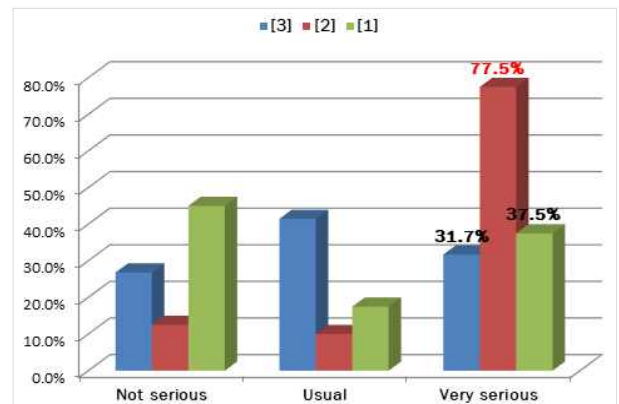
(a) Rank of shellfish attachment difference and problems

(b) Severity of shell attachment difference and problems

Fig. 4 Shellfish attachment problems and severity

Third, we conducted a more detailed opinion on the problem of shellfish attachment, which is one of the most serious factors of steel buoys fouling. As shown in Fig. 4, the effect of the shellfish attachment is more serious for buoys sinking, more work time in buoy lifting work. 77.5% of respondents strongly expressed their opinion at "Very serious", as a result of the fact that it takes more time to work on lifting the steel buoys. As a result, it was the most severe that the more work time for buoy lifting (4.00) among the three effects.

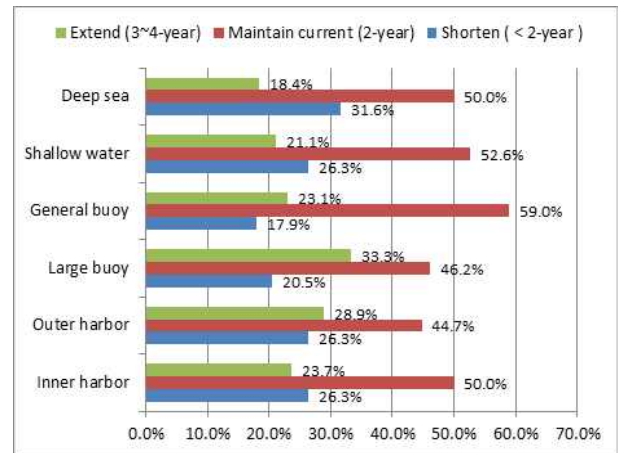
Fig. 5 Perception survey on proper regular inspection cycle by situation

Second, as shown in Fig. 5, the response of expert group was gathered to compare with the current two-year inspection cycle. First, it was shown that the current two-year cycle should be maintained in the Deep-water area (50.0%), Shallow-water area (52.6%), General buoy (59.0%) and Inner harbor (50.0%). Next, 33.3% and 28.9% of the respondents answered that it should be extended to 3~4 years for the Large buoy and Outer harbor buoys. 31.6% in the Deep-water area, 26.3% in the Shallow-water area, Outer harbor and Inner harbor answered that it is need to shorten less than two years.

As shown in Fig. 5 results, the necessity of adjusting the buoy inspection cycle shown was shown that the adjustment period is not necessary in all situations. According to the survey, 50% and 44.7% of the
