A Study on Improving the Strength Properties of Adobe Brick with the use of Agriculture Waste Stabilizer

Sasui, Sasui* Kim, Gyu-Yong** Lee, Sang Kyu* Son, Min-Jae* Hwang, Eui-Chul* Nam, Jeong-Soo***

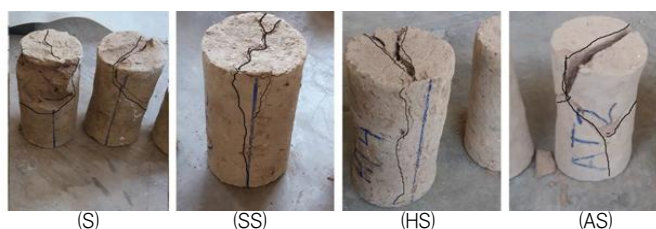
Figure. 1. Failure of specimens after splitting test

The results presented in table 1 indicates that the tensile strength reduced with the addition of husk. However, the effectiveness of stabilizers is determined by the material's failure under tensile loads as shown in figure 1. At the ultimate load, the wide shear crack appeared on (S) and (AS) which thus marked separation of specimen. From the results it is clear that the (AS) increased the tensile strength but the (AS) retains the plastic behavior as at the ultimate load the sudden and brittle rupture was observed. While SS and HS specimens exhibits fine columnar cracks on its height. The crack on specimens containing husk was broad but doesn't leads to the major detachment and the crack on the specimens containing straws was fine and thus no rupture was observed after the removal of load, which thus indicates the elastic behavior under the tensile load.
