## Impacts of Fouling and Cleaning on the Performance of Plate Fin and Spine Fin Heat Exchangers

An experimental study was conducted to investigate the effects of air-side fouling and cleaning on the performances of various condenser coils used in unitary air-conditioning systems. A total of six condenser coils with different fin geometry and row number were tested. Performance tests were performed at three different conditions: clean-as-received, after fouling, and after cleaning. In all cases, it was observed that the fouling was mostly confined to the frontal face of the heat exchanger as reported in the previous investigations. The amount of deposited dust was more dependent on fin geometry for the single-row heat exchangers than for the double-row heat exchangers. The predominant effect of fouling was to cause a more significant increase in air-side pressure drop than a degradation in heat transfer performance. For the single-row heat exchangers, the pressure drop increased by 28 to 31%, while the heat transfer performance decreased by 7 to 12% at the standard air face velocity of 1.53 m/s depending on fin shape. For the double-row heat exchangers, the pressure drop increased

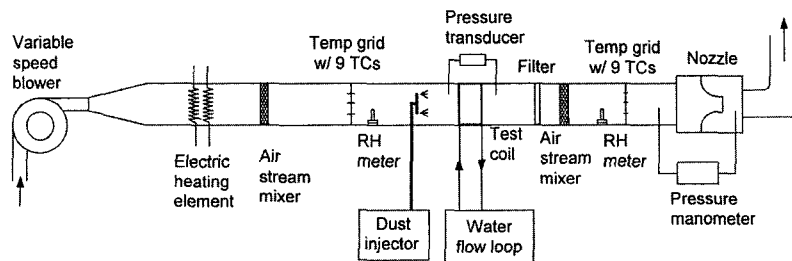
Fig. 1 Schematic diagram of the experimental facilities

Figure 1 shows a schematic diagram of the test facility which consists of an open and rectangular air duct, a closed water loop, a dust injecting system, and the heating coils to be tested. The cross-sectional dimensions of the air duct are 48.82 cm tall by 90.17 cm wide. A variable speed blower draws room air into the preheating sec-

tion of the air duct which was connected to the test section inlet. Four 5 kW electric heaters were located directly downstream of the blower. Currently, the air duct is capable of delivering the coil face velocity from 0.2 to 2.0 m/s approximately and the dry bulb temperature extending from the room temperature to 55°C. In order to measure the static pressure drop across the test coil, a total of eight pressure tap holes with the diameter of 0.159 mm were mounted circumferentially (four holes upstream and four holes downstream of the test coil, respectively).

Temperature grids with nine K-type thermocouples were mounted upstream and downstream of the test coil, respectively. Air stream mixers were installed in front of each temperature grid to get uniform air temperature distributions. Immediately after the test section a final filter was inserted into the air duct to collect the dust passed through the test coil. Two relative humidity meters were also installed inside the air duct upstream and downstream of the test coil in order to measure the relative humidity of the air stream.

The nozzle apparatus constructed according to ASHRAE Standard 33-1978, was located downstream of the test coil and allowed the measurement of the volumetric air flowrate. The discharge of the nozzle apparatus was connected to the outdoors to vent the air. This test loop was sealed with duct tape so that air leakages at places that would influence the capacity measurements did not exceed 1.0% of the test air flowrate.

The test coil itself was directly connected to the closed water flow loop. The main components of the water loop include a flexible impeller pump, a mass flow meter, a surge tank and an electric

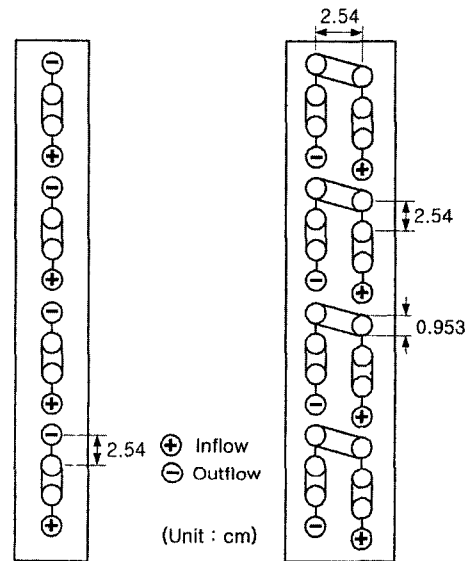
**Fig. 2** Tube circuits of the heat exchangers

(a) Single row coil (b) Double row coil

The exchangers are circuited for both a single row and double row heat exchangers as shown in Fig. 2. All the tubes are connected to either the inlet or outlet manifold. The inlet and outlet manifolds are made by directly soldering the 3/8 in. tubes from the heat exchangers to a 3/4 in. copper tube. A pair of flanges at both sides for each test coil was also added to mount them easily to the air duct. Figure 3 shows a photograph of HX01 (single row with plain plate fins) including the inlet and outlet manifolds and the mounting frame.

bes (i.d.=0.953 cm) in each row. Both single row heat exchangers and double row ones were circuited for water operation according to the suggestion by the sponsor.

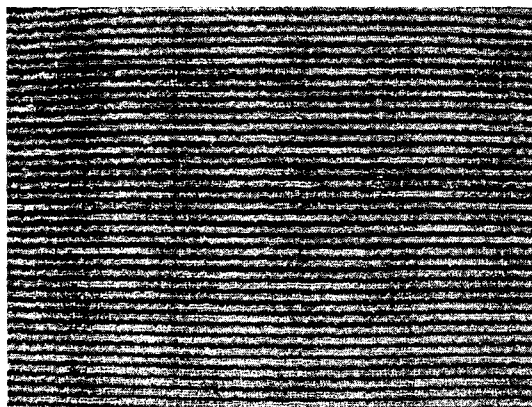
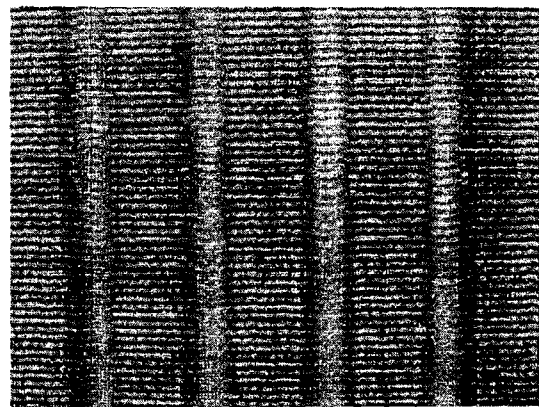
Fig. 4 Photographs of the dust build-up of the single row condenser coil with plain plate fins (HX01)

Enlarged photographic views of the contaminated heat exchanger with plain plate fins (HX01) after dust loading are presented in Figures 4(a) and (b). These figures show partial portions of the frontal view and the rear view of the corresponding heat exchanger. By comparing the frontal views of the heat exchangers with the rear views (even for the other heat exchangers not shown here), it could be seen that the fouling was much more severe on the frontal face of each heat exchanger. The same or similar trends were also reported in previous investigations in the literature (Cowell and Cross, 1981; Bott and Bemrose, 1983). The reason for the restriction of the dust fouling to the frontal face area has not been investigated in great depth. However, it is believed that the basic reason for this behavior is that for the heat exchangers tested, the air flow essentially passes straight through the heat exchanger core. Thus, the frontal surface picks up the fouling particles that impinge directly upon it, and effectively screens the inside of the core. Fin features such

as dimples, louvers, and spines, which stand normal to the surface, and which therefore, may not initially be screened by the frontal surface, very rapidly become so as the face area begins to foul.

It is interesting to note that for the plate fin condenser coil, the dust was more accumulated at the leading edges of the fins as seen in the frontal view of Fig. 4(a) while this was not observed for the spine fin condenser coils. For the plate fin coil, these bridging shapes of the fouling particles act as turbulators that increase the turbulence level of air entering the condenser coil, which results in an increase in pressure drop as well as an increase in heat transfer.

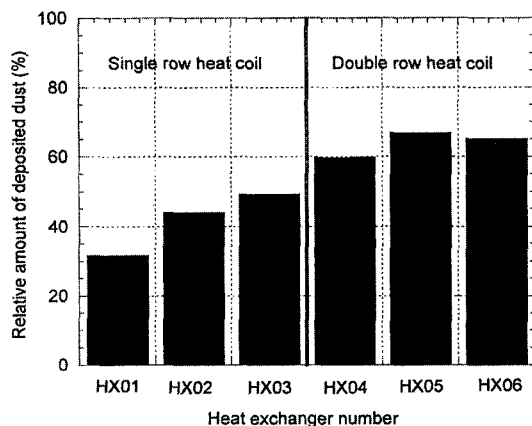
Fig. 5 Relative amount of dust deposited onto the heat exchangers

Figure 5 presents the relative amount of dust deposited onto the heat exchangers. In this figure, the y-axis indicates the ratio of the net deposited amount of dust to the supplied amount of dust (=300g) in percentage. The results show that the amount of dust deposited onto the condenser coils strongly depends on the number of rows as well as the fin configuration. In particular, the dependence of the deposited amount of dust with fin geometry was more significant for the single-row condenser coils than for the double-row coils. The amount of dust deposited onto the single-row condenser coils increased significantly as the fin geometry gets more complex. The amount of

deposited dust also increased with increasing the number of rows as expected. However, the variation of dust deposition with fin geometry was not so significant for the double-row condenser coils when compared to the variation for the single-row condenser coils. As shown in this figure, approximately 30–50% of the dust was accumulated on the single-row condenser coils, while about 60–67% of the dust was accumulated on the double-row condenser coils.

It should be mentioned that the total heat transfer surfaces of HX04 and HX05 are almost twice larger than that of HX02. Intuition may suggest that the amount of dust deposited onto the double-row heat exchangers should also be twice larger than that of the single-row heat exchanger. However, the results show that the deposited amounts of dust onto the double-row condenser coils are only 1.38 to 1.53 times larger than the one deposited on the single-row heat coil. A similar result is obtained by comparing the amount of dust deposited on HX03 (single-row spine fin) and HX06 (double row spine fin).

These results confirm the conclusions that the dust deposition is more significant on the frontal surface/first row fins and tubes than on the second row fins and tubes. Such a different amount of deposited dust depending on the fin geometry and number of rows will cause different effects of fouling on pressure drop and heat transfer characteristics for each condenser coil.

attributed to the larger amount of dust deposited onto the heat exchanger with more complex fin geometries (see Fig. 5). In contrast, the reduction in heat transfer due to fouling decreases as the fin geometry is getting more complex. As mentioned earlier, the deposited amount of dust and its build-up behavior on the heat exchanger depends heavily on the fin shape. Especially, the build-up behavior of dust on the spine fin heat exchanger is different from that of the plate fin heat exchangers. For the plate fin heat exchangers, the dust accumulates on the leading edges of the fins, while the spine fin heat exchanger collects dust, "all over" the frontal surface. This may possible cause the unexpected results. A more detailed study of this phenomenon may be required to completely understand the reasons for these results.

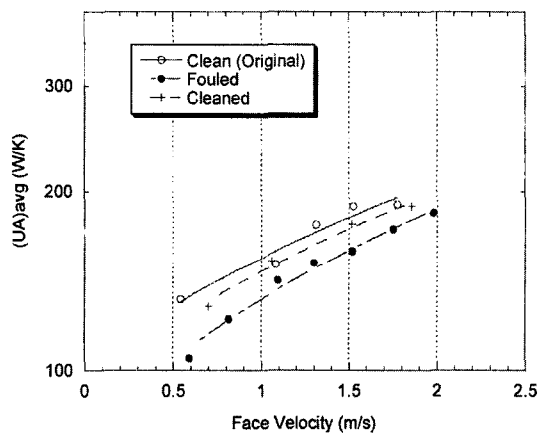
Fig. 6 Pressure drop versus face velocity of HX01 (single-row, plain plate fins)

The air-side pressure drops across the single-row plate fin heat exchanger without enhancement (HX01) at three different conditions as a function of air face velocity are shown in Fig. 6. Experimental data were collected within a range of air face velocities of 0.3 to 2.0 m/s. The open circle and the closed circle symbols indicate pressure drops at clean (as received) and fouled condition, respectively, while the cross symbol presents pressure drops at after-cleaning condition. As shown in the figure, the pressure drop of the heat exchanger for all three conditions increased exponentially with increasing air-side

face velocity as expected.

After fouling of the heat exchanger, the pressure drop across the heat exchanger increased more significantly with air face velocity than the clean heat exchanger. However, after the dust was removed from the heat exchanger by applying the described cleaning procedure, the pressure drop could almost be restored to the level of the clean heat exchanger. At the standard condition of an air face velocity of 1.53 m/s (300 ft/min), the pressure drop increased by approximately 25% due to fouling compared to the clean (as received) coil. After cleaning, the pressure drop decreased to almost the original value and was only about 4% larger than at clean condition.

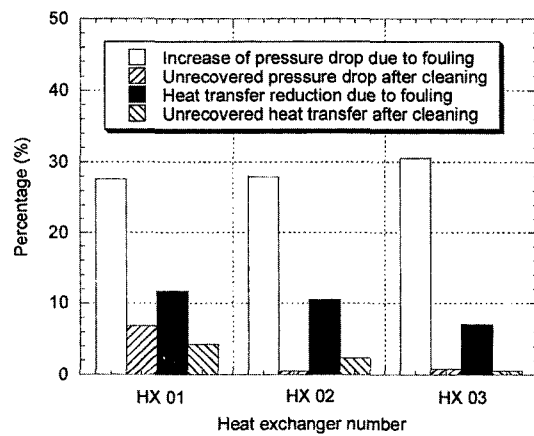
Fig. 9 Pressure drop versus face velocity of HX04 (double-row, one-by-one louvered plate fins)

changer, HX04, are given to Fig. 9 and Fig. 10, representatively. Although the results for HX05 and HX06 are not shown here, similar to the trends observed with the single-row heat exchangers. The pressure drop increased and the heat transfer performance decreased after fouling and using the specified cleaning procedure recovered the original performance after cleaning, in all cases. However, some differences can be noted. The increase in pressure drop after fouling of the double-row heat exchangers is as significant as it was for the single row heat exchangers, but the decrease in heat transfer performance was less

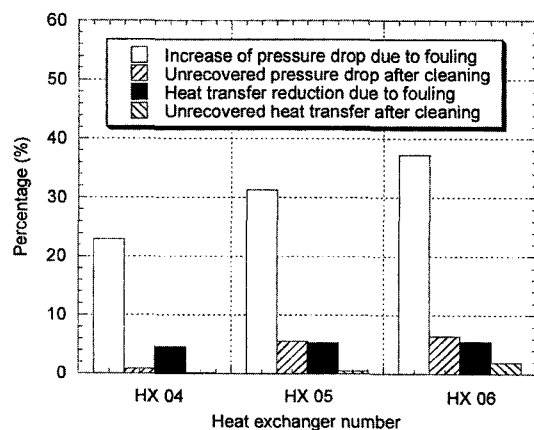
Fig. 10  $(UA)_{avg}$  versus face velocity of HX04 (double-row, one-by-one louvered plate fins)

than what was measured for the single-row heat exchangers.

This can be explained by the fact that the fouling occurs on the leading edges of the heat exchanger and thus, the "blockage" of air flow through the coils is similar for single and double-row heat exchangers, which results in similar trends for the pressure drop. However, if the fouling is mostly occurring on the frontal surface then the double-row heating coils provide a greater depth that is still effective for heat transfer as compared to a single row coil, which results in smaller reduction of heat transfer performance for the double-row coils as compared to the single row coils. Once the loaded dust was removed from the heat exchangers, both pressure drop and heat transfer performance could be recovered to within 1% of the clean-as-received performance.

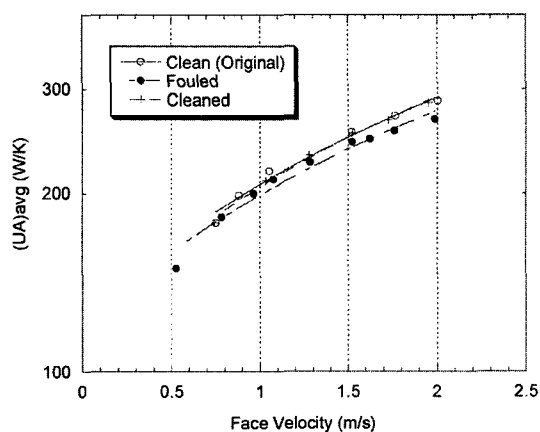
**Fig. 11** Variations of pressure drop and heat transfer of double-row heat exchangers due to fouling and cleaning (air face velocity=1.53 m/s)

Figure 11 shows a comparison of the effects of fouling and cleaning on the pressure drop and heat transfer performance for the double-row heat exchangers at the standard air face velocity of 1.53 m/s. It can be seen in the figure that the pressure drop increases from 23% to 38% whereas heat transfer reduction ranged from 5% to 6%. Again, it has to be noted that the increase in pressure drop due to fouling is significant and in the same range as it was for the single-row heat exchangers, while the reduction in heat transfer

performance is small and much less than that of the single-row heat exchangers. Therefore, it can be concluded that the double-row heat exchangers are more resistant to heat transfer reduction than single-row heat exchangers.

It can also be seen from Fig. 11 that the pressure drop of the spine fin heat exchanger increased more (38%) than for the other two heat exchangers (23%, 31%) due to fouling. Surprisingly, the increase in pressure drop of the continuous plate fin heat exchanger was slightly larger than that of the one-by-one plate fin heat exchanger after fouling, for reason that are not clear and may warrant additional testing to verify these results.

After applying the specified cleaning procedure, the original heat exchangers performance could be recovered to within 1 to 6% just as it was the case for the single-row heat exchangers.
