Case Report

Therapeutic Considerations of Percutaneous Sacroplasty for the Sacral Insufficiency Fracture

Department of Neurosurgery, Sacred Heart Hospital, College of Medicine, The Hallym University of Korea, Anyang, Korea

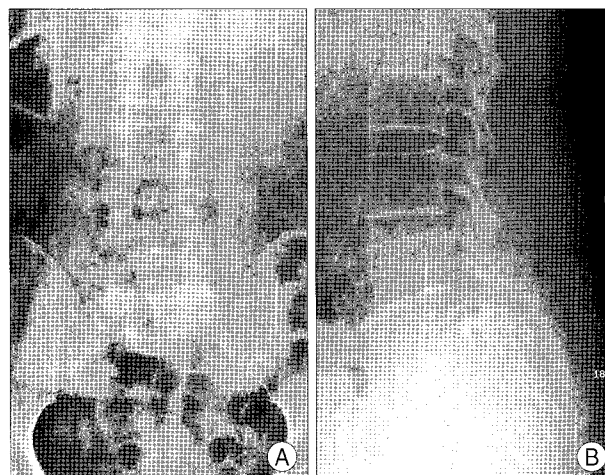
Fig. 1. Plain X-ray radiographs show no definite fracture lines on sacral body and grade I spondylolisthesis L5 on S1 (A : antero-posterior view, B : lateral view).

A 54-year-old female patient visited our hospital with the chief complaints of severe lower back pain and buttock pain on both sides, which she had been feeling for the past 3 months. She had no particular past medical history or trauma history. For over 20 years, she had been doing work that required her to sit on a flat floor for 8 hours a day or longer. Various kinds of conservative therapies had been performed for 3 months, with no relief of symptoms. On physical examinations, she complained severe lower back and buttock pain as well as tenderness in the sacral area. In the neurologic examination, there were neither pain nor hypesthesia in either of the lower limbs. There were also no abnormal manifestations in the laboratory findings. The X-ray radiography revealed degenerative spondylolisthesis L5 on S1 (grade I) and no abnormal finding was observed in the sacrum (Fig. 1). T-score of the lower lumbar spine was -2.0 on the bone densitometry, indicating possible osteo-

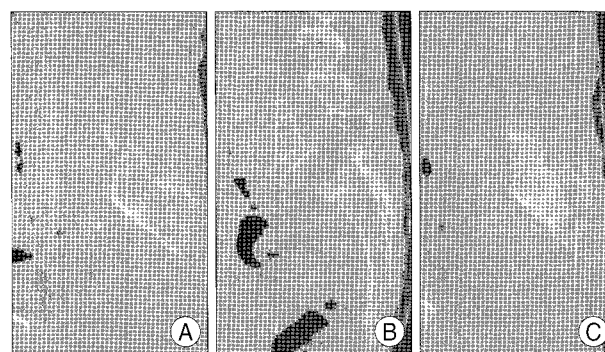
Fig. 2. Computed tomography shows subtle fracture lines on both sacral alae and the second sacral body (A : right parasagittal, B : mid-sagittal, C : left parasagittal).

penia. The lumbar CT showed a subtle fracture on the sacral alae and the S2 body (Fig. 2). The Lumbosacral MRI, showed evidence of degenerative spondylolisthesis L5 on S1, and a lesion revealing abnormal signal intensity was observed in the S2 body (Fig. 3). This lesion showed low-signal intensity in the T2-weighted sagittal image, and low-signal intensity accompanied with surrounding bone edema in the T1-weighted image which was highly enhanced in the enhancement study (Fig. 3). The axial and coronal MR images showed signal changes in both sacral alae and the S2 body, which had a “classical H- or butterfly shaped appearance,” indicating SIF (Fig. 4). She had shown no relief of the symptoms even after approximately 3 months of conservative therapies and she was diagnosed with SIF from the examination of imaging study before the operation. We decided to perform surgical treatment, namely, fluoroscopy-guided percutaneous sacroplasty.

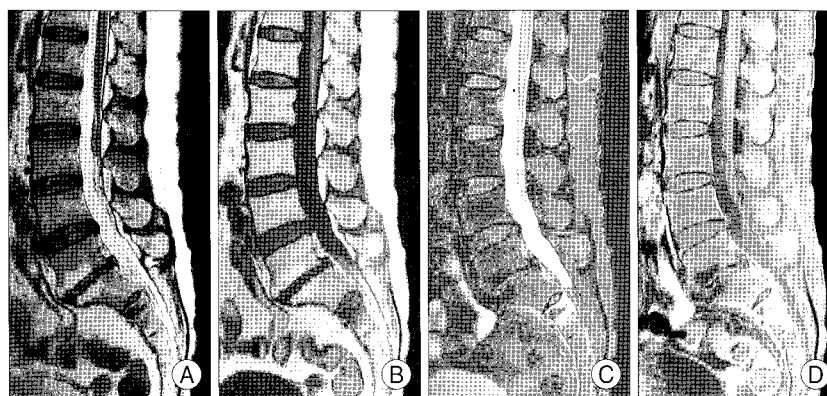
Fig. 3. Magnetic Resonance Images show abnormal signal intensities on the second sacral body. This lesion shows low signal intensity on T2-weighted image (A), low signal intensity and surrounding bone edema on T1-weighted image (B), high signal intensity on fat-suppression T2-weighted image (C) and highly enhanced after gadolinium infusion (D).

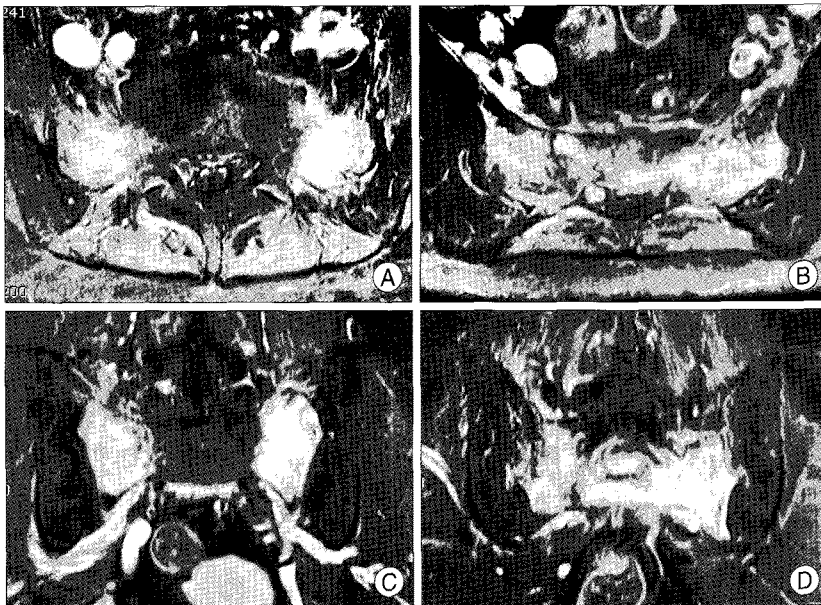
Fig. 4. Magnetic resonance images show highly enhanced lesions on bilateral sacral alars and the second sacral body after gadolinium infusion. This typical shape and pattern of SIF called "classical H- or butterfly shaped appearance". This is a pathognomic hallmark for sacral insufficiency fracture (A and B : axial views, C and D : coronal views).

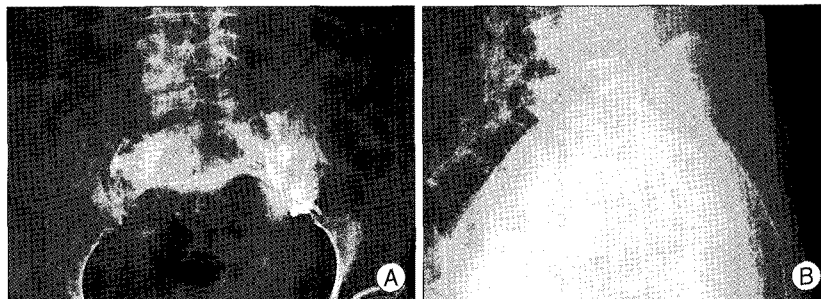
Fig. 5. Post-sacroplasty X-Ray radiographs. PMMA cement is well injected into the bilateral sacral alars. Small amount of cement leak is found in both L5 neural foramina and left sacroiliac joint (A : anteroposterior view, B : lateral view).

The patient was operated on in a prone position under local anesthesia. The operation area was draped with usual sterile manner. Under C-arm fluoroscopic guidance, needle entry point was identified. This was attempted first on the left side using the “long axis injection technique” (Fig. 5). In the frontal plane, the image intensifier was rotated in a cephalad direction, so that the beam was positioned parallel to the L5-S1 disc space, and was aligned to be perpendicular to the long axis of the upper sacrum (S1-S3). To approach the left sacral ala, the image intensifier was turned to the right by around 25-30 degrees to position the beam parallel to the left sacroiliac joint. However, the overall condition of visualization of the C-arm fluoroscopy was inadequate, due to the pelvic bone. The skin insertion site and entry point of the vertebroplasty needle were decided to be at the mid-point between the inferior border of sacroiliac joint and the lateral border of left S3 neural foramen. The skin and the periosteum were anesthetized with 1% lidocaine and bupivacaine. A small skin incision was made and the vertebroplasty needle was inserted and thrust until it touched the bone. The image intensifier was laterally rotated and the needle was directed to point to the center of the S1 body. In the frontal and lateral projection of the image intensifier, while the tip of the cannula was pointing to the geometrical center of the S1 body, the needle was inserted into the medullary cavity

plane. The standard PMMA cement mixture was injected first and then about 2 cc of the cement was injected. As soon as the cement was being injected, a cement leak occurred toward the right L5 neural foramen. In the same manner as earlier described, another needle was inserted into the S2 level to inject about 2 cc of the cement (Fig. 5-7). The small skin incision was primarily closed before completion of the operation.

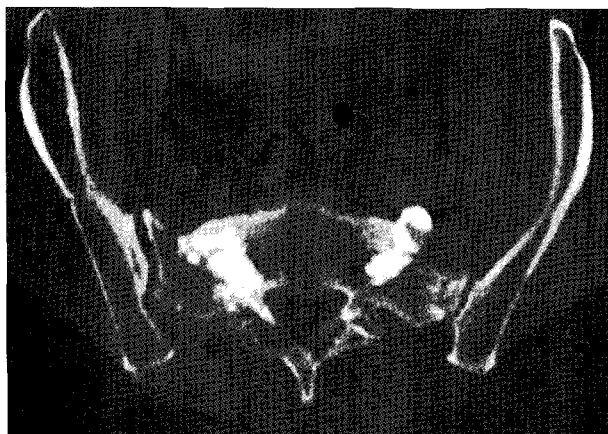
Fig. 7. Post-sacroplasty axial CT scan. PMMA injected into sacral vertebra.
